**NORTHEAST METROPOLITAN  
REGIONAL VOCATIONAL HIGH SCHOOL**  
*Wakefield, Massachusetts*

**PRE-FEASIBILITY STUDY:  
EXISTING CONDITIONS INVESTIGATION AND  
EDUCATIONAL VISIONING REPORT**

**February 1, 2016**

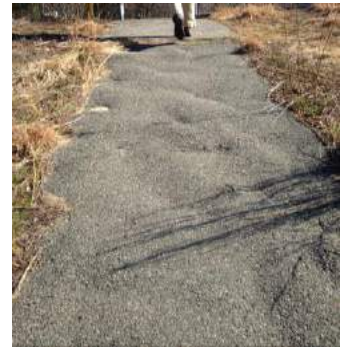
Image 4

The basketball courts adjacent to the track also site on the ledge at a higher elevation than the existing building. The paved ramp to access the courts are in poor condition and have a slope that does not meet accessibility guidelines (Image 4). The basketball courts are in need of general maintenance; replace or reset the chain-link fence; cleanup of debris on the court; replace nets for

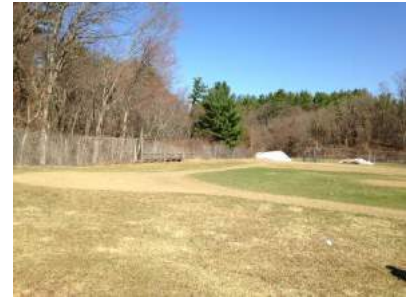
Image 8

The baseball field is located near the entrance of the site, adjacent to the entrance/access road (Image 8). Currently, there are no dugouts for the players and no specified area for spectators. According to maintenance staff, spectators provide their own seating and reside just outside the fence of the field. The field itself, similar to the other playing fields on the campus, would benefit from re-sodding provided it has enough time to “take” without use. Maintenance staff has difficulty maintaining the current field conditions with heavy and consistent wear and tear.

- Players dugouts and spectator seating with accessible ramp
- New grass field
- Replace or reset chain-link fence

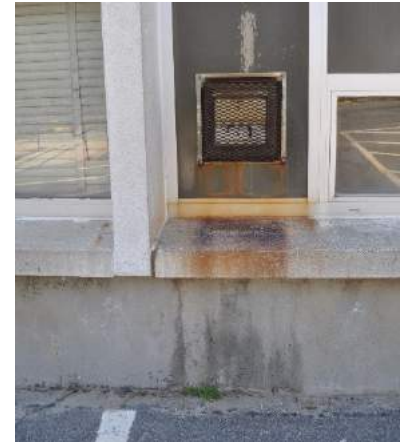
Image 17

10. Rust stains were noted due to vents or fans just above the sill (Image 17).
11. Cracking caulk at the concrete mullions (Image 18) was typical around the building.

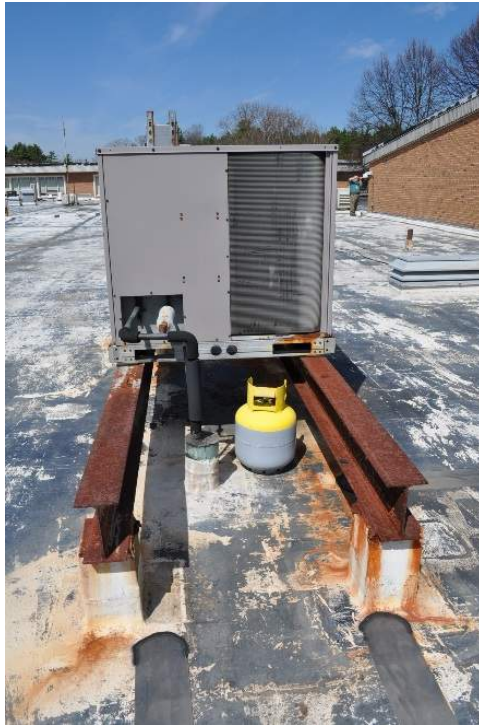
Image 36

4. Most roof top equipment and supporting structures and ladders are rusted and staining the membrane in the surrounding areas (Images 35 and 36).

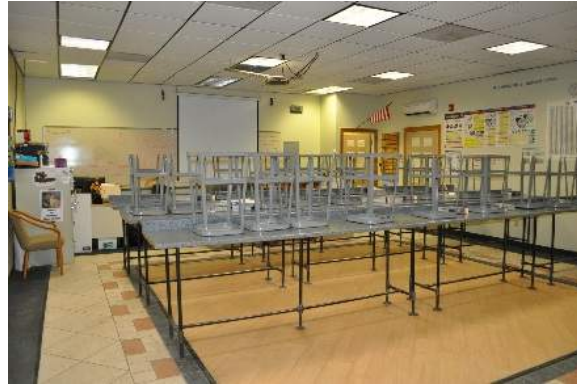
Image 68

perimeter of the walls. All three (3) flooring types appear to be in mostly good condition (Image 73). The carpet has a large water stain along the teaching wall (Image 68). Based on the missing ceiling tiles and stained substrate panels above, there was likely a roof leak.

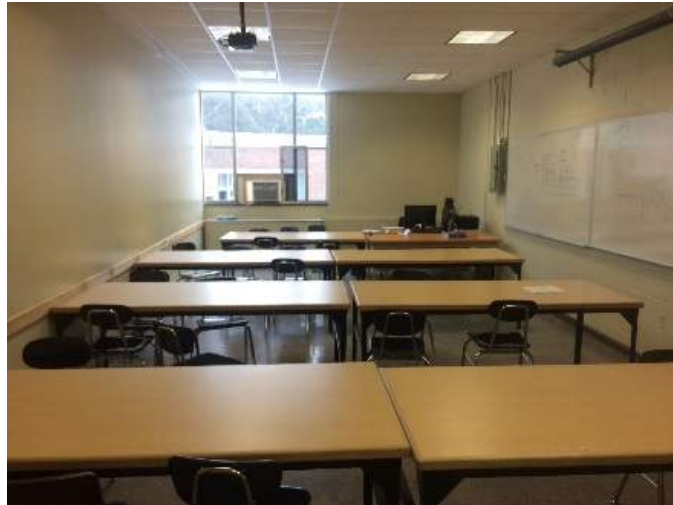
Image 138

Though not necessarily a code violation, the density of furniture in some classrooms is a safety issue, in that there is not a wide enough, clearly defined egress pathway to the door allowing safe orderly egress from the room (Image 138).

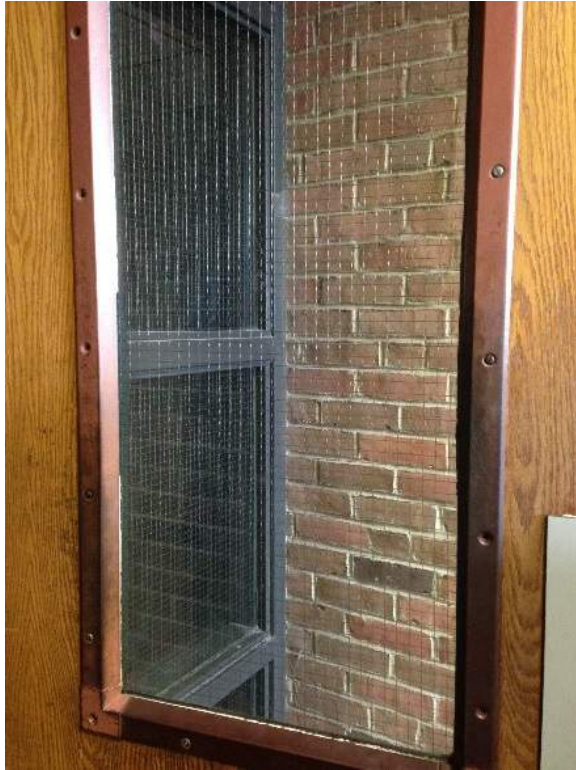
Image 142

Some doors feature wired glass panels (Image 142). Wired glass has recently fallen out of favor since it has been proven to provide no better level of impact resistance than regular plate glass, and once broken the wire strands present a significant cutting hazard. Wired glass is no longer permitted in schools per federal codes and standards.

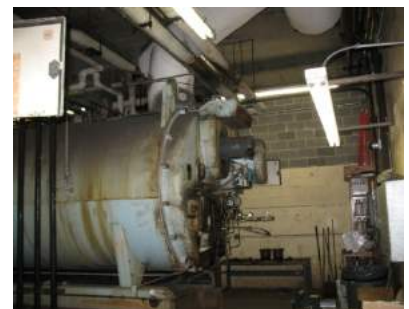
There are two (2) Cleaver Brooks CB 655-350 350 boiler horsepower fire-tube hot water boilers, each with an estimated capacity of 14,645 MBH input with the capability of burning 97.6 gallons per hour of No. 4 fuel oil. These boilers are original to the building. These boilers supply 180 deg. F hot water to the building. Each boiler is provided with dual low water cut-offs and all operating and safety controls. (Image 4)

Fire tube Boiler - Image 4

It is our understanding that the boilers were re-tubed about 10-12 years ago and currently tubes are replaced as needed.

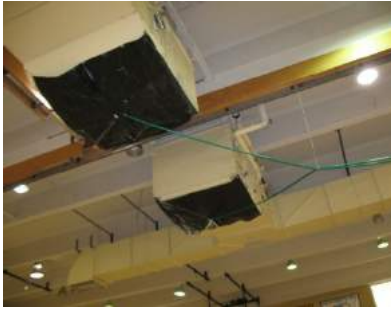
Gymnasium Fresh Air Hood Leaking -  
Image 10

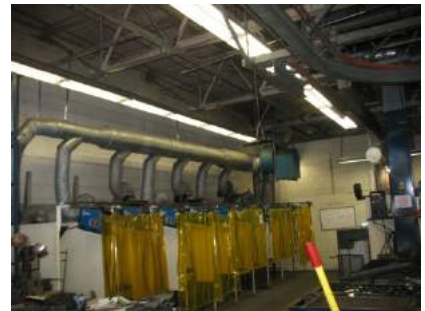
The metal fabrication shop is served by a 6000 CFM heating and ventilating unit with roof mounted fresh air hood. The welding booths and benches have Fume Gator snorkels tied into utility set exhaust fans hung from the ceiling. The instructor's office has some ventilation off the central shop system and is cooled by a wall mounted air conditioner rejecting heat into the shop. (Image 13)

Welding Booth Exhaust - Image 13

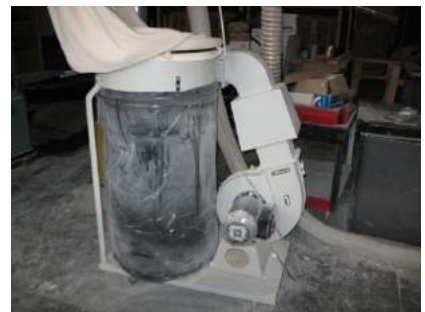
The carpentry shop 151 is served by a 6000 CFM heating and ventilating unit with roof mounted fresh air hood. Each piece of woodworking equipment is connected to a dedicated dust collector/filtration unit that discharges air back into the shop. (Image 14)

Carpentry Shop Local Dust Collector - Image 14

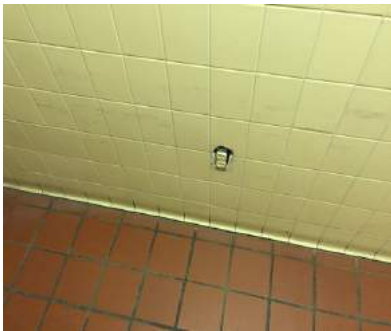
In other instances wall plates have been removed creating a potential for an electrical shock hazard. Image 11 shows the missing wall plate. Wires can be seen and somewhat exposed.

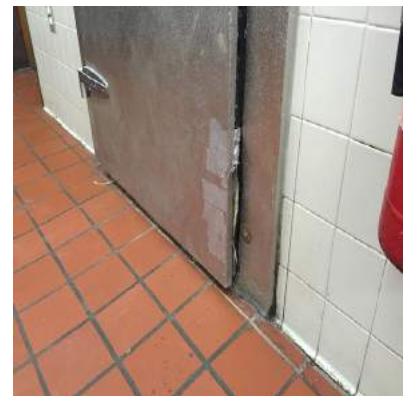
Image 14 is showing a walk-in cooler door that has already been replace once. The replacement door is showing significant rot in the lower right corner and duct tape is being used to keep the paneling in place. The door gaskets are leaking and overall the energy efficiency of the door is poor.

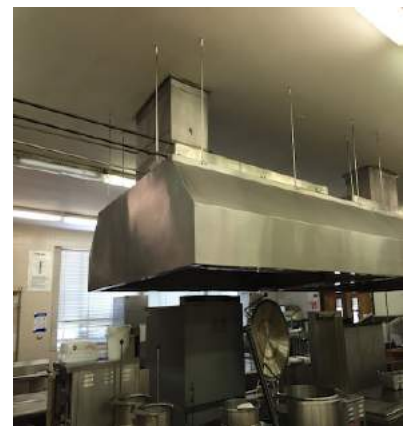
Image 15 is a hood in the Culinary Arts kitchen. Similar to the main kitchen hood it is open to the finished ceiling above. Again, modern standards call for it to be sealed to the flat ceiling above. The ducts in this case appear to be in better condition. The construction of the hood is antiquated and lighting is poor. Modern hoods are more energy efficient and offer the adequate lighting levels needed for instruction.

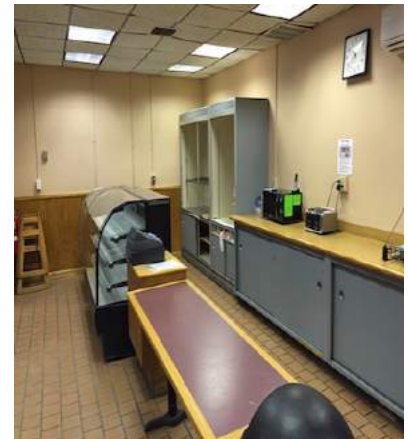
Image 20 - As a supplement to the sit down meal option there is a retail bakery area where baked goods and refrigerated items are displayed for sale. At the rear wall there is a tall bread display case and adjacent to that is a back counter offering beverages as well as supplementing the beverage service of the sit down restaurant. The equipment is reusable but the millwork components need to be replaced.
