**Re: Landscape Existing Conditions Report**  
Northeast Metropolitan Regional Vocational High School  
100 Hemlock Rd, Wakefield, MA 01880

### **Module 3: Section 3.1.4 Evaluation of Existing Conditions**

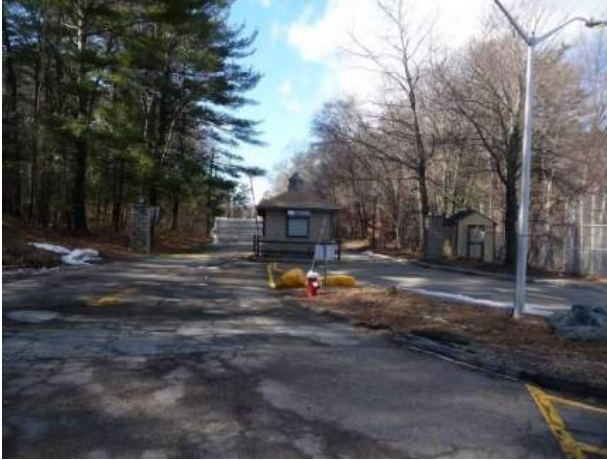
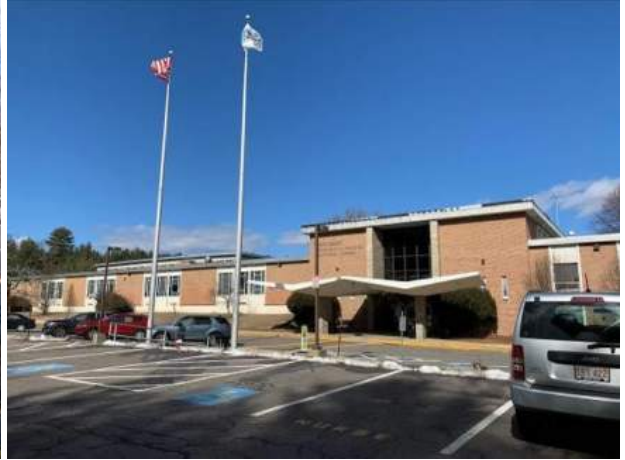
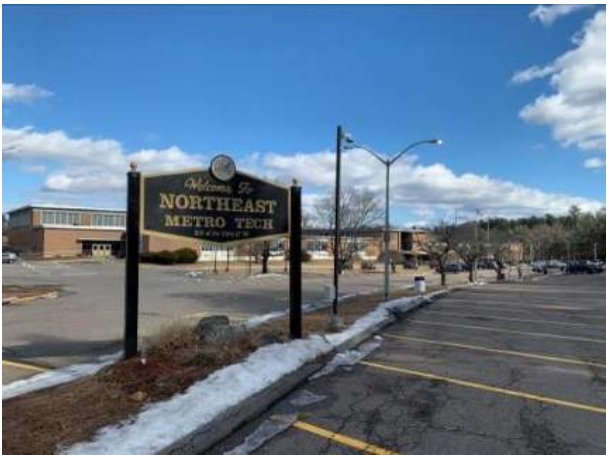
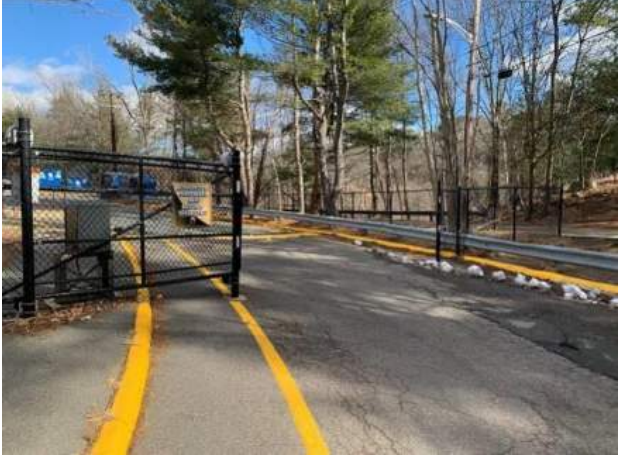
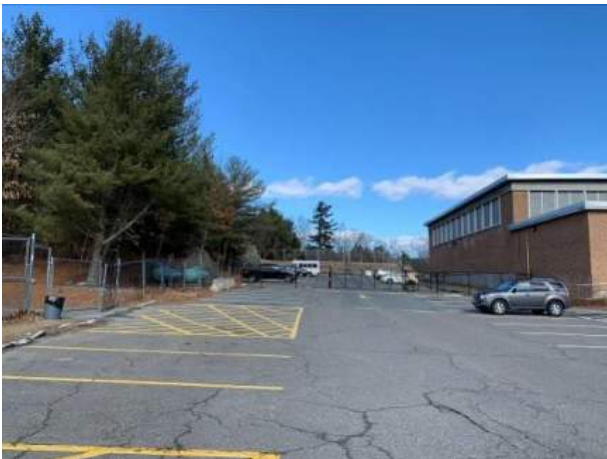
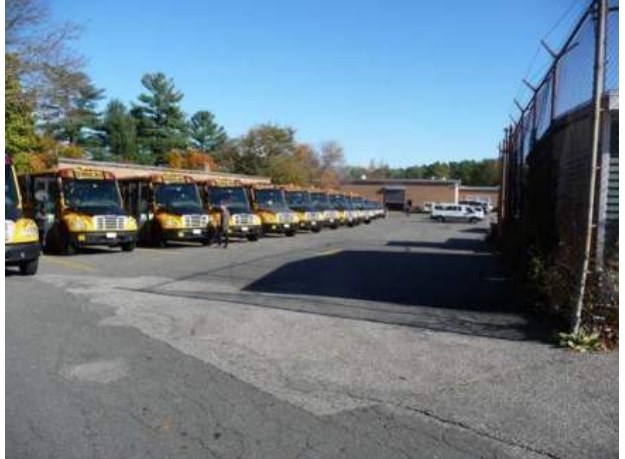
There is a one-way loop provided in the main parking lot for drop off and pick up along the front of the school. The parking spaces are oriented diagonally along landscape medians with no sidewalks. This main parking area in front of the building slopes down toward the school entrance. The counterclockwise one way driveway around the building perimeter also serves as emergency access.

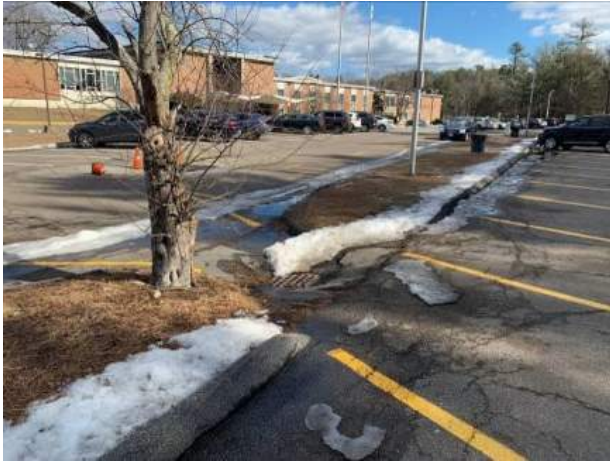
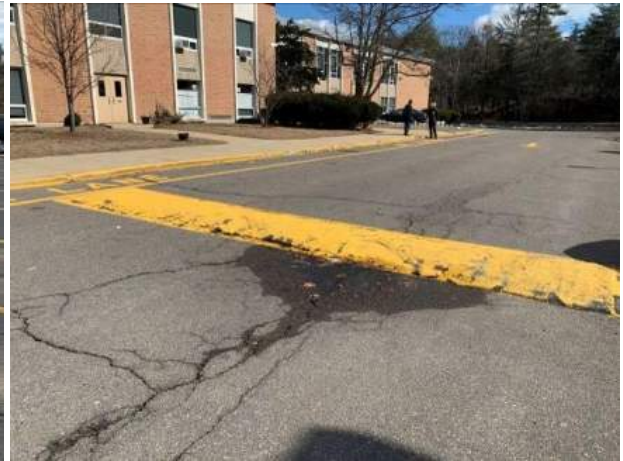
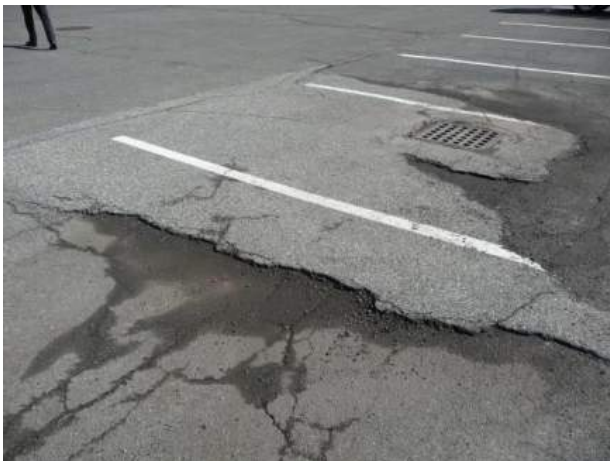
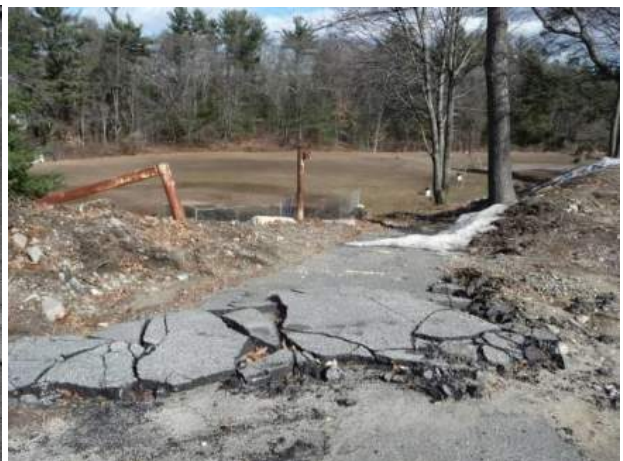
Per the Head of Maintenance, there is not sufficient parking for the schools needs. The curbing is asphalt curb in most spaces and concrete curb along some key areas like the front drop entrance. All of the curbing is in poor condition. Most of the driveways and associated parking have deteriorated pavement and large cracks were observed. Some of the access roads to the fields are hazardous.

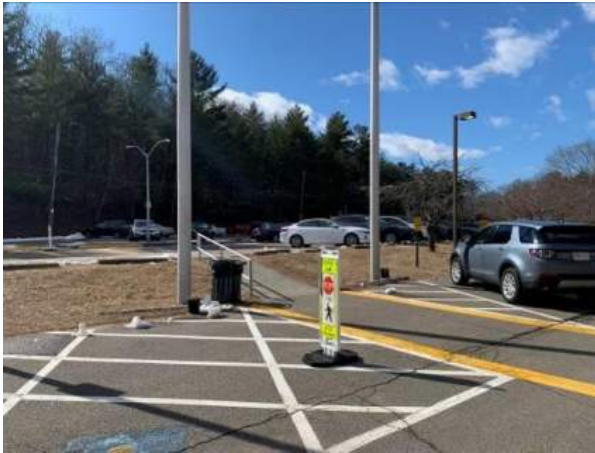
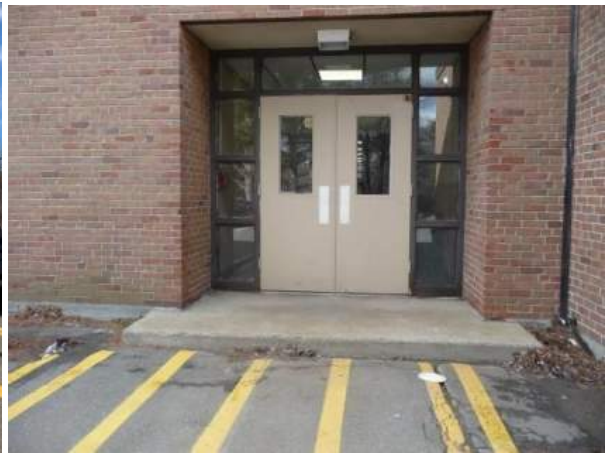
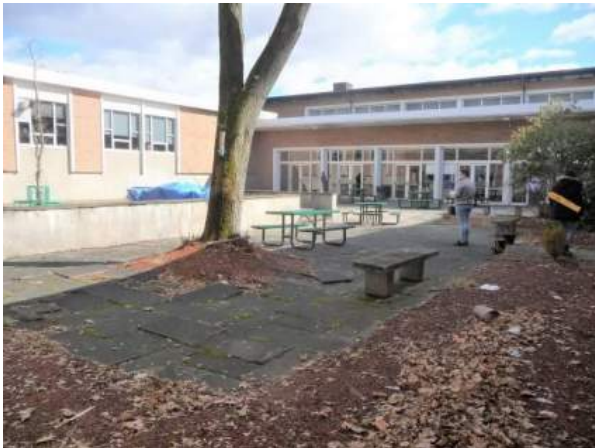
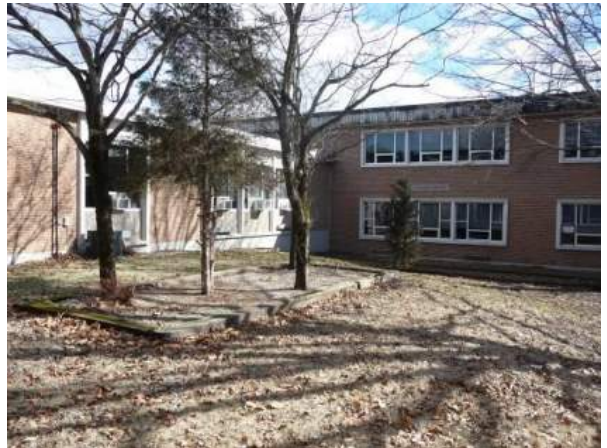
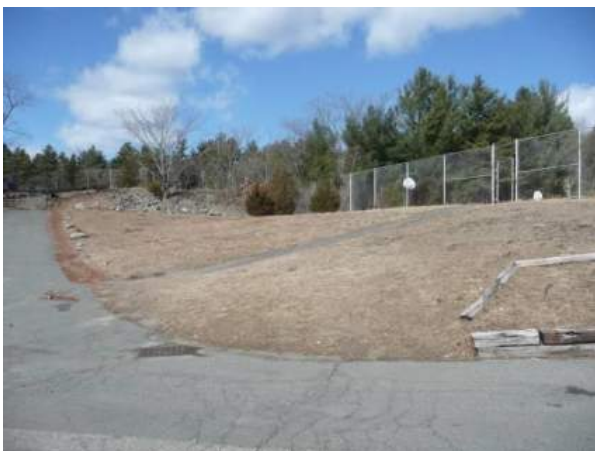
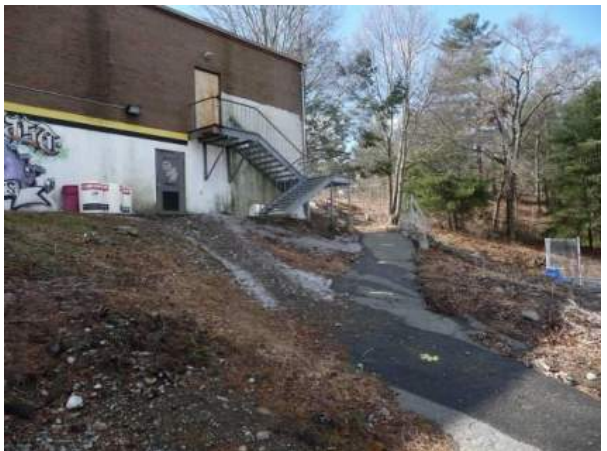
All site facilities including the fields and playground are lacking accessible routes and the bleachers do not have accessible seating. The pedestrian access to the fields is shared with service vehicles.

There is accessible parking and associated ramps at the front and the side parking lots but the handrails are non-compliant. We observed several building doorways that do not have flush conditions. Refer to the separate accessibility report by KMA, LLC.

The one courtyard with outdoor seating and tables does not have wheelchair accommodation at the tables and has uneven surfacing that poses accessibility and safety issues. The other courtyard is an open space not used for public access.

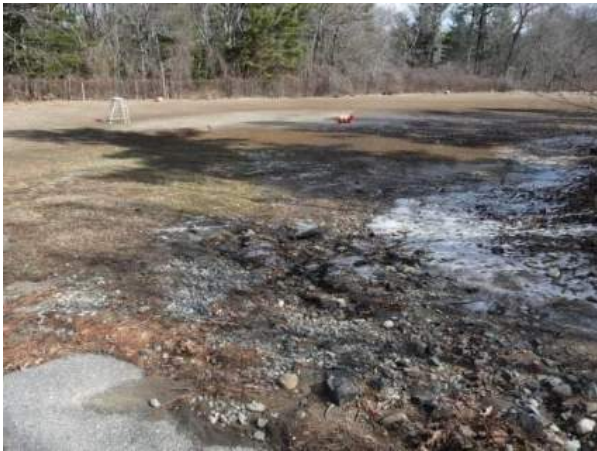
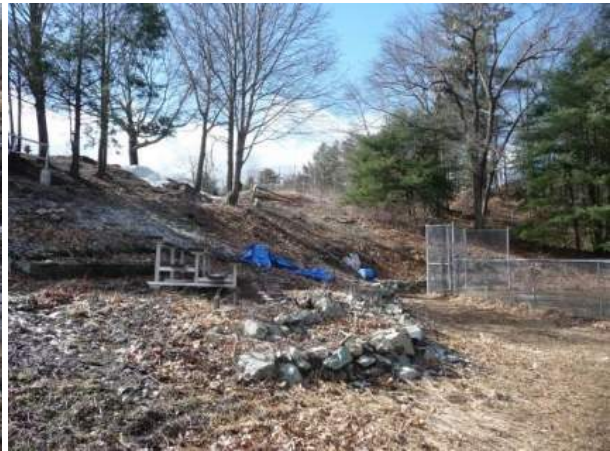
The softball and the practice fields are situated on the back of the school on the north side and are natural grass fields without irrigation. The football practice field is undersized. Both of these fields have poor drainage and are in extremely poor condition with uneven grading, bare patches of grasses and exposed stones and holes. There is a bleacher for the softball field that is in poor condition and is not accessible. The softball field is varsity and JV with no lights. The outfield is shared by the football practice team. Lacrosse also practices on the grass fields which makes maintaining grass even more difficult. The backstop fencing is in fair condition but perimeter fencing is in poor condition.

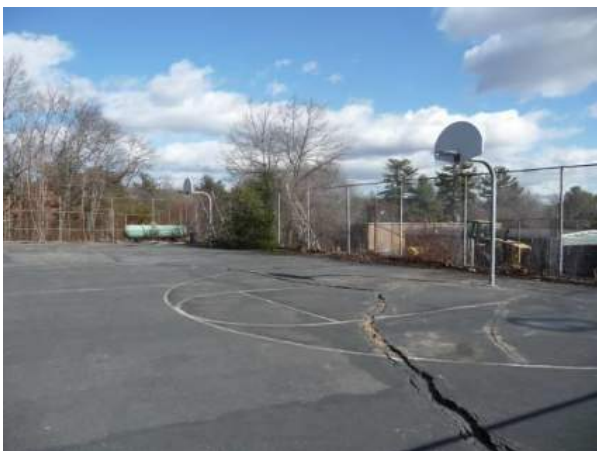
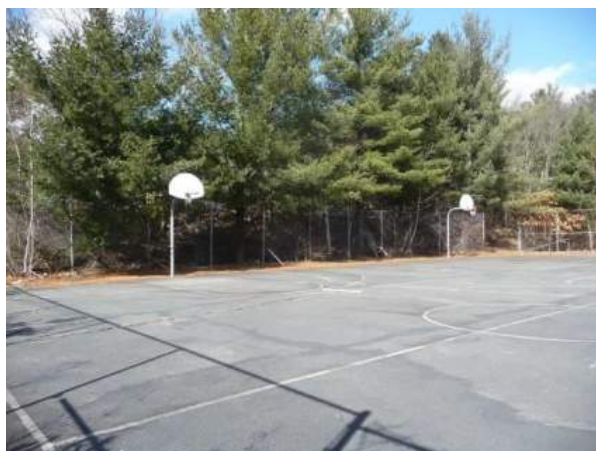
There are two full size basketball courts with asphalt pavement in disrepair. The posts are in fair condition but the hoops are in poor condition. The perimeter fencing is in fair to poor condition. The school does not have any tennis courts.

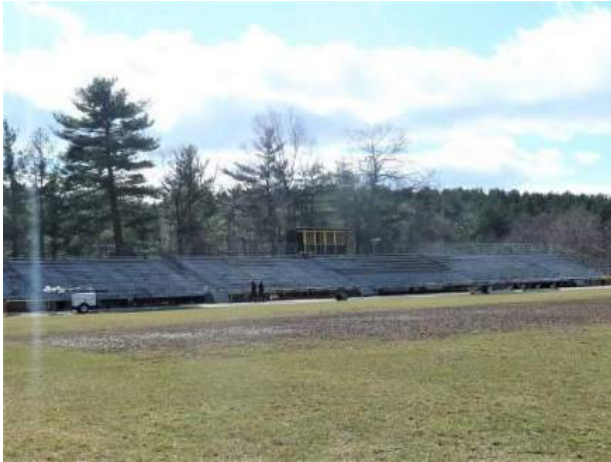
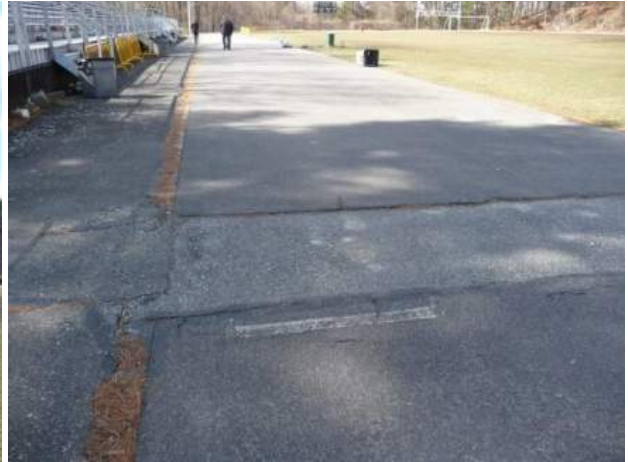
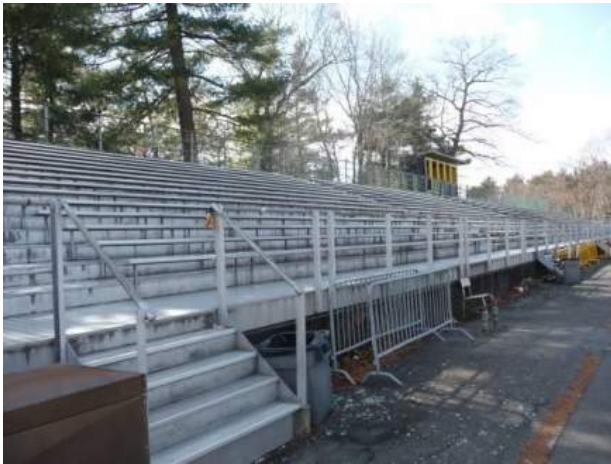
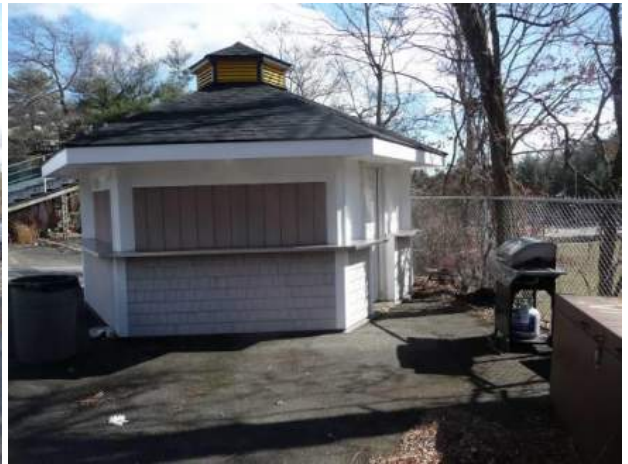
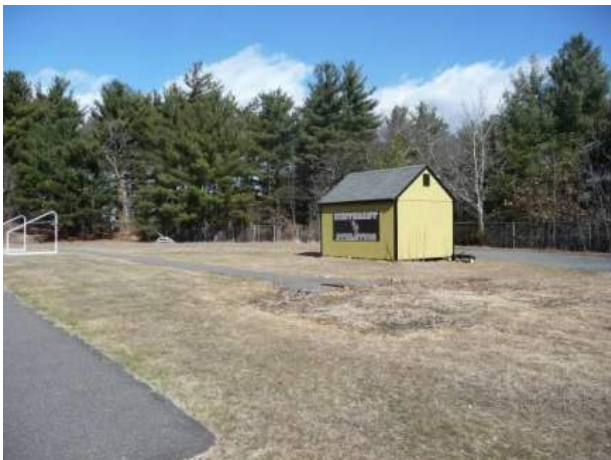
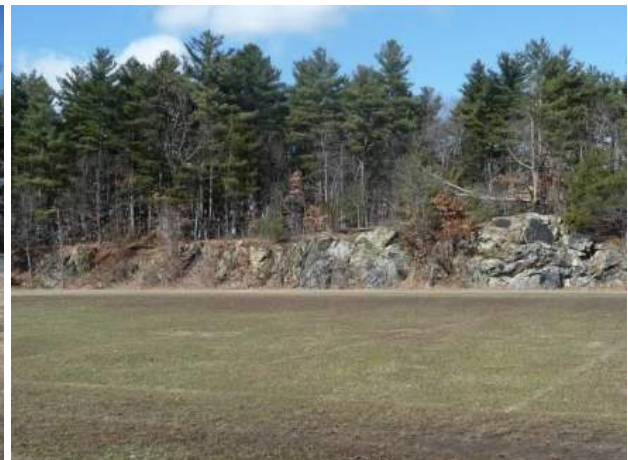
The football field inside the track is a natural grass field with an underperforming irrigation system fed from an undersized water line connected to town water. There is substantial aluminum bleacher and wooden pressbox on steel frame and concrete footings. A small wooden storage building is located east of the track, and a relatively new small wooden

concession building and outdoor grills exist off the west end of the bleacher. The natural grass field is shared by Boys Soccer and Girls Soccer and is in poor condition by being worn out. There are no lights and an old scoreboard. There is no restroom facility. The track is asphalt in disrepair with cracks and uneven bumps and is not regulation size. The bleachers and press box are not ADA compliant and need to be evaluated for compliance with current structural engineering requirements. North of the track is a large rock outcropping where the land is higher.

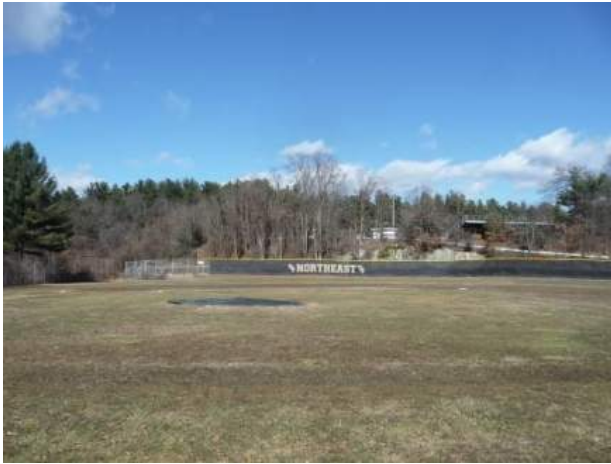
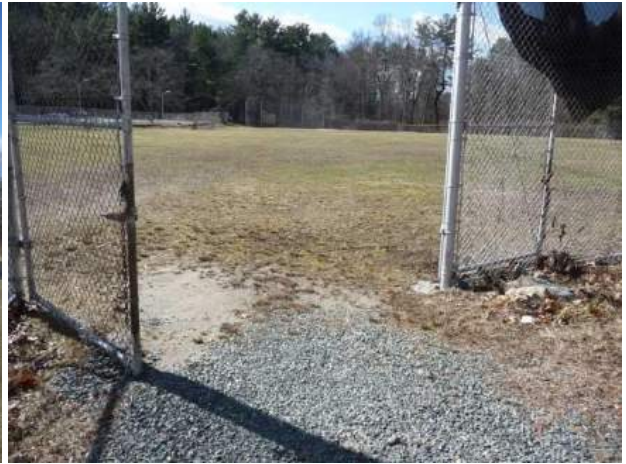
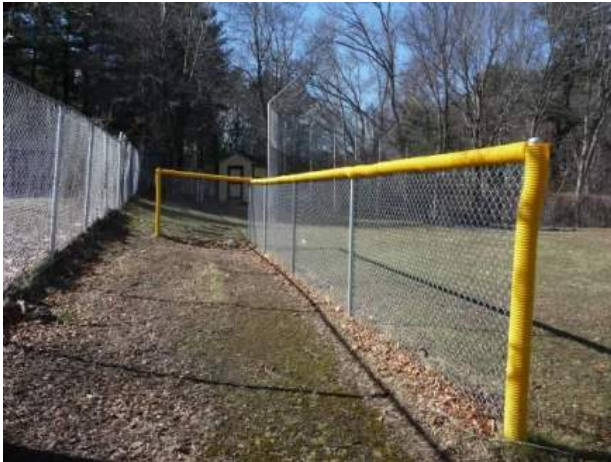
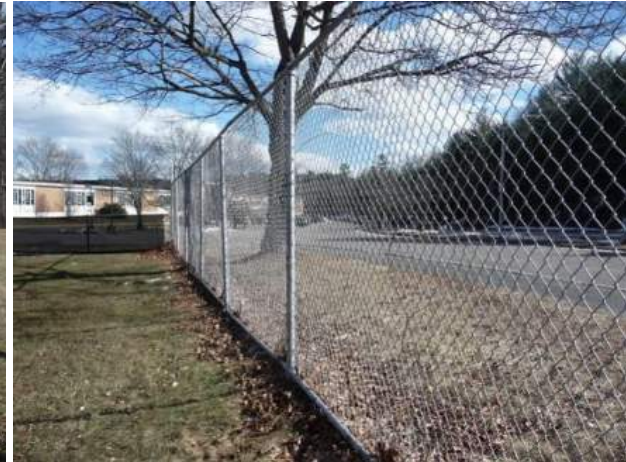
The baseball field is shared with Field Hockey practice in Fall allowing only “half field” for baseball practice. The grass in in poor condition with exposed rocks. An irrigation system was installed a few years ago and is fed by town water from behind the backstop. The field is not big enough to accommodate space for dugouts or spectator seating as there are no bleachers. The players have no place to sit that is protected by fencing. The fencing is in fair to poor condition. There is an electronic scoreboard

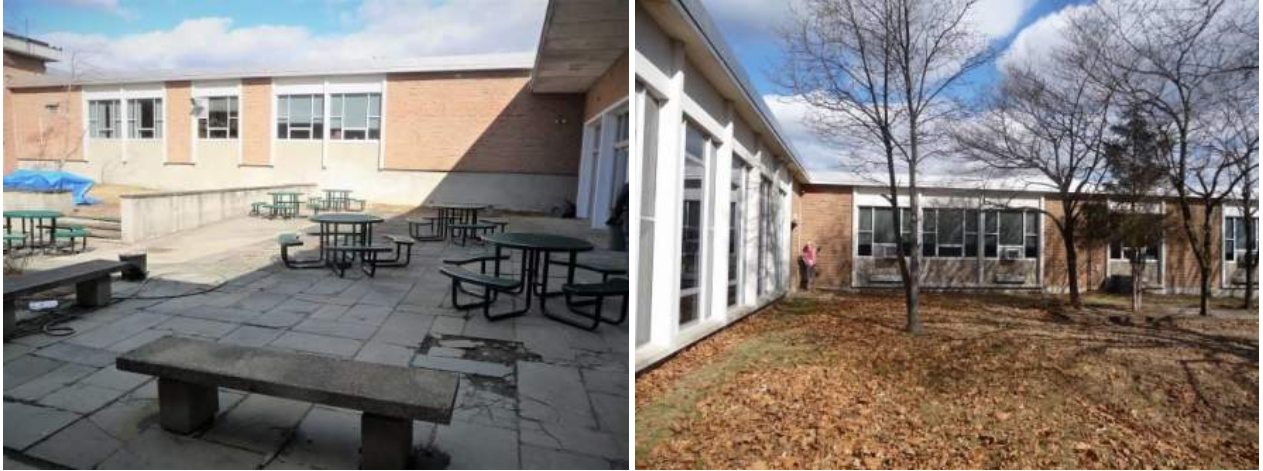
There are two internal courtyards. One serves as the outdoor cafeteria with some benches and café tables. The site furnishings are in poor condition and not accessible. The courtyard surfacing is bluestone and is in complete disrepair. There is a small raised area for outdoor gardens. The landscaping is neglected with leaves covering the only catch basin. There is one mature Elm tree. The other courtyard is an open lawn space with some trees and slopes gradually with no pathways. This courtyard does have a mature London Plane tree.

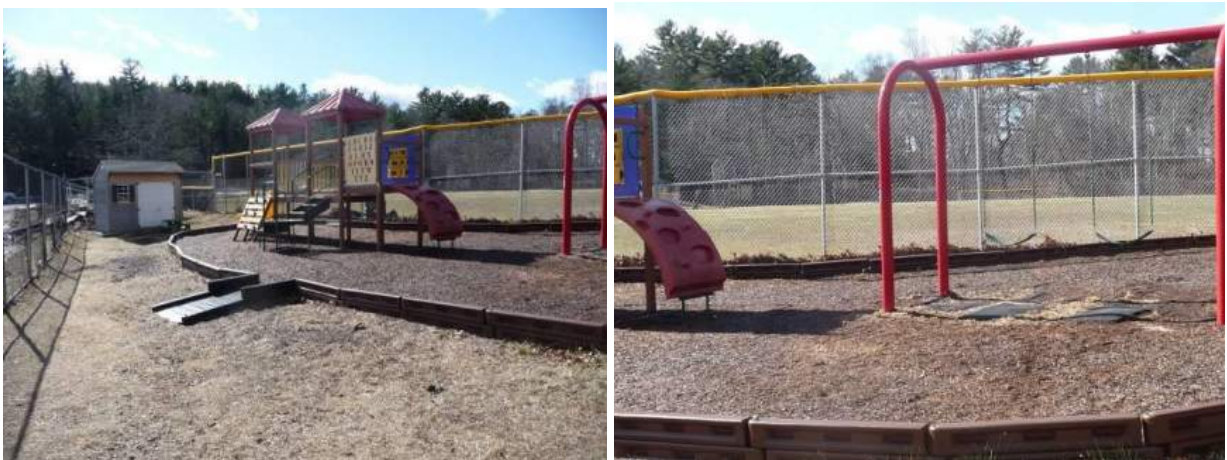
There is an early childhood playground to the west of the school which is accessed by crossing the perimeter driveway and is adjacent to the baseball field outfield fence. The chain link fence is in poor condition. The playground equipment appears to be outdated. The safety surfacing is engineered wood fiber which is compacted and needs replenishment and maintenance to provide required fall protection. Wood fiber is not considered accessible by the Massachusetts Architectural Access Board. Poured in place rubber surfacing is required for accessible routes to each type of play activity from an accessible route around the inside the perimeter.

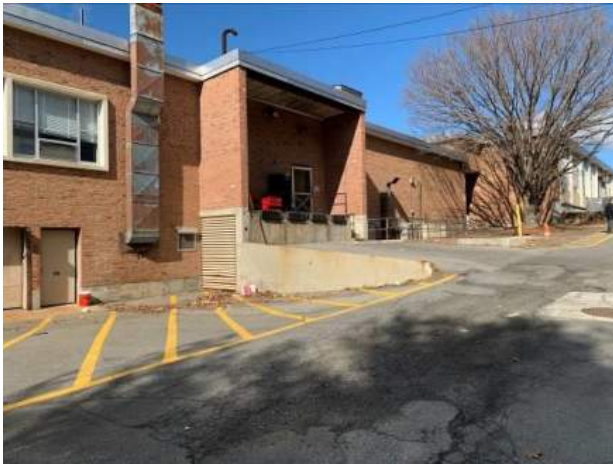
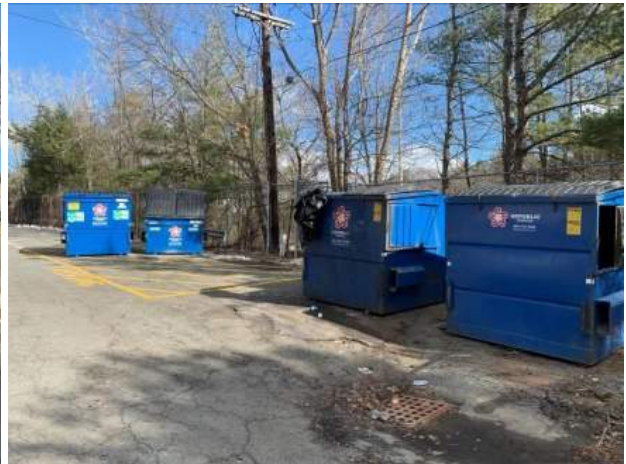
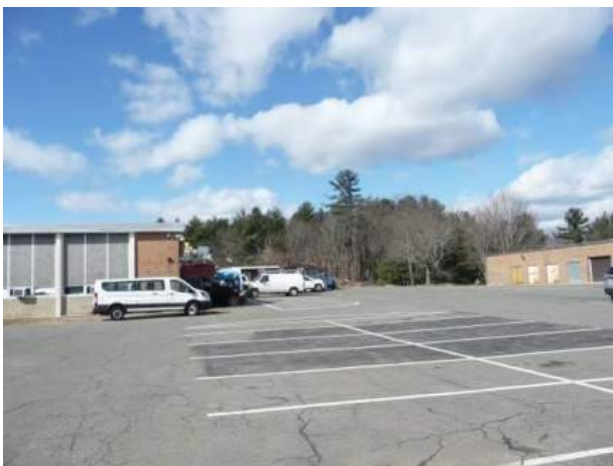
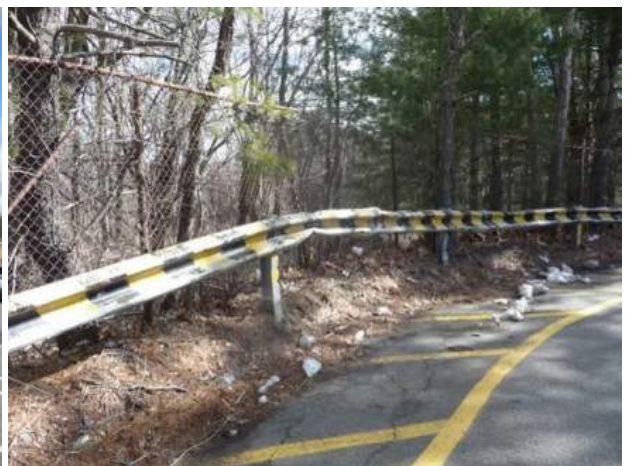
The service areas around the school perimeter are shared with some school parking and vocational program needs. The kitchen service area to the east has a loading dock with severely restricted maneuvering space that does not accommodate large trucks. An underground oil tank located in front of the kitchen loading dock provides the primary fuel source for the school's heating system which is also served by a propane tank located on the opposite side of the driveway. The main receiving area to the north does not have a loading dock, but functions adequately. Dumpsters and recycling containers are located around the perimeter driveway.

The asphalt is deteriorated in several places with visible cracks and bumps. There is a lot of vocational material left out back in an unorganized way interfering with driveway and parking. There are access gates on both entrance and exit to the service areas which doubles as emergency access. The perimeter fencing and guard rails where the grade drops off to the surrounding Breakwater Reservation are in complete disrepair.

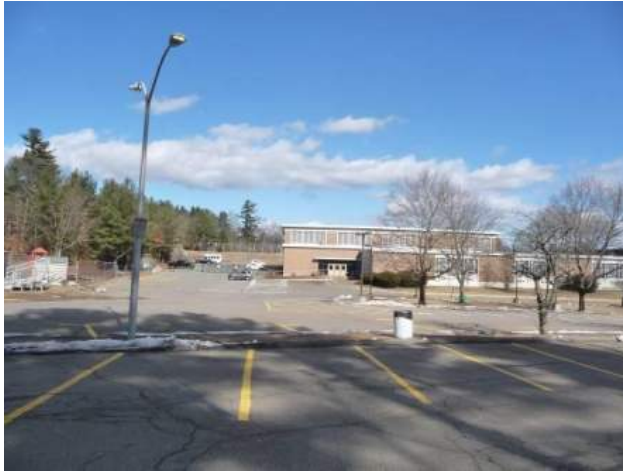
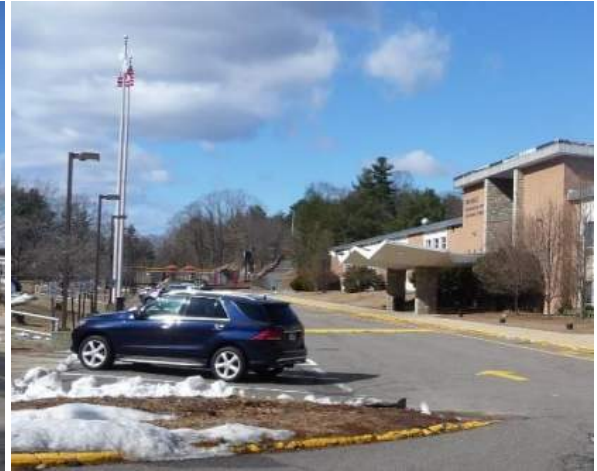
There are two types of exterior site lighting. There are dual-arm fixtures at parking lot light fixtures and downwards mount pedestrian light fixtures. The pedestrian light fixtures appear to be in fair condition.

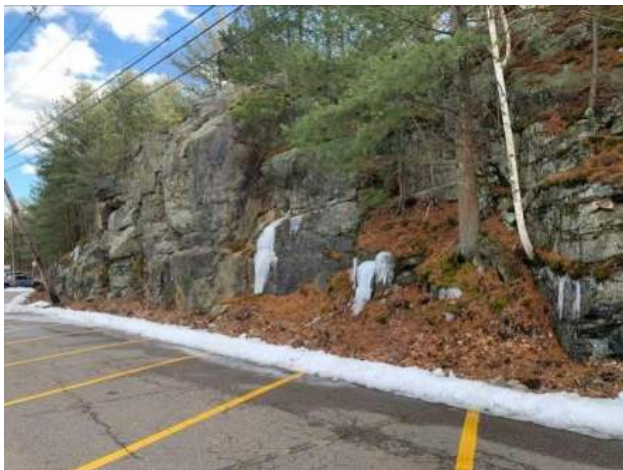
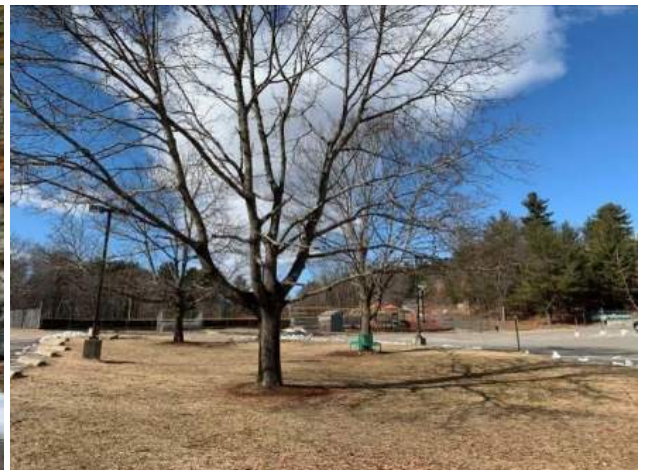
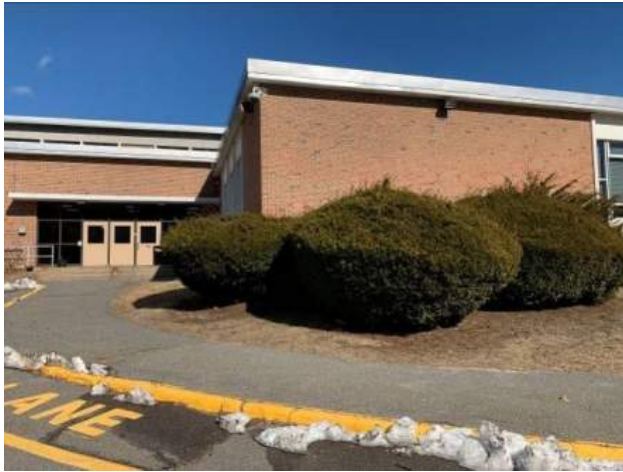
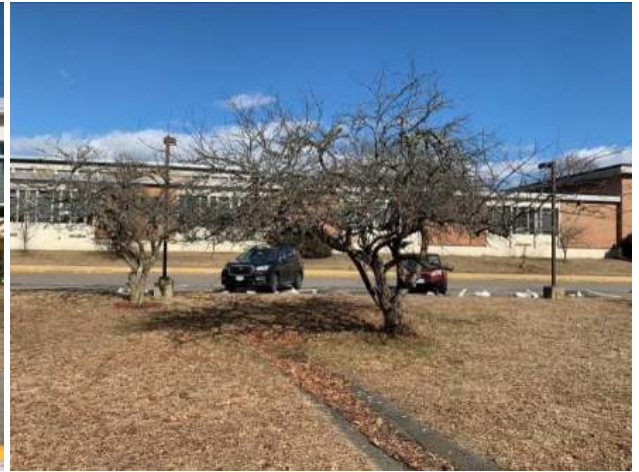
The school is adjacent to the Breakwater Reservation and as such surrounded by mature woodland of mainly native trees such as pine, beech and oak. The landscape type on school grounds is primarily lawn and trees with minimal foundation shrubs primarily yews which are poisonous if ingested. There are few mature trees. Most of the trees would benefit from pruning to improve health and not in good shape particularly the crabapples along the parking lot.
