## Architectural Existing Conditions Report

**Northeast Metropolitan Regional Vocational High School**, also known as Northeast Metro Tech, is located at 100 Hemlock Rd, Wakefield Massachusetts. The school was built 1967-68 and was opened in 1968 to teach both traditional high school classes such as English, Math, and Science, along with offering students a multitude of other trades. The existing building is a 3 story, steel joist and masonry framed structure except for the Gym and pool areas where the roof is comprised of large concrete tees. The assumed construction type is Type 2C, not sprinklered. The building measures approximately 624 feet long (at its longest) x 531 feet wide (at its widest) x 33 feet high (at its highest). The building contains a total of 239,444 square feet, spread over three floors. The main floor features multiple levels- one half-level midway into the building and a second half-level by the northwest Carpentry shop wing. Over the last 52 years, there have been a number of additions and minor renovations to the building, including the compressor room for the automotive shop, the storage room for the maintenance department, and numerous partitions to sub

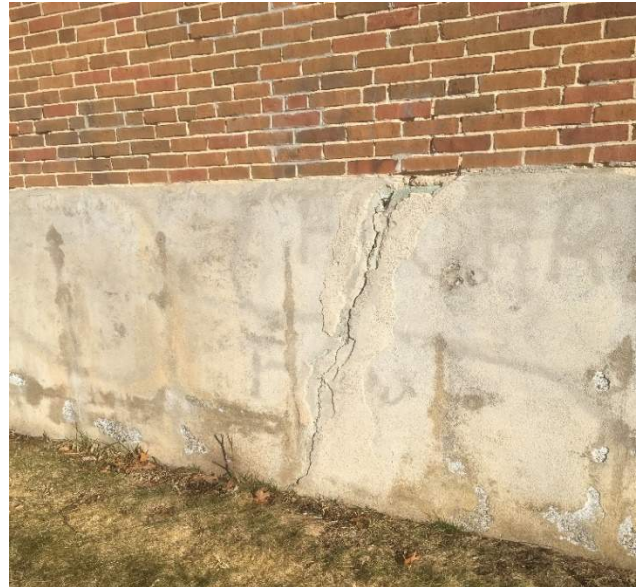
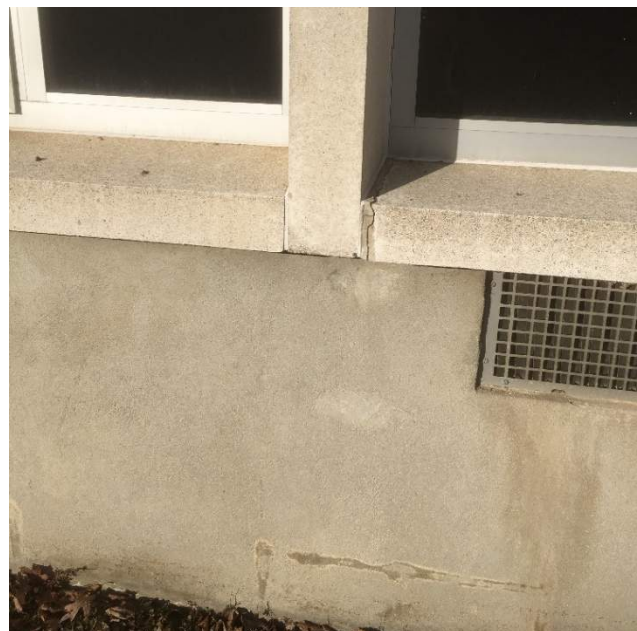
The typical exterior wall construction is double wythe loadbearing masonry wall. According to the original drawings, the exterior wall is composed of Concrete Masonry Unit (CMU) interior of various widths, with an integral 4" standard face brick with no insulation in between. Together with the fact that windows are not insulated, this construction results in a very inefficient building envelope. Precast concrete panels and exposed concrete are also used as exterior finishes, generally in the areas adjacent to windows. The exterior masonry at the pool area is showing wear and spalling. Masonry joints at all three sides of the pool structure are cracking and spalling and will require between 75 to 85 % repointing. The brick, precast concrete panels, and exposed concrete on the rest of the building seems to be in reasonably good condition. Visual observations of the exterior vertical precast frames around the windows reveal caulking gaps between precast and windows, and between precast and masonry. This condition could lead to water infiltration into the inner layers that could cause deterioration of the interior wall systems. The caulking seems to be the original, meaning it is over 50 years old. A few areas appear to have been patched with newer caulking. The exterior unit ventilator louvers are showing rust around the perimeters, the perimeter caulking is failing partially or completely. Because the unit ventilators are in front of the louvers, it is difficult to determine the extent of any interior damage. See recommendations.

From a close study of the original drawings, the vertical structural precast members around the windows are full thickness matching the thickness of the masonry wall. Thus, the importance of re-caulking these elements to maintain the weather barrier.

**RECOMMENDATIONS:** Repoint brick joints at pool structure and elsewhere. Remove and replace caulking at all precast members around windows

including precast headers and sills. Inspect all cabinet unit heater louvers, remove and inspect conditions. Remove all caulking and replace with new. Presence of the asbestos-containing materials (ACM) in the sealants shall be considered when the scope of work is determined.

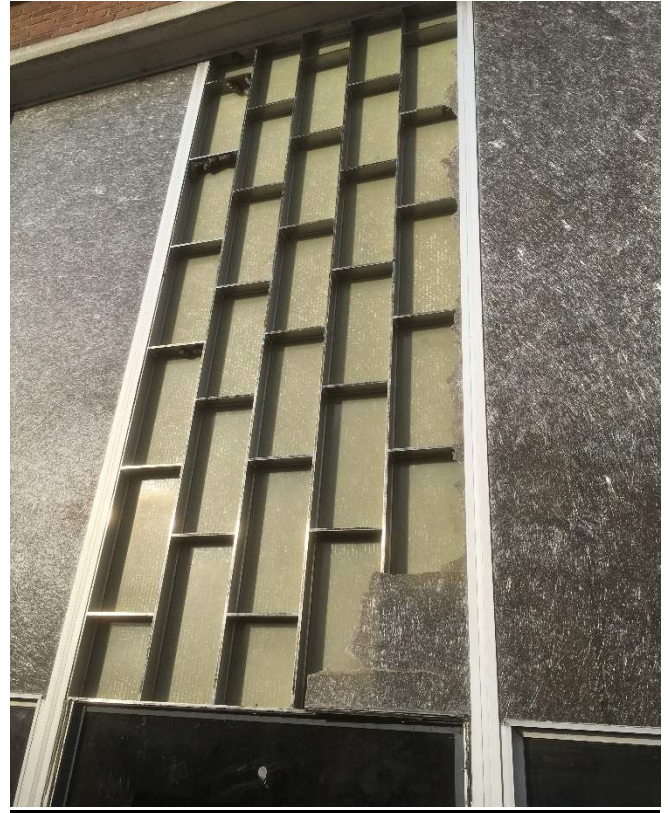
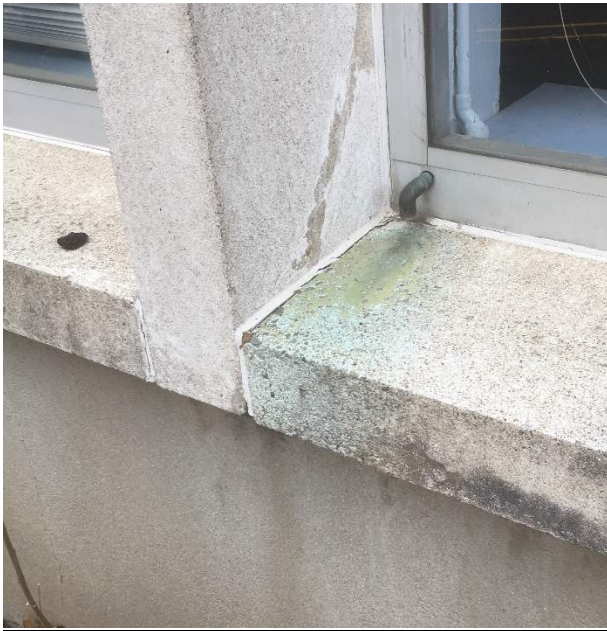
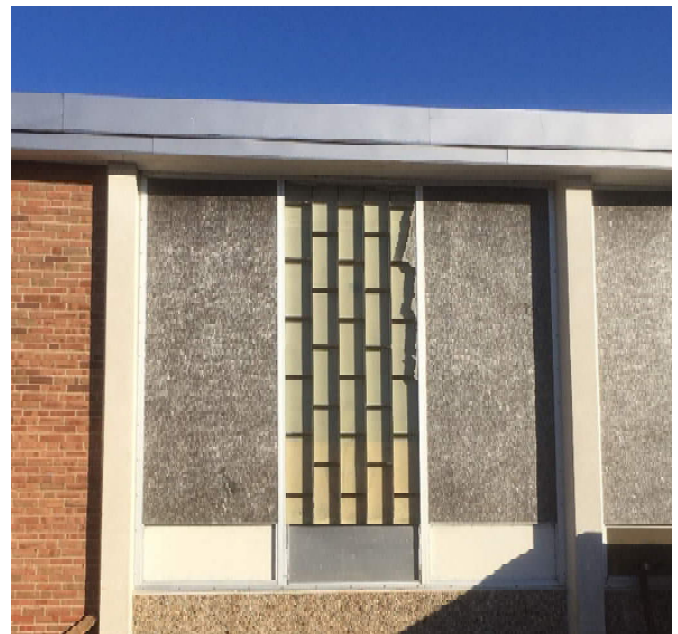
The existing exterior windows are original to the building. They are typically 2" aluminum frame construction, not thermally broken, with single-pane clear glass. Some of the windows have transoms that have translucent sandwich uninsulated panels. Some panels are broken and exposed to the weather. Seals and caulking are failing, making the system more thermally inefficient. Refer to the environmental report for the detailed test result information on the fenestration perimeter caulking and glazing compounds. The window hardware condition and operation is poor. Some windows do not work, many of the hardware components are worn, causing either tight or dangerously loose operation.

**RECOMMENDATIONS:** The exterior window systems should be replaced in their entirety. Those windows that have not already failed are likely to fail in the near future due to age and failing window caulking. Replacement window systems, including Storefronts, shall be thermally broken aluminum frames and insulating Low-E argon filled Glass, and insulated panels as required for compliance with the new energy codes.

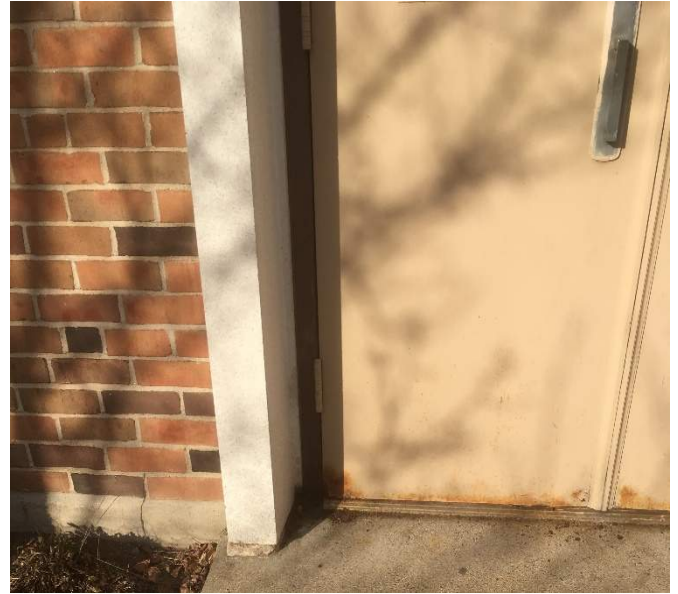
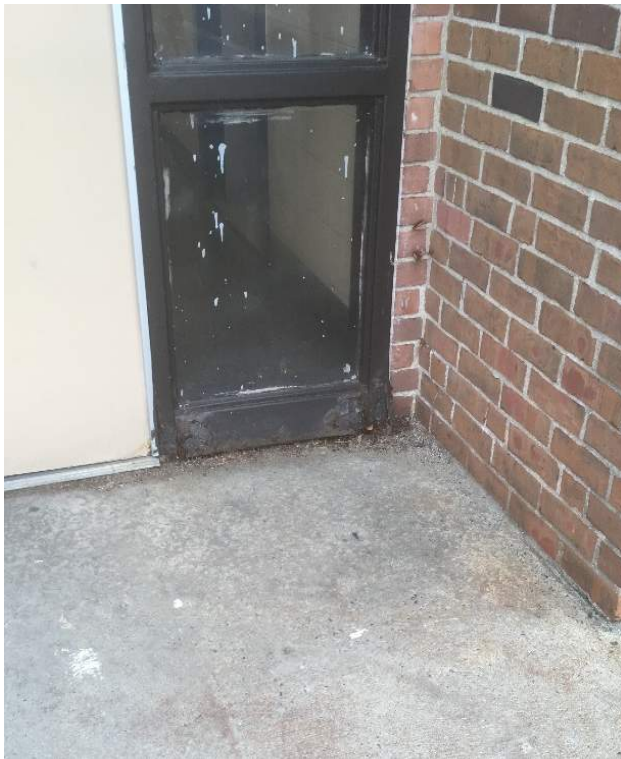
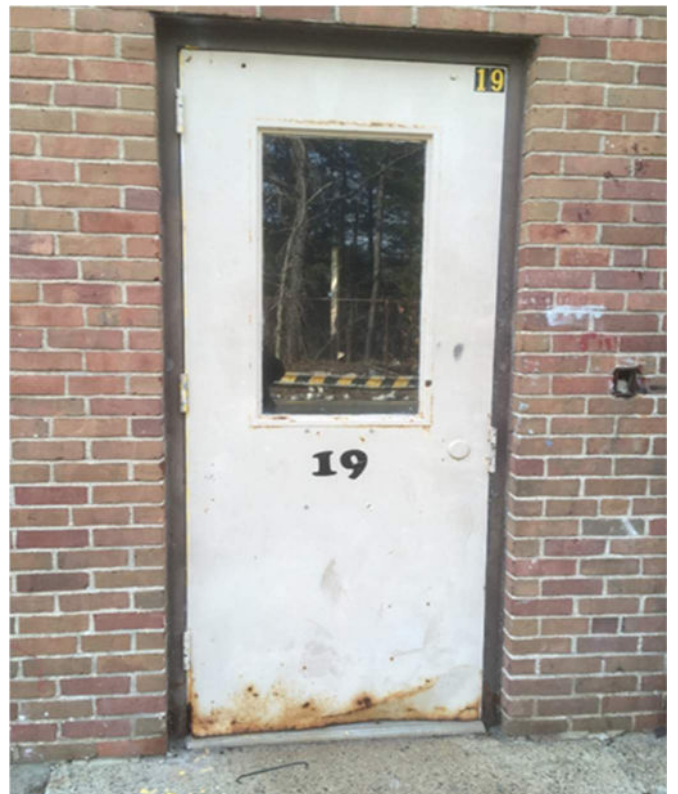
Main entry doors & pass doors appear to be original and show wear and tear. Most metal doors and frames show extensive rust and deterioration, typically at the bottom of jambs. Most doors have air gaps and lack proper weatherstripping.

RECOMMENDATIONS: Original passage Doors and frames at the various Exits should be replaced with insulated doors. Joints at overhead doors should be replaced to cut down on air leaks. Overhead doors should be retrofitted with gaskets to minimize air leakage. Un-insulated doors should be replaced with insulated doors.

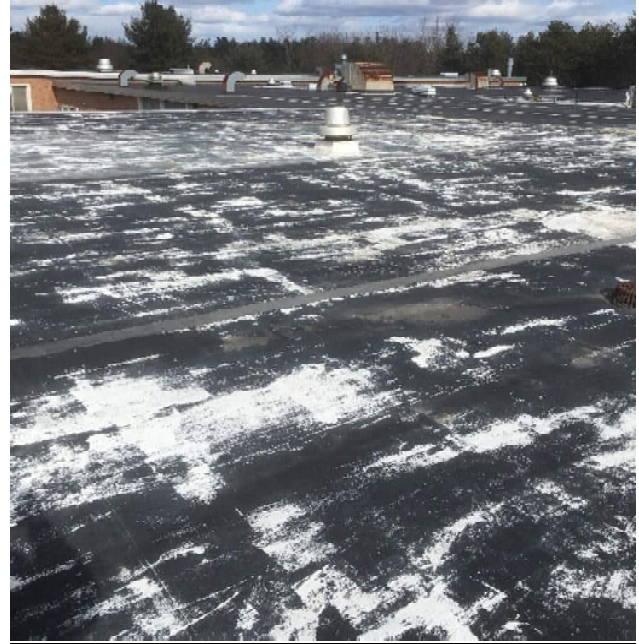
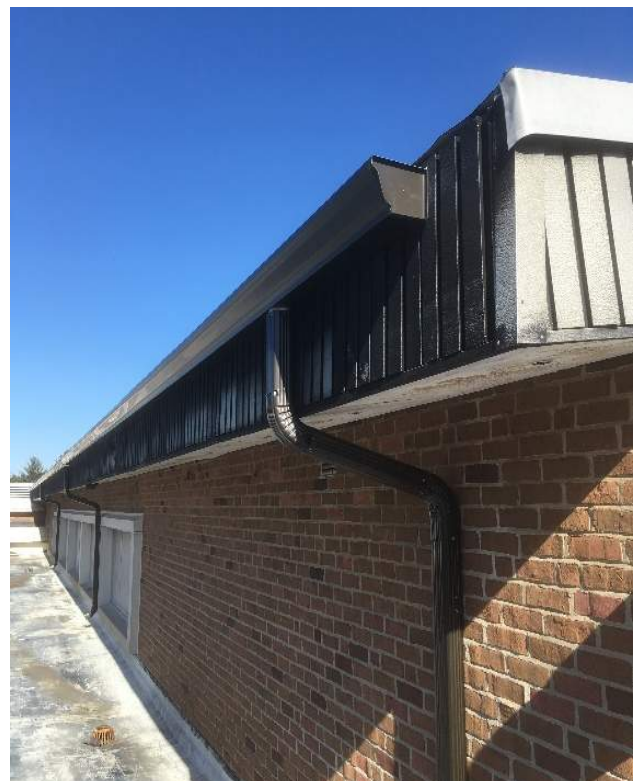
The original roof construction at the flat roofs, according to the original drawings, was a built-up roof on 2" poured gypsum over 1-1/2" formboard. The flat sloped roofs were replaced around year 2000 with an EPDM roof over insulation of unknown thickness and type. The roof is coming to the end of its useful life. It is assumed that the roof must be replaced as part of a renovation project. Evidence of water infiltration on the roof is apparent by the fact that repairs using some type of rolled-on waterproofing treatment had been applied in patches throughout the roof area. These white patches are wearing off allowing the potential of recurrence of the leaks that they intended to protect. Minor areas of ponding are occurring at the flat roofs, and some adhesion separation can be observed. The roof in the pool area is completely delaminated from its substrate. This needs immediate attention.

The metal fascia's seem to be in good condition. The soffits show water stains from old leaks. The metal fascia's at Main Entrance two story classroom area show wear and tear and discoloring. The eave at west side of the sloped roof in the Cafetorium does not have termination flashing. Wind-driven rain may be infiltrating this eave which could eventually delaminate the edge causing serious problems.

**RECOMMENDATIONS:** Complete Removal of existing roofing membrane including any underlayment materials is recommended. All existing insulation shall be removed, and existing structural decks shall be evaluated for pull-out strength for new fastening system and repaired as necessary. Install a new vapor barrier, mechanically fastened polyisocyanurate insulation to meet energy code, recovery board, and fully adhered PVC or EPDM membrane roofing system. Replace with new all roof drains, roof edge blocking, mechanical curbs, and all other roof top accessories. Curbs at mechanical

equipment may have to be replaced depending on the final scope of Mechanical upgrades required for the building.

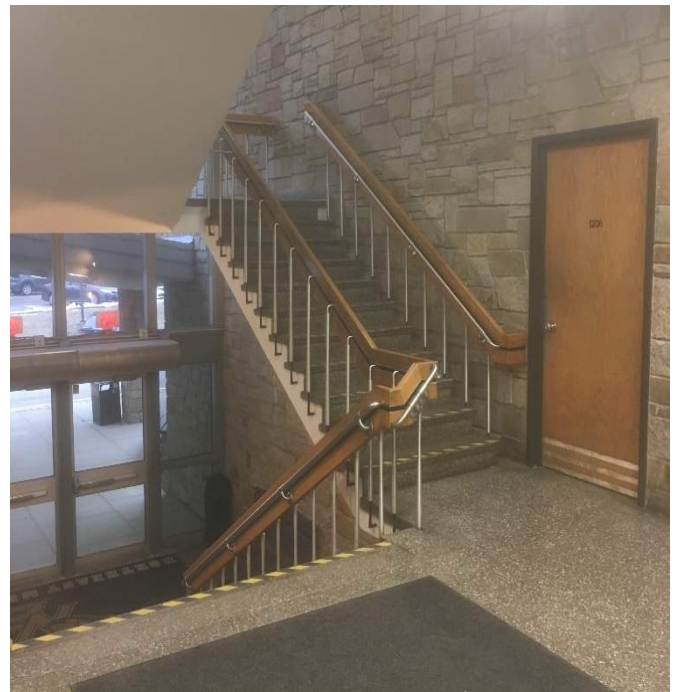
The interior doors of the main entry lobby were removed to make room for the security desk, leaving the security desk with no protection and encroaching on the main lobby. The guardrail at the main entry stair leading to the first and second floors is not code compliant in height or the spacing between balusters.

good condition. The brick, painted CMU, and tile walls are all in fair to good condition. Some tiled corners are chipped. Second floor and basement corridors are in similar condition to first floor.

Doors appear to be the original wood doors with half vision panels for corridor doors and small vision panels for classroom doors. Hollow metal frames are in generally good condition except for exterior frames which are rusted and pitted on the exterior side. Most hardware is original to the building and is beyond the expected service life. In addition, most hardware is not barrier-free.

Entrances to some of the classrooms do not meet barrier-free door clearance dimensions. Signage is not Barrier-free and is missing from a significant percentage of classrooms and office doors, making it hard to navigate the building for newcomers and visitors.

**RECOMMENDATIONS:** Existing CMU walls should be painted. Tiled corners should have corner protection. Metal Lockers should be replaced with wider lockers and double tiered. Replace all Doors and Hardware. Provide magnetic hold open hardware at all corridor doors. Provide Exterior door with weather protection hardware including electrical security monitoring protection. Provide fabric wrapped acoustical panels to help with sound control within the two and half-story lobby space. Consider relocating the security desk to the waiting area of the Admin space and recreating an airlock vestibule in the enclosed lobby space. Provide an elevator to make the Main Entrance barrier-free. Replace all guardrails and handrails to meet code, including at all stairs. Provide lifts or ramps at all stairs and half-flight stairs.

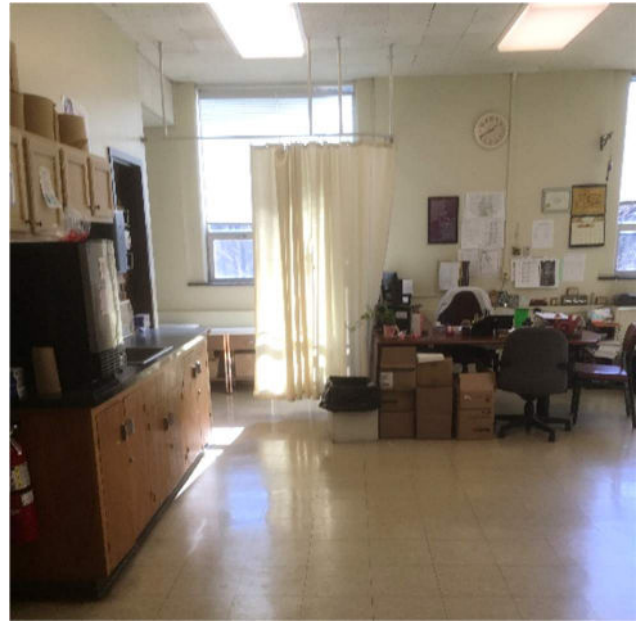
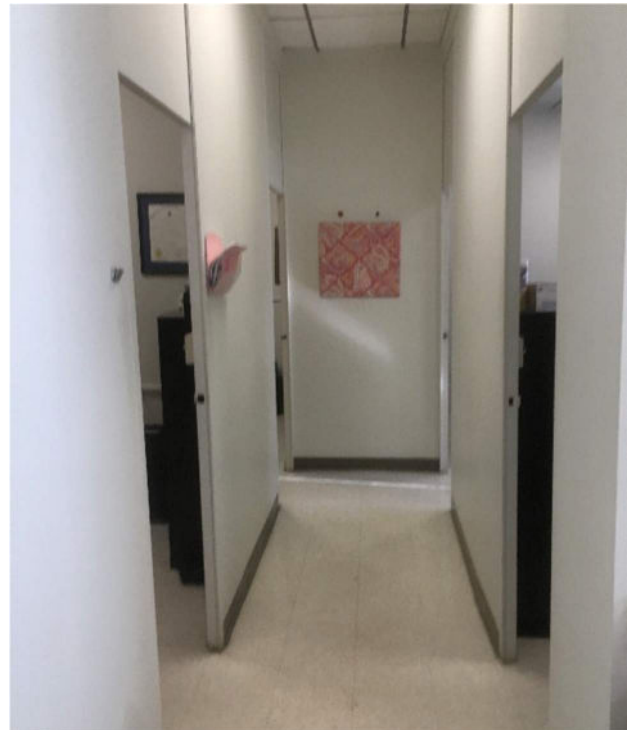
Each office has similar finishes and conditions: Ceilings are either 2x2 ACT in fair condition, or the original 1x1 concealed-spline tiles in poor shape. Walls are plastered CMU, generally in good condition. Floors are Carpet in fair to good condition and VCT showing wear and tear. Some areas of tile have been replaced with non-matching VCT. Doors are original wood in metal frames, generally in poor condition, heavily used, and badly worn. Most hardware either functions poorly or is inoperable, and is not barrier-free. Casework is in poor condition with delaminating counters, failing joinery, and poor hardware. Individual offices within the suites have similar finishes in like conditions.

**RECOMMENDATIONS:** Replace all floor, wall and ceiling finishes. Install new lighting. Existing walls to be painted. Replace all VCT Flooring with Linoleum Tile or Carpeting. Replace all Doors and Hardware. Upgrade the toilet rooms in the Health and Administrative suites to be barrier-free and accessible.

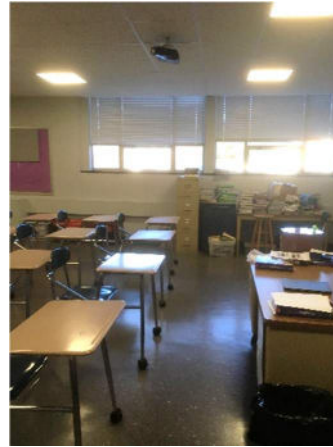
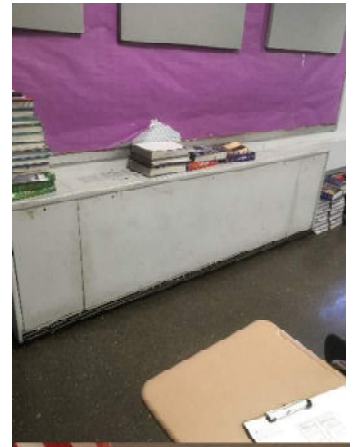
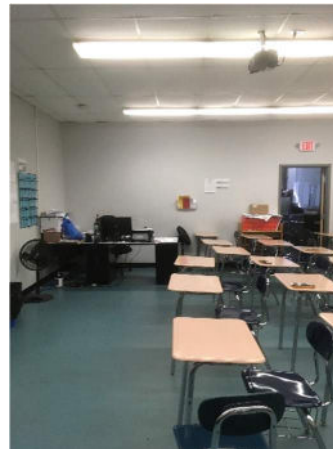
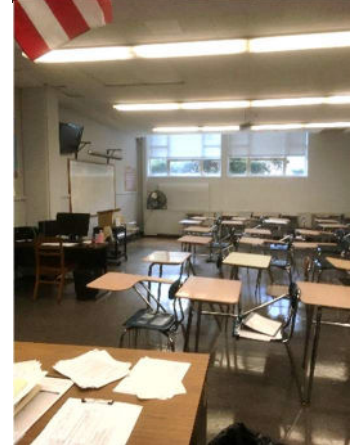
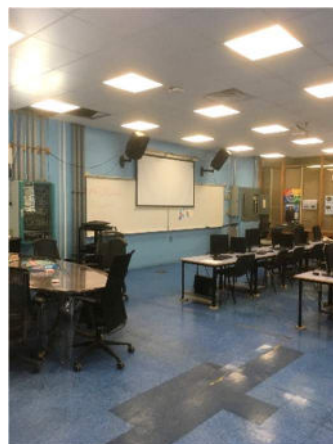
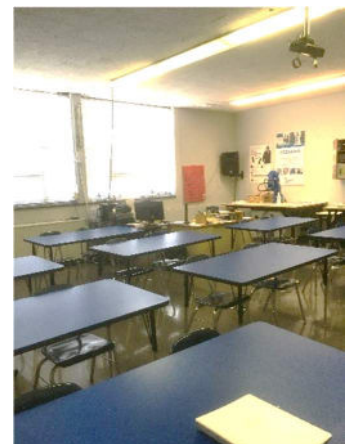
General Classrooms are located at the first and second floors of the building. There are also classrooms in the Vocational Areas which serve as Related Rooms for these programs. Each of the classrooms have similar finishes comprised of ACT ceilings, CMU or Plaster Walls, and VCT flooring. The ACT Ceilings throughout are in poor condition- badly damaged, sagging, and water stained. Most have the original 1x1 conceal-spline tiles. The CMU and plaster walls are generally in fair to good condition, structurally intact but with tired finishes. A few of the classrooms, including Related Rooms, are interior spaces with no access to daylight. Some new partitions have been installed in certain locations to create classrooms but provide poor acoustical separation from the adjoining spaces.

On the second floor there are a few classrooms separated by the movable partitions that are in poor shape, do not provide adequate acoustical separation between the spaces, and do not have functioning pass-doors. Floors are VCT with extensive degradation, wear, and damage. Some areas of tile have been replaced with non-matching VCT. Doors are original wood and metal, all in metal frames, which are in poor condition, heavily used, and badly worn. Most hardware either functions poorly or is inoperable. Window systems are as categorized elsewhere in this report, in poor condition. Minimal storage exists within classrooms. Display boards in classrooms vary between green chalk boards and whiteboards. All are in poor to fair condition. Every room observed has a smart projector for interactive instruction. There are several variations to the size and configuration of the academic classrooms.

The Related Classrooms for the vocational programs, have similar finishes but are generally in poorer overall condition. There are

nine interior classrooms on both the first and basement floors with no access to daylight and with poor acoustics.

**RECOMMENDATIONS:** Replace all finishes and ceiling systems. Install new lighting and HVAC Systems. Existing CMU walls to be patched and painted. Replace all VCT Flooring with Linoleum or LVT tiles. At second floor and first floor over basement classrooms install linoleum floor finish with acoustical properties. Replace all Doors and Hardware. Replace all writing boards with new whiteboards and tackboards. Replace all casework. Provide new smart boards or teaching monitors with new technology to bring classrooms to 21<sup>st</sup> century teaching style.

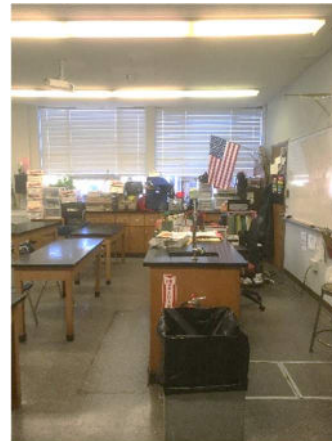
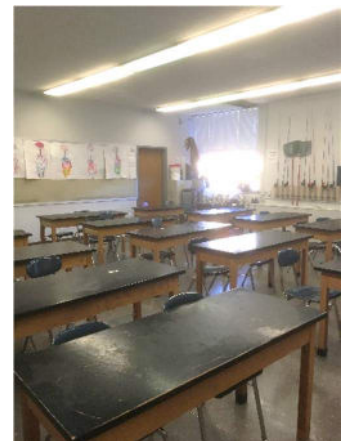
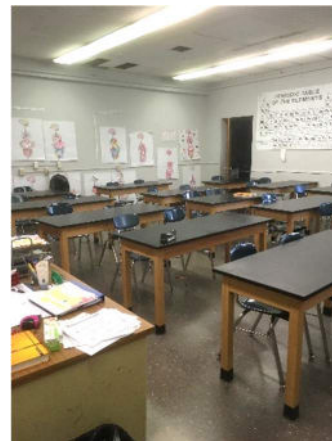
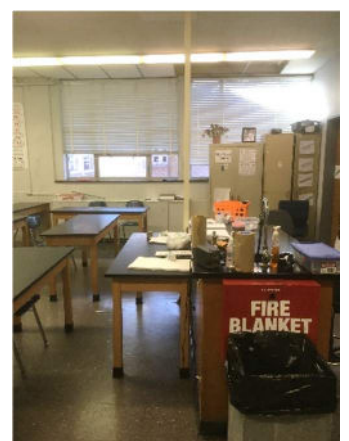
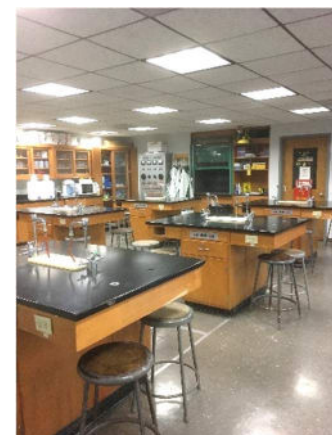
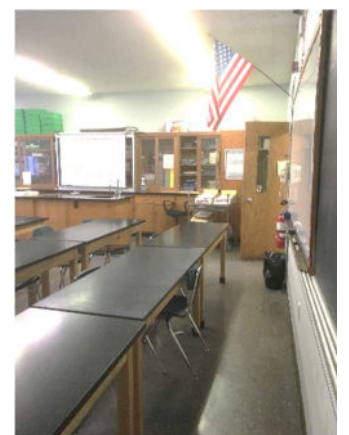
The Science Classrooms and only Science Lab are located on the central corridor of the first floor level. All of these classrooms have direct access to daylight. Programs include Physics, Chemistry, and Biology. All of the Science rooms are significantly undersized in comparison to current MSBA Standards. Each of the classrooms have similar finishes to those of the regular classrooms listed above and are in similar condition. Doors are primarily wood, all in metal frames. Most hardware either functions poorly or is inoperable. Window systems, as categorized elsewhere in this report, are in poor condition. There are some provisions for storage within the science rooms, but the sizes are inadequate. The casework is in fair condition given its age, but hardware is in poor condition. Hardware, Electrical and Plumbing at Lab benches is in fair condition and mostly operable. The Epoxy tops on the Science Lab benches have held up very well, with only a few topical scratches. Damaged tops were observed in the science classrooms. Also refer to the FF&E existing conditions report.

**RECOMMENDATIONS:** Science Labs do not meet current MSBA Space standards and therefore will require significant renovations and/or relocation to develop a compliant size and configuration. Along with the reconfiguration will be new finishes, ceiling systems, new lighting, and a new HVAC system. Existing CMU walls are to be patched and painted. Replace Flooring with sheet vinyl flooring. Replace all Doors and Hardware. Replace all display boards with new whiteboards and tackboards. Incorporate smart boards or the technology that is determined better suited for the school. Replace all casework. Replace

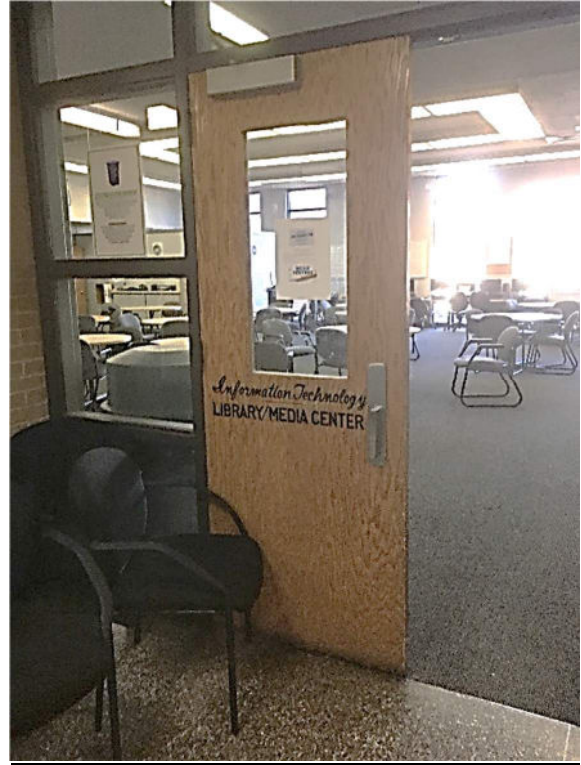
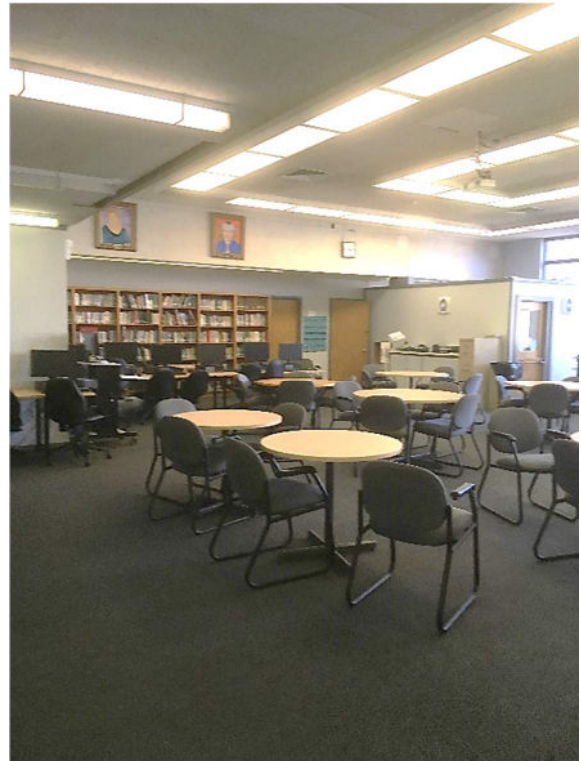
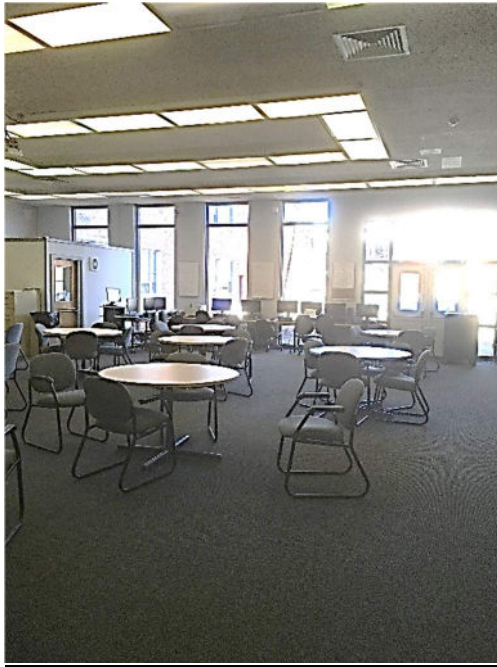
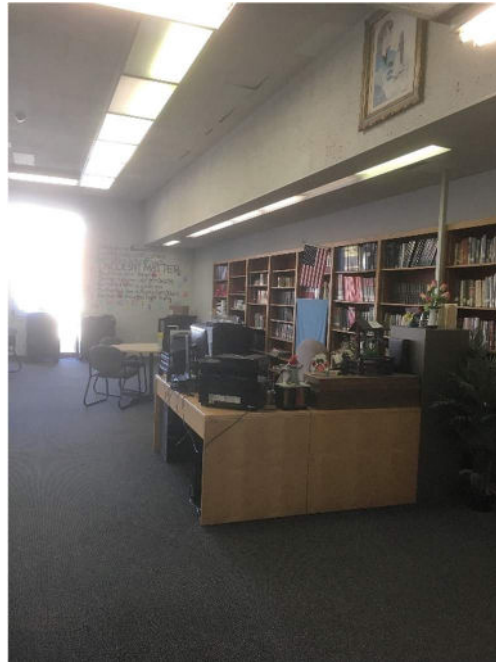
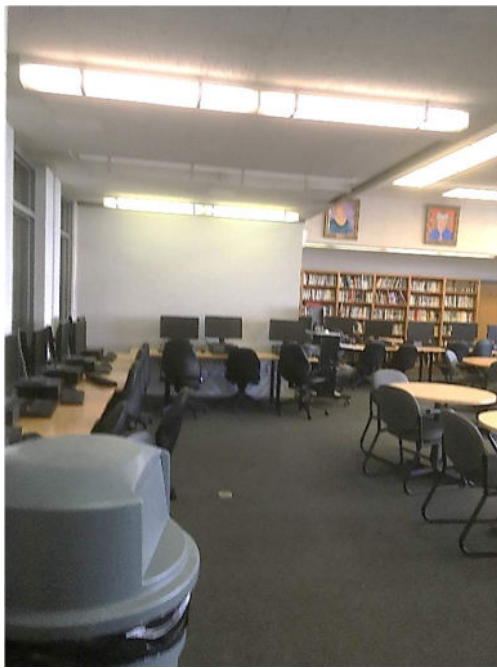
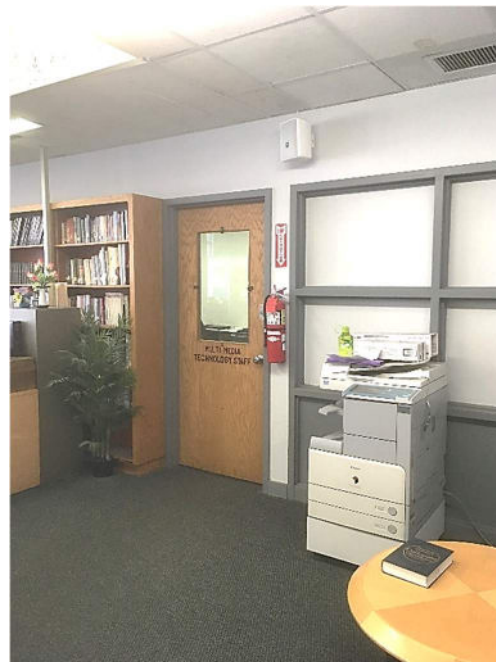
The Library is 2060 SF and is generally organized as one large open space, with computer banks on the north wall facing the courtyard, the south wall facing the corridor, and west wall facing one of two bookshelves in the media center. The space has two makeshift rooms created with low walls. The Ceiling has the original 1x1 concealed-spline ACT with surface-mounted lighting which is in fair condition. Walls are mostly plaster and painted GWB and are in fair to good condition. The carpeting appears to be newer but is worn and deteriorated. The bookshelves are limited to just two on the east and west walls and are original to the building; they are in good condition. Casework in the circulation desk area is in good condition. Tables and chairs are relatively new and in good condition. Doors and frames within the library are primarily wood with hollow metal frames, which are in fair condition. Door hardware is not barrier-free except for egress doors. Exterior windows have single pane glass are very cold during the winter months.

**RECOMMENDATIONS:** Evaluate existing space recommendations relative to Programmatic Requirements. This space has major reconfiguration associated with it to bring it up to contemporary standards for a high school media center. All finish systems are recommended to be replaced, new ceiling system with new lighting, new carpeting throughout. Book storage system and furnishings shall be upgraded. Replace all doors. We recommend perimeter exterior walls be insulated either from the exterior or from the interior, this will require some thoughtful strategies and estimating for comparison.

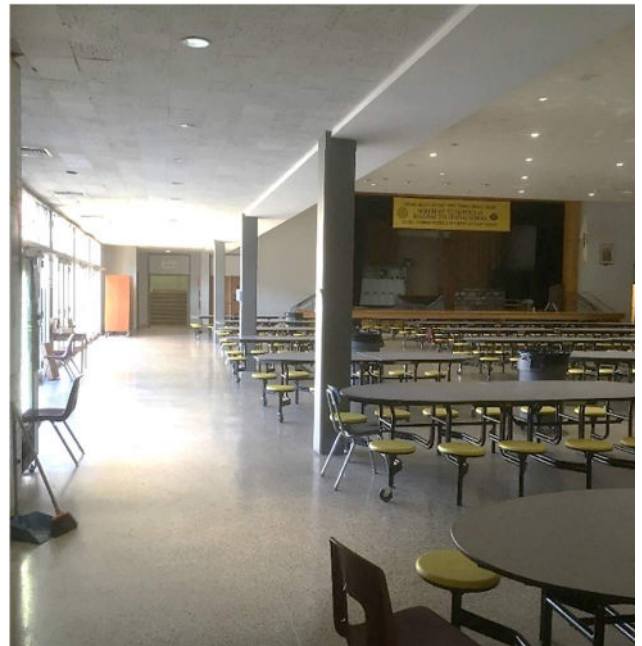
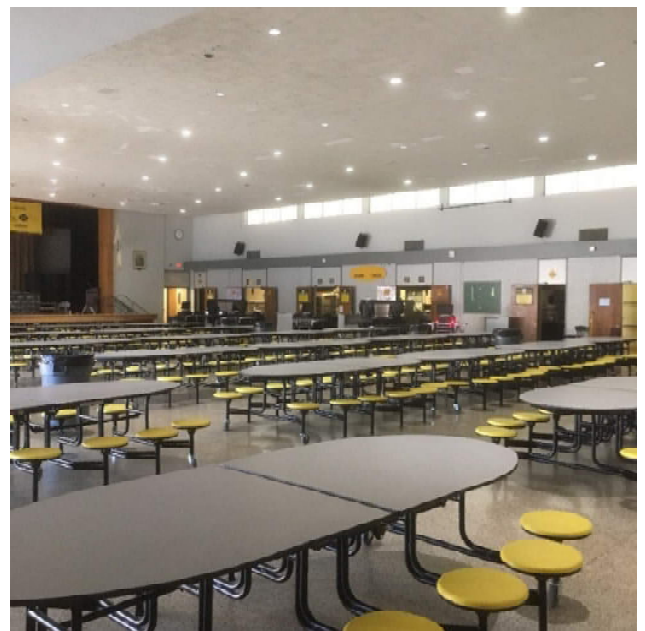
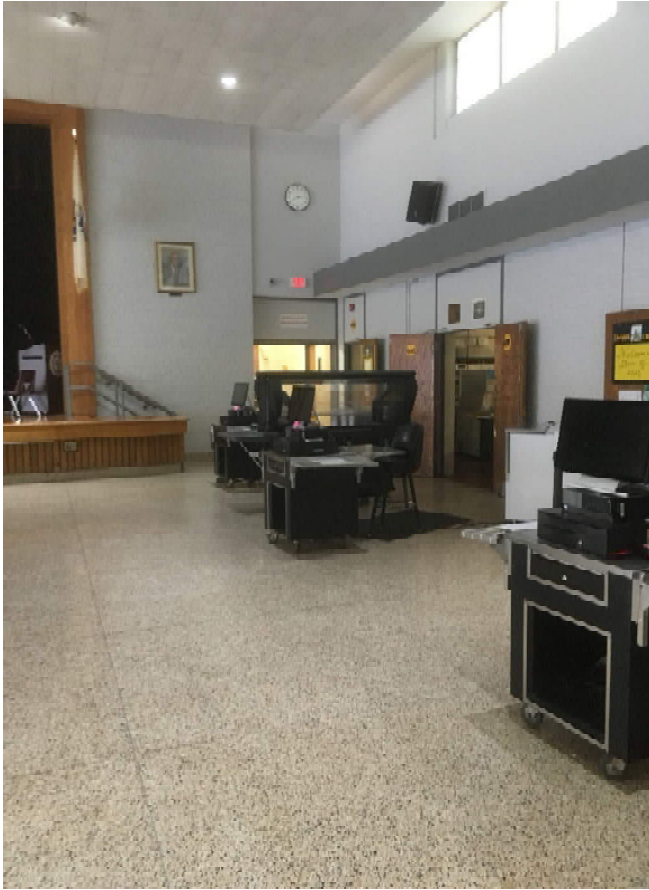
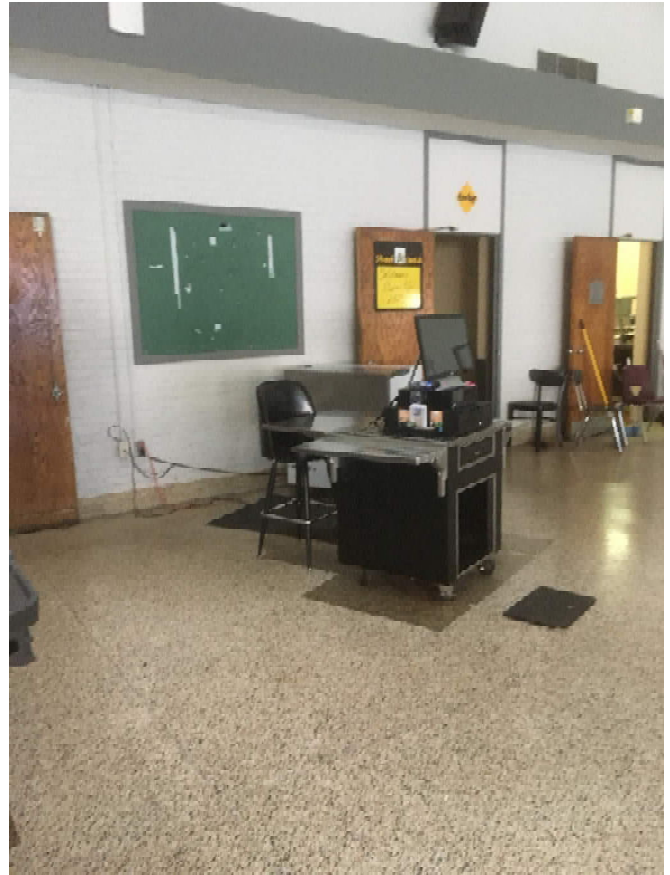
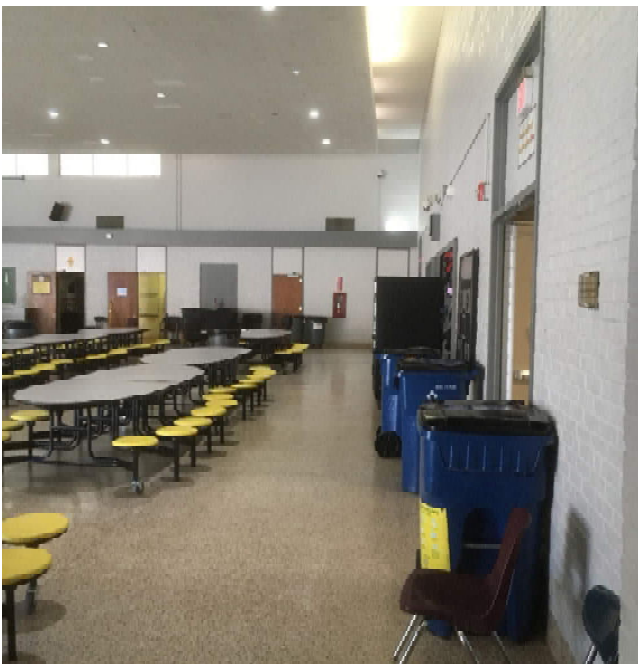
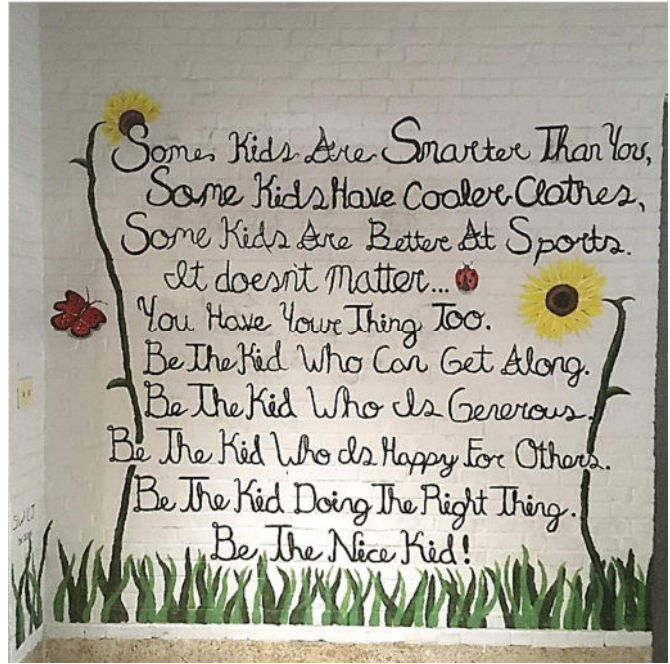
The Cafetorium space is located at the main level and serves as theater, dining, and multipurpose assembly space. The high and low ceilings have the original 1x1 ACT concealed grid. The high ceiling seems to be in good condition but looks dated. The low ceiling is in poor shape. Both ceilings have recessed can light fixtures which seem to be in fair condition (light levels should be tested and analyzed). Valance lighting of east and west sides at the low ceiling level with valances on three sides of the high ceilings are meant to give ambience while augmenting lighting levels. The walls are mostly plaster and painted brick and are in good condition. Terrazzo floor is in good condition. The furniture (folding tables with rounded corners and integral stools) are in good condition, having been recently purchased, but feel institutional. Also the rounded ends are awkward to sit at and are not made to butt together in rows. The doors to the servery are wood, original to the building, and look old and tired. The hollow metal frames are in good shape. The aluminum doors and metal frames to the Courtyard seem to be in good condition. But since they are not insulated or thermally broken, they are thermally ineffective. Exit doors to corridors are held open with wedges, which should be replaced with magnetic hold-opens.

**RECOMMENDATIONS:** Replace all finishes, replace ceiling system, install new lighting, new HVAC system. Replace all Doors and Hardware. Replace aluminum doors and frames with new energy code-compliant doors. Function and efficiency of operations require further evaluation to determine extent of architectural modifications required for this area. Replace at least some of the folding tables with more appropriate styles.

The valance light fixtures should be replaced with LEDs. Theater lighting should be upgraded.

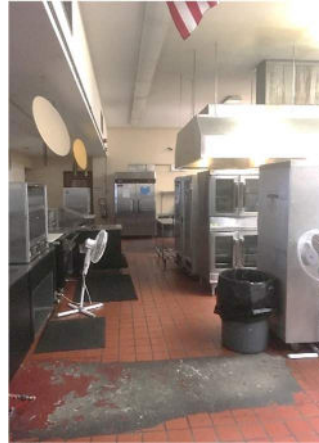
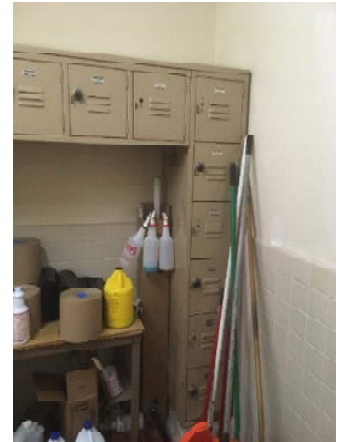
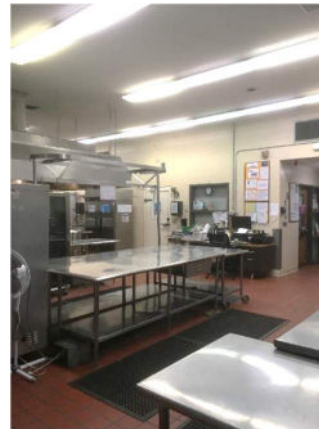
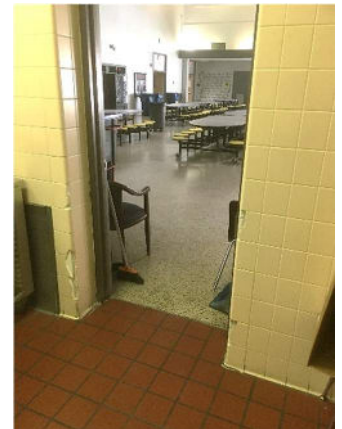
The Kitchen equipment appears to be in good condition. The Serving line is in its original dated design with very tight circulation preventing adequate flow. The plaster ceilings seem to be in good shape. The surface fluorescent wraparound light fixtures appear to be original. Lighting levels should be tested. Tiled walls seem to be in good condition except at corners next to doors. Quarry tile floor is in fair to good condition except as shown in photo where tile is missing, and concrete was used to level the floor surface. The HVAC is probably not adequate for the fact of the portable fans on same photo. The walk-in cooler & freezer seem to be original to building, past its life expectancy. Kitchen staff bathrooms & lockers are not barrier-free and are used as additional storage. Kitchen office is probably undersized due to fact that an office desk is in the kitchen floor area.

**RECOMMENDATIONS:** Replace lighting with new LED fixtures, replace mechanical equipment with new. Improve servery access for a more flexible and efficient flow. Make all public spaces barrier-free. Protect tile corners with heavy duty corner guards. See also the food service equipment report. Insulate the exterior walls.

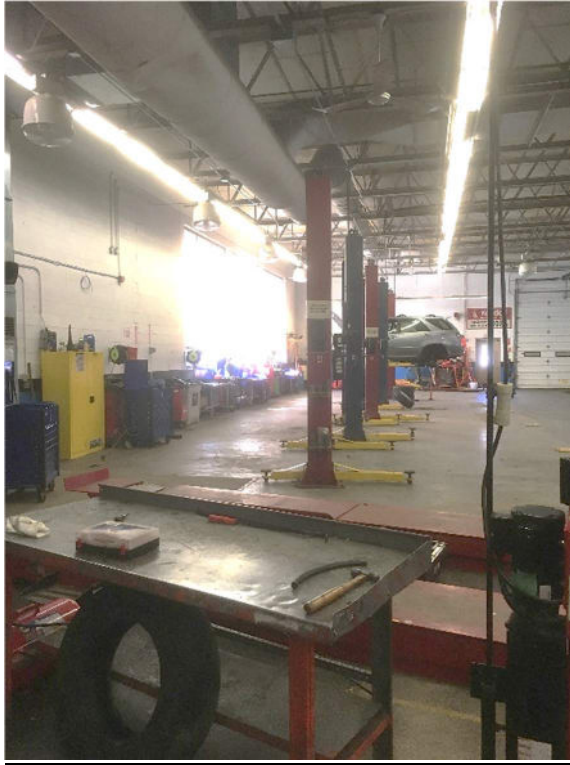
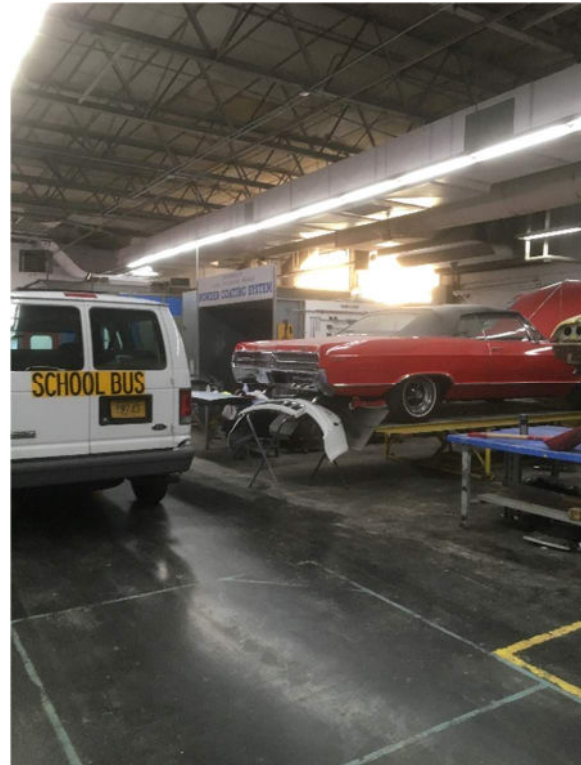
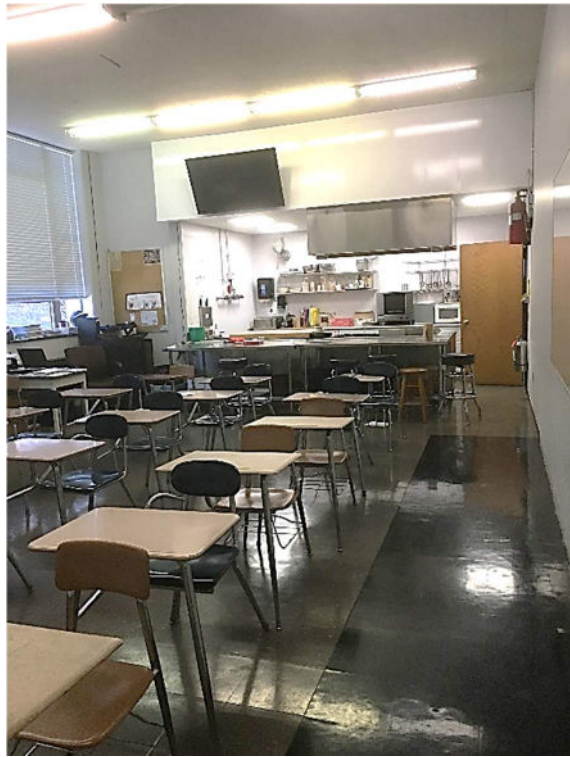
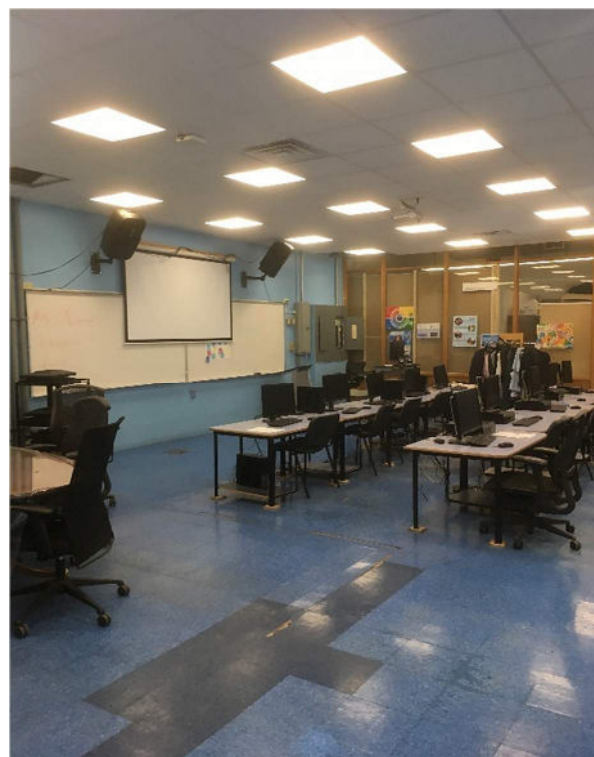
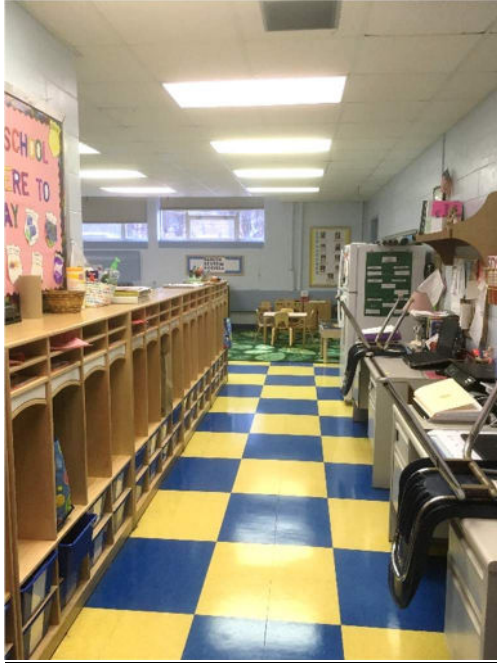
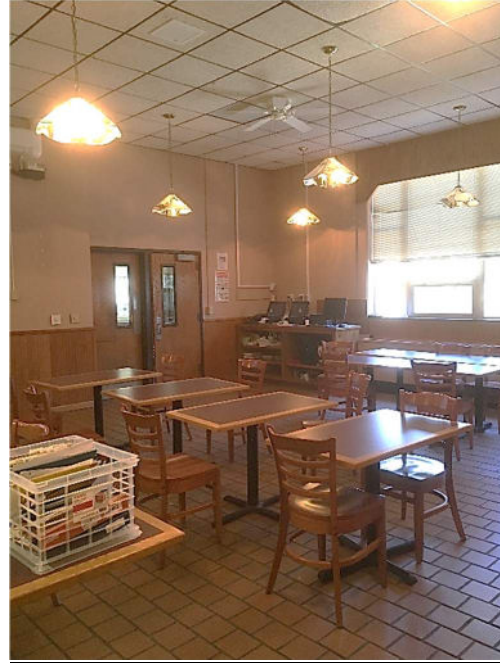
A few notes on shop conditions: The Culinary Arts Kitchen shares the dishwashing room with the Main Kitchen, which is unusual based on the similar programs observed in other schools. Foodservice equipment is generally older but functional. Finishes are generally in fair condition. The other vocational programs are mostly in poor condition with finishes well-worn and dated. Equipment is antiquated and has not been updated to industry standards. Exterior walls, windows, doors, and overhead doors are all in poor condition and thermally ineffective. Roof leaks have occurred in several of these areas in the past, but repairs seem to have mitigated this problem. The Carpentry Shop is relatively new due to recent renovations after a fire. It is the only space in the building that is sprinklered. Doors and frames within all of the shop areas are heavily worn and in poor conditions. Hardware is in poor condition and minimally operable. The STEM program, which is the newest program to be incorporated into the school curriculum, is located in the former Electronics area, but is awkwardly configured

such that two of the classrooms are accessed through an adjacent classroom. The shop toilet rooms are not barrier-free and are not consistently distributed. Most of Theory classrooms do not have access to daylight and some are shared or inconveniently located.

**RECOMMENDATIONS:** Major reconfiguration may be necessary to the entire vocational shop program to right-size the vocational shops for current and future enrollment trends. Most shops require new equipment to replace the original. Comprehensive upgrades are recommended to all finishes, including resealing, recoating, or replacement of floor systems. All new lighting, HVAC systems are necessary. Exterior Doors, Overhead Doors and Window systems are all in need of replacement. Handicapped Accessible improvements shall be considered as part of the re-planning of the shop spaces. Storage areas, toilets, changing rooms will need to be added/reconstructed and made accessible.
