## Architectural Existing Conditions Report

**Northeast Metropolitan Regional Vocational High School**, also known as Northeast Metro Tech, is located at 100 Hemlock Rd, Wakefield Massachusetts. The school was built 1967-68 and was opened in 1968 to teach both traditional high school classes such as English, Math, and Science, along with offering students a multitude of other trades. The existing building is a 3 story, steel joist and masonry framed structure except for the Gym and pool areas where the roof is comprised of large concrete tees. The assumed construction type is Type 2C, not sprinklered. The building measures approximately 624 feet long (at its longest) x 531 feet wide (at its widest) x 33 feet high (at its highest). The building contains a total of 239,444 square feet, spread over three floors. The main floor features multiple levels- one half-level midway into the building and a second half-level by the northwest Carpentry shop wing. Over the last 52 years, there have been a number of additions and minor renovations to the building, including the compressor room for the automotive shop, the storage room for the maintenance department, and numerous partitions to sub

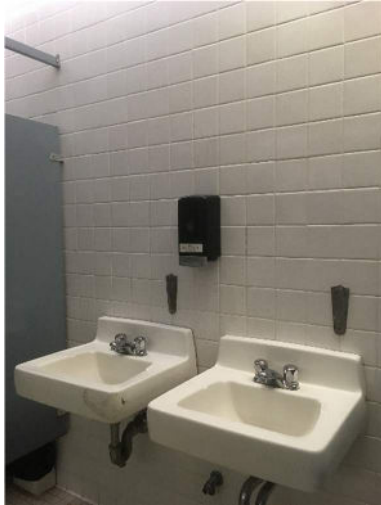
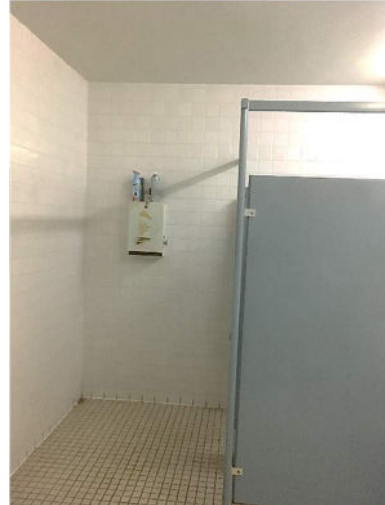
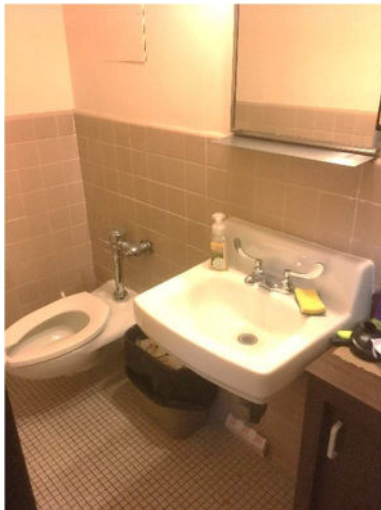
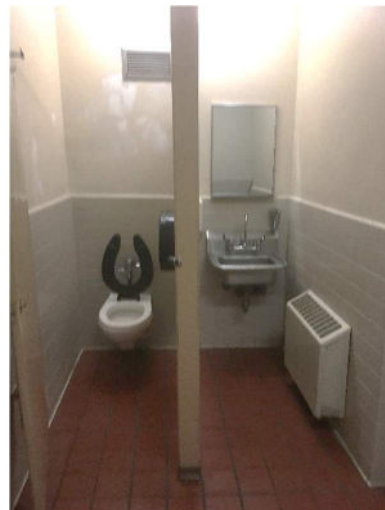
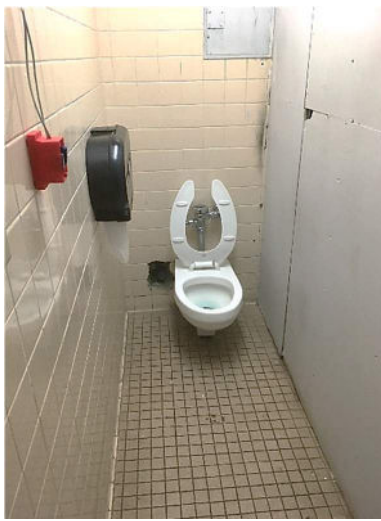
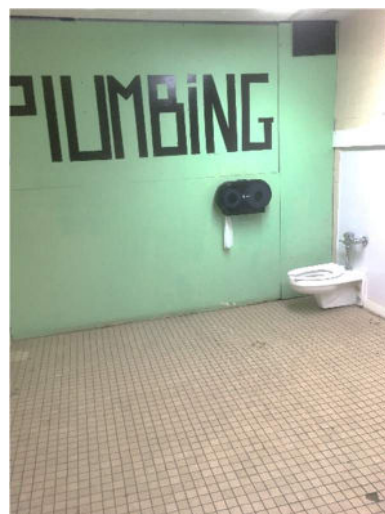
The Public Student Toilets located throughout the facility are in poor condition. Ceilings are painted plaster, with surface mounted strip fluorescent lighting with bulbs typically exposed. Walls are CMU, badly damaged, but structurally intact. Floors are 2x2 inch ceramic tile with ceramic tile base. Fixtures and Toilet accessories appear to be an on-going maintenance challenge. Sinks and fixtures have been replaced with non-matching ones, faucets are not barrier-free and or have been removed completely. Most mirrors have been removed. Toilet accessories (paper towel dispensers, soap dispensers, etc.) are minimal. Most of the toilet stalls are factory painted steel and the doors have been continually retrofitted to maintain operation. The doors and hardware are in very poor condition, the doors are badly damaged and the hardware non-operable, much of which has been replaced or retrofired to maintain minimal operation. The toilet rooms generally have issues regarding handicapped accessibility.

Staff Toilets are well maintained and in fair condition however, the fixtures are antiquated and the operations of some of the fixtures is poor. There are individual user toilet rooms in the administrative area and other staff toilet rooms throughout the facility. Finishes are the same as the student toilet rooms listed above, Acoustical Ceiling Tiles, CMU walls and Ceramic Mosaic Tile, but generally in much better condition. Staff Toilets have toilet partitions which are in fair condition.

Toilet Rooms within Vocational Shops vary widely in their condition, but generally are in very poor condition. Many fixtures are damaged, minimally operable. All finishes are in poor condition and the toilet accessories are minimal. Most toilet stalls are not barrier-free.

RECOMMENDATIONS: All Toilet Rooms are in need of complete replacement of all piping, infrastructure, fixtures and equipment. All finishes will need complete upgrade. Material selection will be critical to minimize damage and maintain operation due to the heavy use that the student toilet rooms get. Walls to get Ceramic Tile full height with Ceramic Mosaic Tile flooring, with phenolic partitions. Many of the rooms would need to be expanded in area to be able to make them handicapped accessible.
