### Re: Northeast Metro Tech High School – Accessibility Audit

On Wednesday, February 19, 2020, KMA staff Julia Garofalo and Verónica Mansilla performed a comprehensive accessibility audit of the immediate site, entrances, and all public and employee spaces at Northeast Metropolitan Regional Vocational School, located at 100 Hemlock Road in Wakefield, MA. The purpose of this audit was to identify conditions that do not comply with either the 2010 Americans with Disabilities Act (ADA) Standards or 521 CMR: The Rules and Regulations of the MA Architectural Access Board (MAAB).

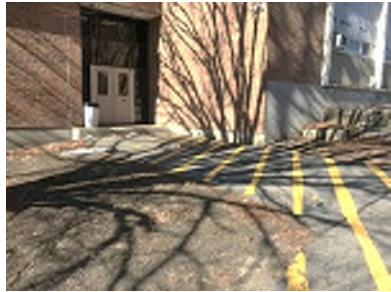
| EXTERIOR & ENTRANCE ISSUES | | |
|---|---|---|
| 1. | <b>Entrances</b><br>Not all of the entrances are accessible due to a step or change of level $>1/2"$ . | |

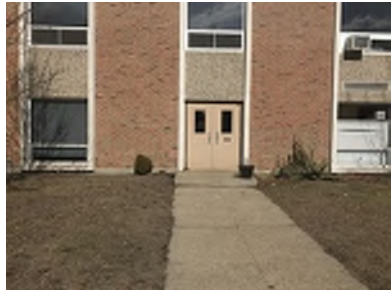
| EXTERIOR & ENTRANCE ISSUES | | |
|---|---|---|
| 2. | <b>Egress Doors</b><br>Most egress doors are not accessible, due to a step or change of level $>1/2"$ , @ 1".<br>Most do not lead to an accessible route. | |

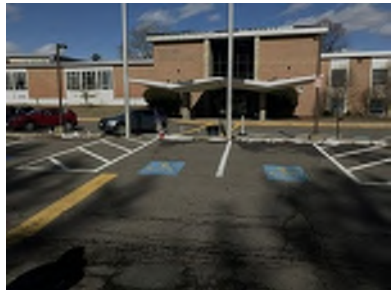
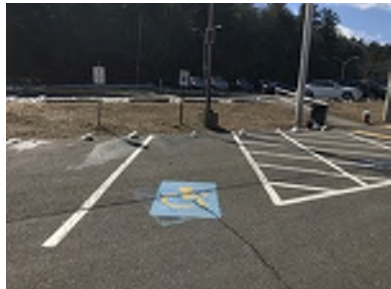
| EXTERIOR & ENTRANCE ISSUES | | |
|---|---|---|
| 3. | <b>Parking near Main Entrance</b><br>There is no signage indicating the van accessible parking space.<br>Some parking spaces lack signage at the head of the space.<br>The designated accessible parking spaces have slopes $>2\%$ , @ 2.7%. | |

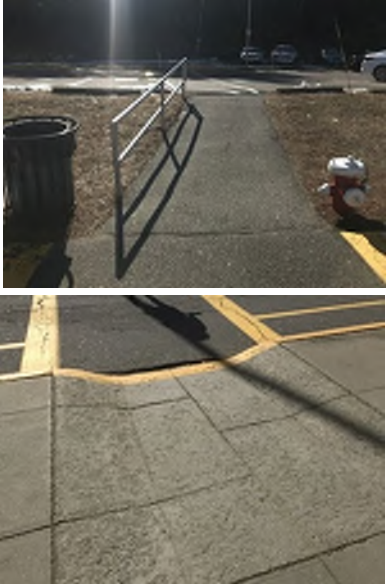
| <p>4.</p> | <p><b>Route from Parking to the Main Entrance</b></p> <p>The slopes of the ramps are &gt;8.3%, @ 8.8%-13%.</p> <p>Handrails are not provided on both sides of the ramps.</p> <p>Handrail extensions are not provided at the top and bottom of the ramps.</p> <p>The slope of the curb cut is &gt;8.3%, @ 10.8% and the flared sides are &gt;10%, @ 20.7%.</p> | |

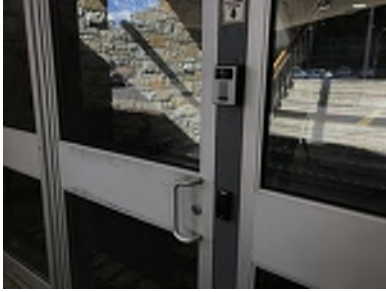
| <p>5.</p> | <p><b>Main Entrance</b></p> <p>The intercom is mounted &gt;48" AFF, @ 56.5".</p> | |

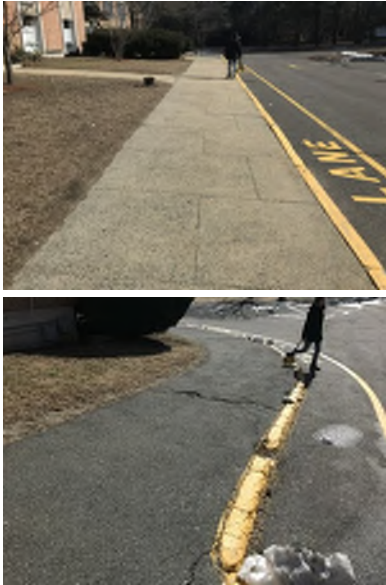
| <p>6.</p> | <p><b>Walkways</b></p> <p>Cracks and bulging create abrupt changes in level.</p> <p>Most cross-slopes are &gt;2%, @ up to 4%.</p> <p>Most running-slopes are &gt;5%, @ up to 8.5%.</p> | |

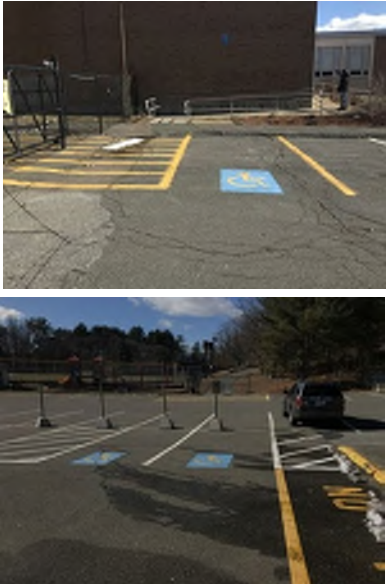
| <p>7.</p> | <p><b>Parking near Pool Area Entrance (#02)</b></p> <p>The designated accessible parking spaces have slopes &gt;2%, @ 4.2%-6.9%.</p> <p>The access aisles are &lt;60" wide and do not connect to an accessible route.</p> <p>The slope of the curb cut is &gt;8.3%, @ 11%.</p> <p>The designated accessible parking spaces lack signage at the head of each space.</p> | |

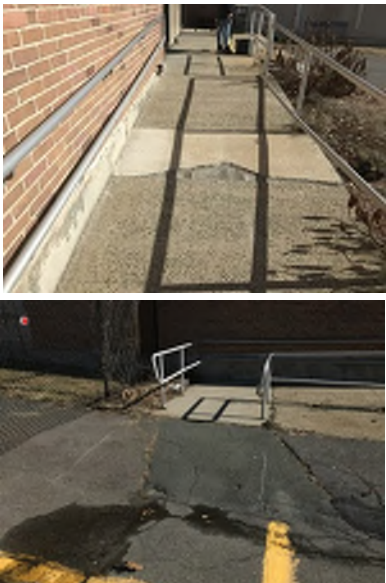
| <p>8.</p> | <p><b>Ramp to Pool Area Entrance (#02)</b></p> <p>The ramp lacks edge protection.</p> <p>Handrail extensions are not provided at the bottom of the ramp.</p> <p>The clear space between the handrail and the wall is &gt;1.5", @ 2".</p> <p>The bottom landing is not level, @ 10%.</p> <p>There is no level landing where the ramp changes direction, @ 6.7%.</p> | |

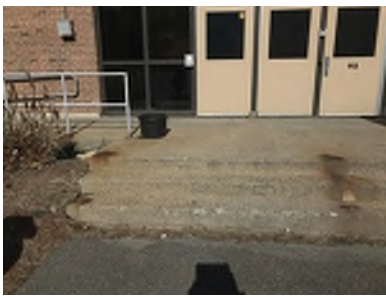
| <p>9.</p> | <p><b>Pool Area Entrance (#02)</b></p> <p>The intercom is mounted &gt;48" AFF, @ 59".</p> <p>The stairs lack handrails on both sides.</p> | |

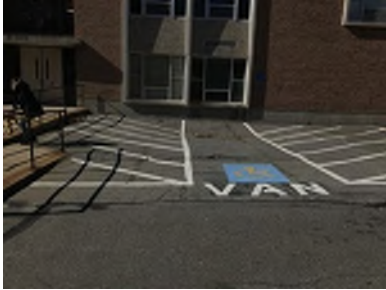
| 10. | <p><b>Parking near Breakheart Inn Entrance</b></p> <p>The designated van accessible parking space lacks signage at the head of the space.</p> <p>The designated van accessible parking space has slopes &gt;2%, @ 7%.</p> | |

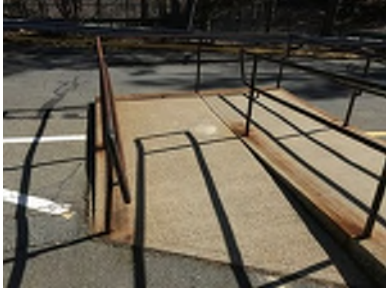
| 11. | <p><b>Ramp to Breakheart Inn Entrance</b></p> <p>The ramp lacks edge protection.</p> <p>The ramp lacks handrails on both sides.</p> <p>The lower handrail is not mounted 18"-20" AFF, @ 22".</p> | |

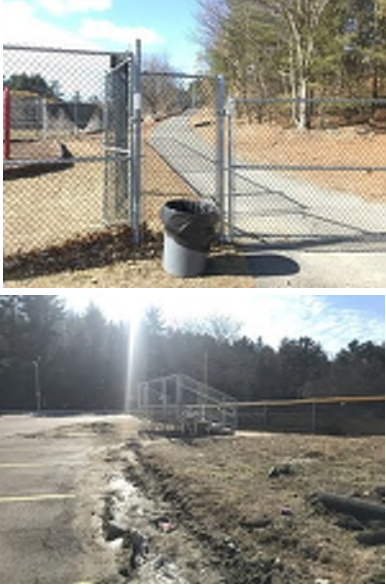
| 12. | <p><b>Playing Fields</b></p> <p>There is no accessible route to the sport fields.</p> <p>There is no accessible route to the bleachers and no accessible seating provided.</p> | |

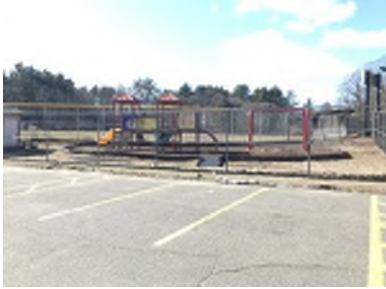
| 13. | <p><b>Playground</b></p> <p>There is no accessible route provided to reach the playground equipment.</p> | |

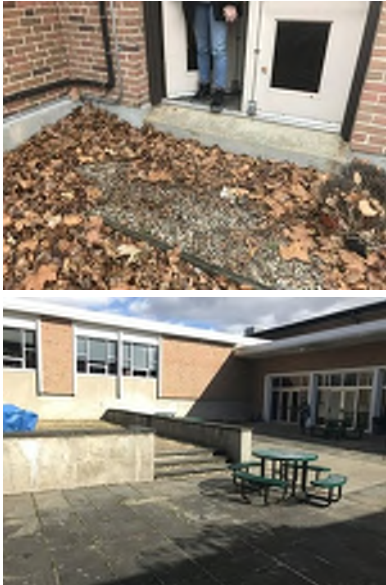
| 14. | <p><b>Interior Courtyards</b></p> <p>The courtyard is not located on an accessible route.</p> <p>The courtyard has areas of deterioration creating abrupt changes of level.</p> <p>The picnic tables do not provide the required knee and toe clearance.</p> | |

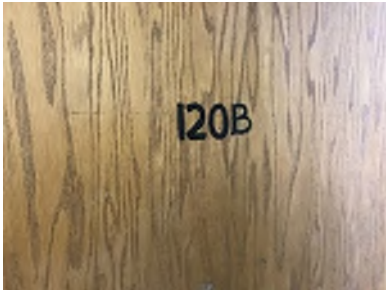
| 15. | <p><b>Signage</b></p> <p>All rooms lack tactile/Braille signage mounted on the latch side of the door.</p> <p>Designated accessible toilet rooms lack the International Symbol of Accessibility.</p> | |

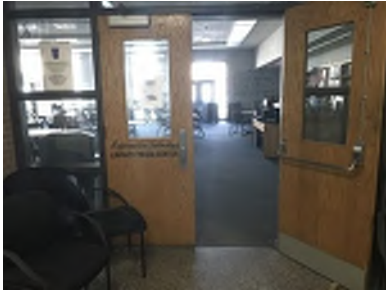
| 17. | <p><b>Double-Leaf Doors</b></p> <p>The double doors leading to the library and graphics shop lack at least one leaf that provides the 32" minimum clear width, @ 29".</p> | |

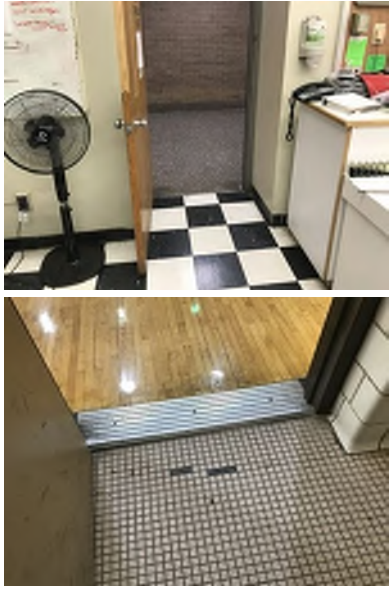
| <p>18.</p> | <p><b>Doors</b></p> <p>Most doors throughout the building have knob hardware that requires tight grasping, pinching, and/or twisting of the wrist to operate.</p> <p>Some doors require &gt;5lbs of force to open.</p> <p>Most doors to adjacent classrooms lack the required 32" minimum clear width, @ 25".</p> <p>Most doors lack the required 18" pull side maneuvering clearance.</p> <p>Some thresholds are &gt;1/2" high and not beveled, @ 1".</p> <p>All recessed doors lack the required 12" minimum push side maneuvering clearance where both a latch and closer are provided.</p> | |

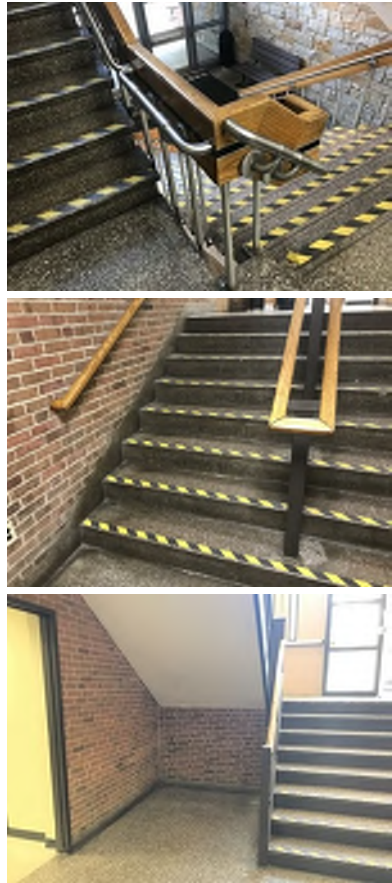
| <p>19.</p> | <p><b>Interior Stairs</b></p> <p>The inside handrails on dogleg stairs are not continuous.</p> <p>There are no handrail extensions at the top and bottom of the stairs.</p> <p>The handrails are not mounted 33"-38" AFF, @ 31" AFF.</p> <p>Some stairs lack handrails on both sides.</p> <p>Some stairs have handrails with cross sections that are not rounded or oval.</p> <p>The headroom under the stairs on the basement floor provides &lt;80" of vertical clearance.</p> | |

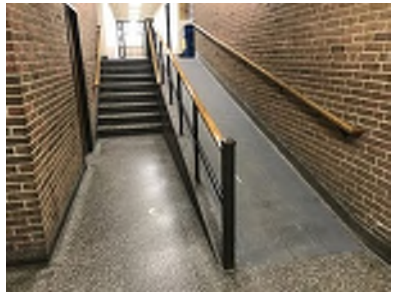
| 20. | <p><b>Interior Ramp</b></p> <p>The slope of the ramp is &gt;8.3%, @ 22%.</p> <p>The ramp lacks edge protection.</p> <p>The ramp lacks compliant handrails on both sides.</p> | |

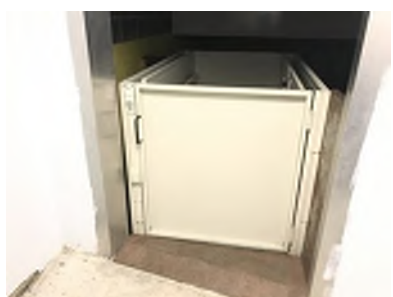
| 22. | <p><b>Lift near Cafeteria</b></p> <p>The lift is not flush with the finished floor, @ 1" AFF.</p> <p>The doorway lacks the required 18" minimum pull side maneuvering clearance.</p> | |

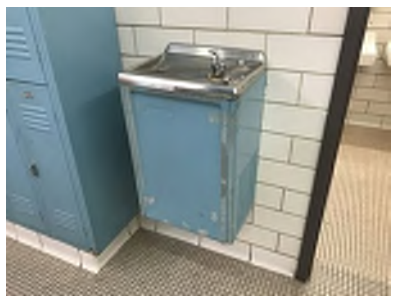
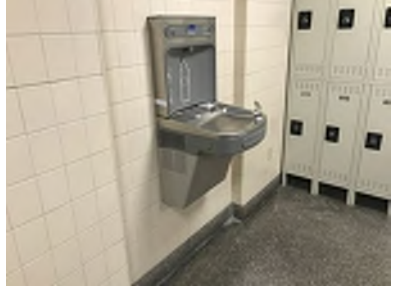
| 23. | <p><b>Drinking Fountains</b></p> <p>Many drinking fountains lack the required 27" AFF minimum knee clearance for a forward approach, @ 26.75" AFF.</p> <p>All drinking fountain spouts are mounted &gt;36" AFF, @ 44" AFF.</p> <p>Most drinking fountains protrude &gt;4" into the circulation route, @ 18".</p> | <br> |

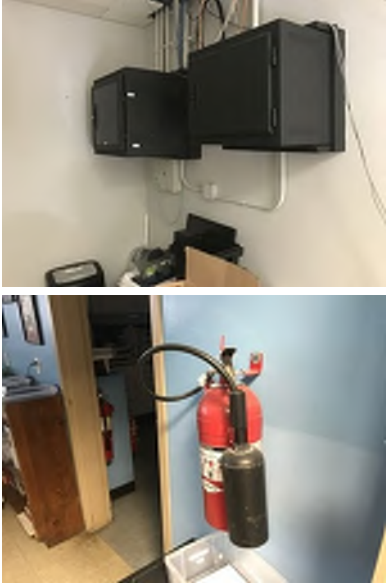
| <p>24.</p> | <p><b>Protruding Objects</b></p> <p>There are elements throughout the building that protrudes &gt;4", @ up to 23", including hand sanitizer dispensers, paper towel dispensers, data boxes, and fire extinguishers.</p> | |

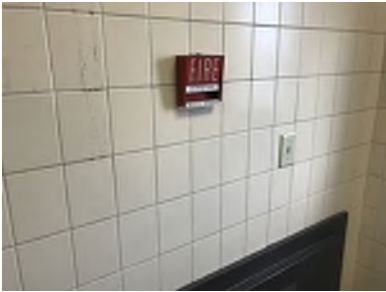
| <p>25.</p> | <p><b>Fire Pull Boxes</b></p> <p>Many fire pull boxes are mounted &gt;48" AFF for a forward approach and &gt;54" AFF for a side approach, @ 56" AFF.</p> | |

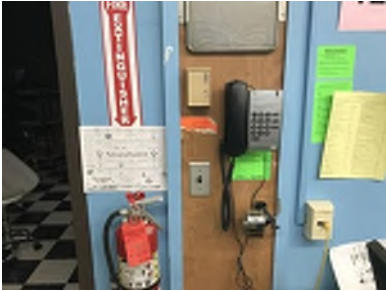
| <p>26.</p> | <p><b>Telephones</b></p> <p>All telephones are mounted &gt;48" AFF for a forward approach and &gt;54" AFF for a side approach, @ 54.5" AFF.</p> | |

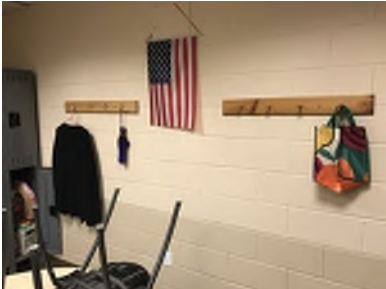
| <p>27.</p> | <p><b>Hooks</b></p> <p>Most coat hooks are mounted &gt;54" AFF, @ up to 64".</p> | |

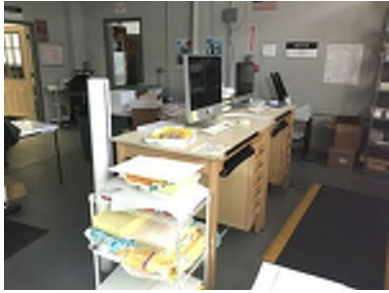
| 28. | <p><b>Furniture</b></p> <p>Many of the furniture in classrooms and offices obstruct the required clear floor space, door maneuvering clearance, and accessible routes.</p> | |

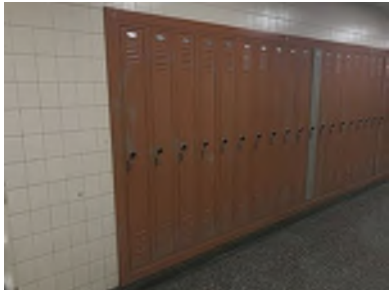
| 29. | <p><b>Lockers</b></p> <p>At least 5% of the lockers, but no less than one, do not provide accessible hardware that is operable with a closed fist.</p> | |

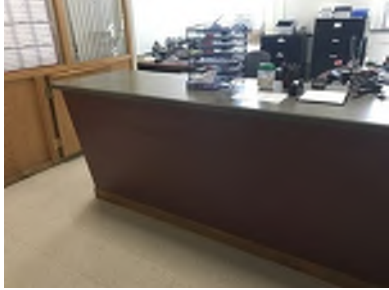
| 30. | <p><b>Reception &amp; Transaction Counters</b></p> <p>Many of the reception and transaction counters lack a 36" minimum wide portion mounted at 36" AFF maximum, @ 43" AFF (i.e. main office, school store, Breakheart Inn).</p> | |

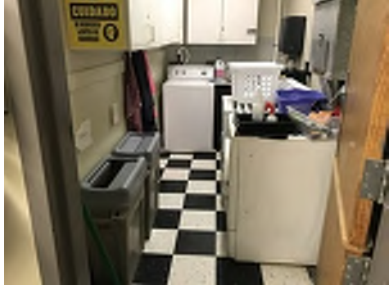
| 31. | <p><b>Offices and Service Rooms</b></p> <p>Many offices and service rooms lack the required turning space.</p> <p>Many offices have pedestal tables that do not provide the required knee and toe clearance.</p> | |

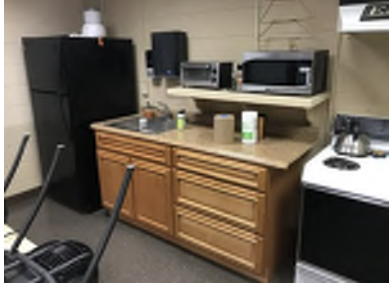
| 32. | <p><b>Teacher's Lounge</b></p> <p>The sink lacks the required knee clearance for a forward approach.</p> <p>The sink is &gt;34" AFF, @ 36" AFF.</p> | |

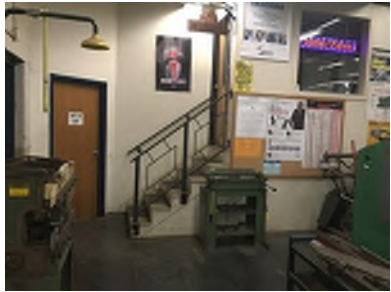
| <p>33.</p> | <p><b>Offices within Shops and Classrooms</b></p> <p>Many of the offices within shops and classrooms are not located on an accessible route (i.e. Cosmetology, Carpentry Shop, Electrical Shop, etc.).</p> | |

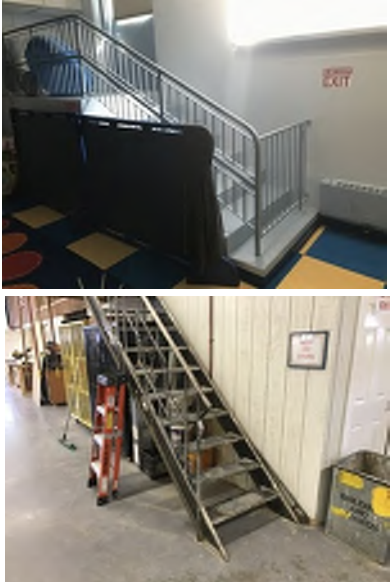
| <p>34.</p> | <p><b>Stairs within Shops and Classrooms</b></p> <p>The handrails are not continuous due to the railing posts.</p> <p>There are no handrails both sides of the stairs.</p> <p>There are no handrail extensions at the top and bottom of the stairs.</p> <p>The handgrip cross section is not rounded or oval.</p> <p>Some headroom under the stairs provides &lt;80" of vertical clearance.</p> <p>Some stairs have open risers.</p> | |

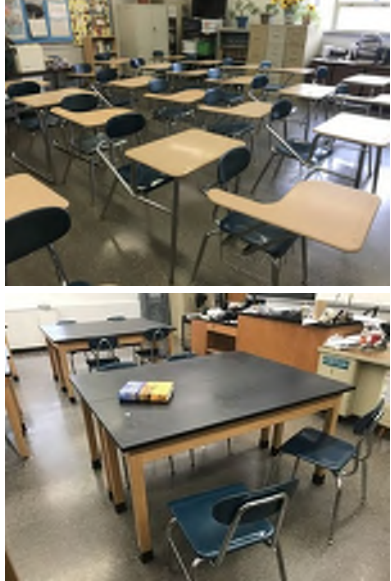
| <p>35.</p> | <p><b>Classroom Desks and Tables</b></p> <p>Many desks and tables lack the required 27" AFF minimum knee clearance, @ 25" AFF, and/or the required 30" minimum width, @ 21".</p> <p>Most classrooms have moveable chairs with desk attachments.</p> | |

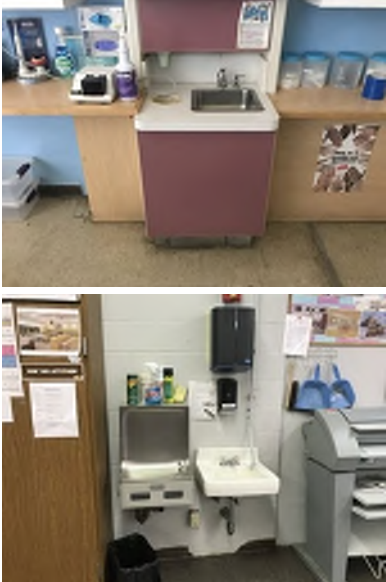
| <p>36.</p> | <p><b>Classroom Sinks and Dispensers</b></p> <p>All classroom sinks lack the required knee clearance for a forward approach.</p> <p>Most classroom sinks are &gt;34" AFF, @ 37" AFF.</p> <p>Some classroom sinks lack insulated piping.</p> <p>Most paper towel and soap dispensers are mounted &gt;46" AFF for an obstructed side approach, @ 63" AFF.</p> | |

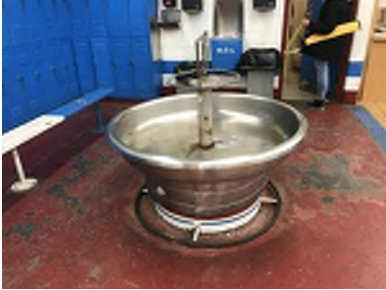
| <p>37.</p> | <p><b>Specialty Sinks</b></p> <p>Classrooms with specialty sinks (i.e. Auto Body, Metal Fab, and Plumbing Shops) lack an adjacent accessible sink with the required knee clearance for a forward approach.</p> | |

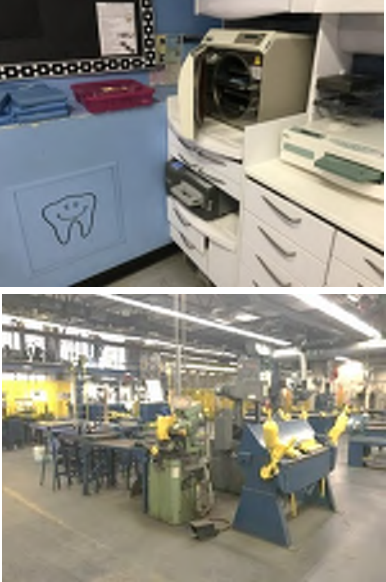
| <p>38.</p> | <p><b>Specialty Equipment</b></p> <p>Many equipment controls are mounted &gt;48" AFF for a forward approach and &gt;54" AFF for a side approach, @ 55.5" AFF or higher, and have controls that require tight grasping, pinching, and/or twisting of the wrist to operate.</p> <p>Most vocational classrooms lack at least one work bench mounted at 34" AFF maximum and providing compliant knee space for a forward approach.</p> | |

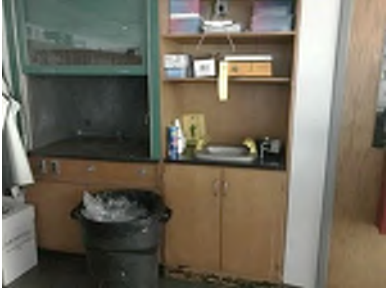
| 39. | <p><b>Emergency Showers</b></p> <p>The emergency shower pull is mounted &gt;48" AFF, @ up to 65.5" AFF.</p> | |

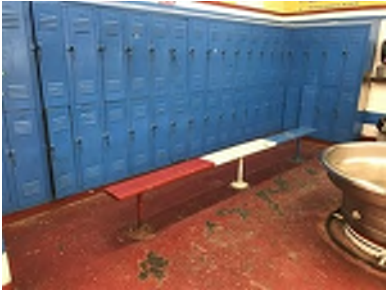
| 40. | <p><b>Benches within Shops</b></p> <p>The benches lack the required clear floor space positioned at the end of the bench seat and parallel to the short axis of the benches and do not provide back support.</p> | |

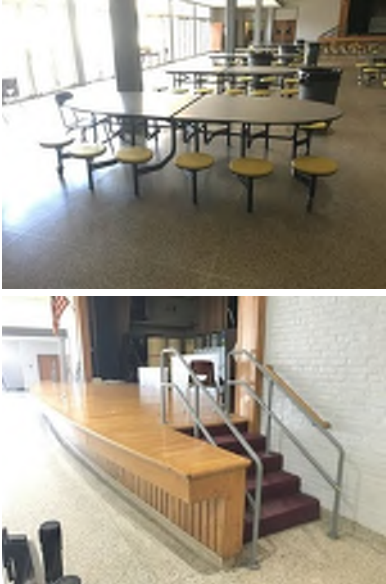
| 41. | <p><b>Cafeteria</b></p> <p>The lunch tables lack the required knee and toe clearance for a forward approach.</p> <p>There is no accessible route to stage.</p> <p>There are no handrail extensions at the bottom of the stairs.</p> | |

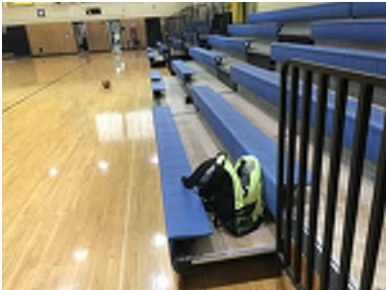
| 42. | <p><b>Gymnasium</b></p> <p>There is no designated accessible wheelchair seating provided in the bleachers.</p> <p>The bleachers do not provide handrails at the risers when open.</p> | |

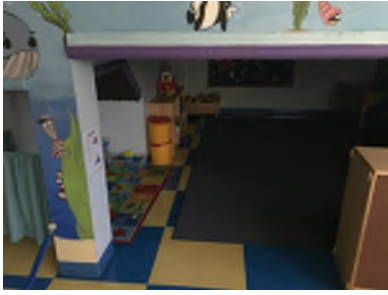
| <p>43.</p> | <p><b>Child Care</b></p> <p>The children's toilet rooms lack all accessible elements.</p> <p>The ceiling in the play area provides &lt;80" AFF of vertical clearance, @ 54" AFF.</p> | |

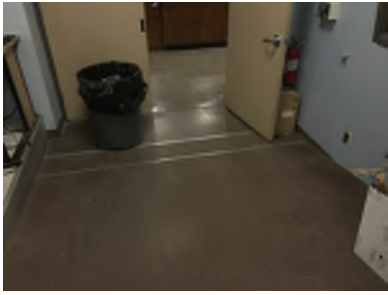
| <p>44.</p> | <p><b>IT Office</b></p> <p>The slope of the ramp is &gt;8.3%, @ 12%.</p> <p>The ramp lacks compliant handrails on both sides.</p> <p>The landing at the bottom of the ramp is &lt;60", @ 27".</p> | |

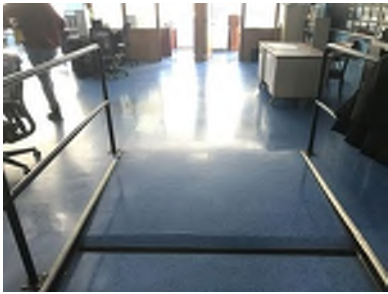
| <p>45.</p> | <p><b>Office Tech Computer Labs</b></p> <p>The accessible route has running slopes &gt;5% and is not treated as a ramp, @ 5.9%.</p> | |

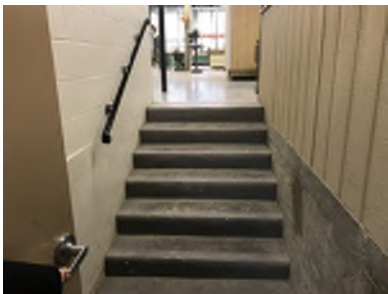
| <p>46.</p> | <p><b>Carpentry Shop</b></p> <p>There is no accessible route to the Carpentry Shop.</p> | |

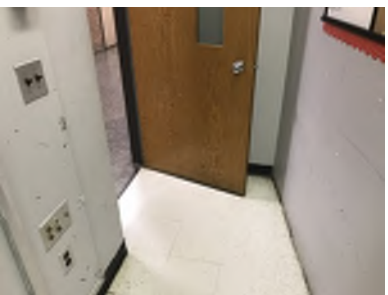
| <p>47.</p> | <p><b>SPED Resource Room</b></p> <p>The door lacks the required 48" minimum pull side maneuvering clearance depth for a latch side approach, @ 40".</p> | |

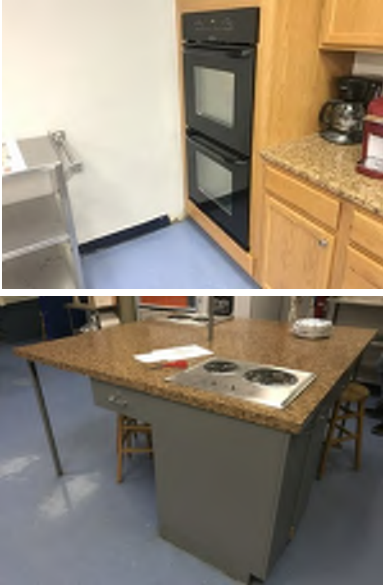
| <p>48.</p> | <p><b>Nursing Classroom (Basement)</b></p> <p>The oven controls are mounted &gt;48" AFF for a forward approach and &gt;54" AFF for a side approach, @ 59" AFF.</p> <p>The cooktop lacks the required knee clearance for a forward approach.</p> | |

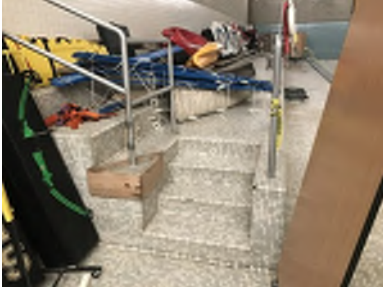
| <p>49.</p> | <p><b>Pool</b></p> <p>There is no accessible route to the pool spectator seating area.</p> <p>There is no pool lift provided.</p> | |

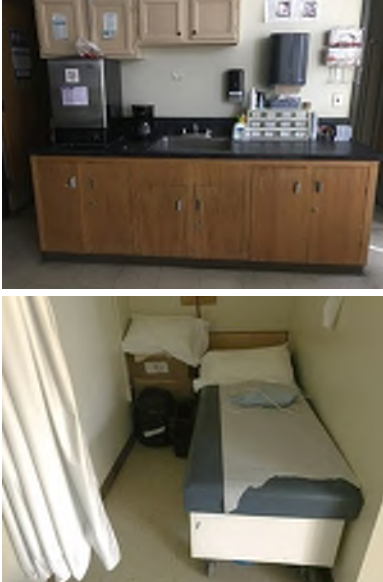
| <p>50.</p> | <p><b>Nurse's Office</b></p> <p>The sink lacks the required knee clearance for a forward approach.</p> <p>The sink is &gt;34" AFF, @ 36" AFF.</p> <p>The beds lack an adjacent 30"x48" clear floor space, @ 27.5" wide.</p> <p>The toilet rooms lack all accessible elements.</p> | |

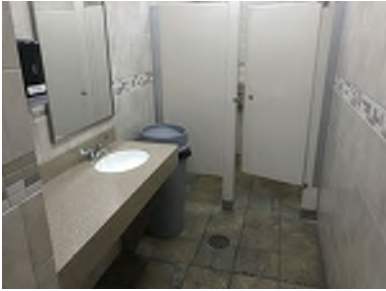
| <p>51.</p> | <p><b>Typical Toilet Rooms</b></p> <p>All toilet rooms for students and most for staff are non-compliant due to the following:</p> <ul style="list-style-type: none"> <li>• The doors lack the required 32" minimum clear width, @ 25".</li> <li>• The toilet rooms lack all accessible elements.</li> </ul> | |

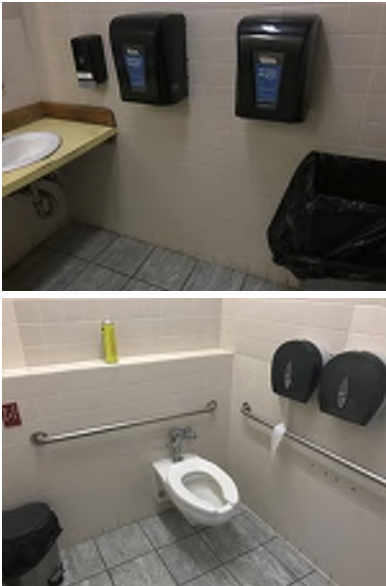
| <p>52.</p> | <p><b>Unisex Staff Toilet Room near Cafeteria</b></p> <p>The bottom of the reflective surface of the mirror is &gt;40" AFF, @ 41.5".</p> <p>The sink pipes are not insulated.</p> <p>The paper towel protrudes &gt;4" into the circulation route, @ 8.5".</p> <p>The toilet centerline is not 16"-18" from the side wall, @ 18.5".</p> <p>The grab bars are not mounted 33"-36" AFF, @ 30".</p> <p>The toilet paper dispenser is mounted &lt;12" above the side grab bar, @ 8".</p> <p>The side grab bar extends &lt;54" from the rear wall, @ 48.5".</p> <p>The toilet flush control is not located on the wide side of the toilet.</p> | |

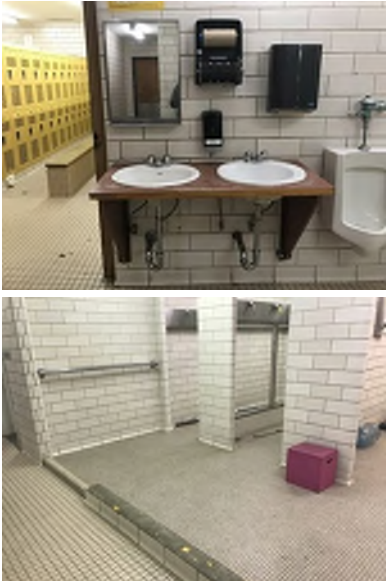
| <p>53.</p> | <p><b>Locker Rooms</b></p> <p>The doors lack the required 32" minimum clear width, @ 25".</p> <p>There are no accessible toilet stalls provided.</p> <p>All sinks lack insulated pipes, are mounted &gt;34" AFF, @ 36.5" AFF, and/or lack the required knee clearance for a forward approach.</p> <p>Most of the bottom of the reflective surface of the mirrors are &gt;40" AFF, @ 50".</p> <p>Hand dryers protrude &gt;4" into the circulation route, @ 8".</p> <p>Urinals are mounted &gt;17" AFF, @ 20" AFF.</p> | |

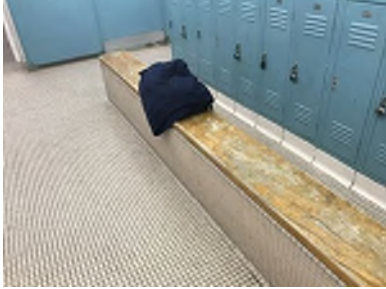
| | <p>All shelves are mounted &gt;48" AFF for a forward approach and &gt;54" AFF for a side approach, @ 68" AFF.</p> <p>All locker rooms lack at least one accessible transfer or roll-in shower.</p> <p>The locker room benches lack the required clear floor space positioned at the end of the bench seat and parallel to the short axis of the benches and do not provide back support.</p> | |
