## R.W. Sullivan Engineering

## NE Metro Regional Vocational Technical School Wakefield, Massachusetts

## Existing Building Code Report

July 21, 2020

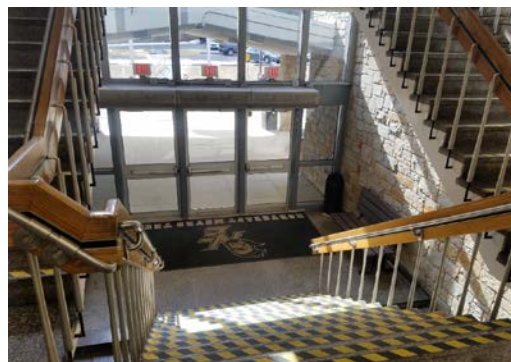
The main entrance as well as the majority of the exterior doors to the school are not assessible.

*Entrance not accessible due to stairs.*

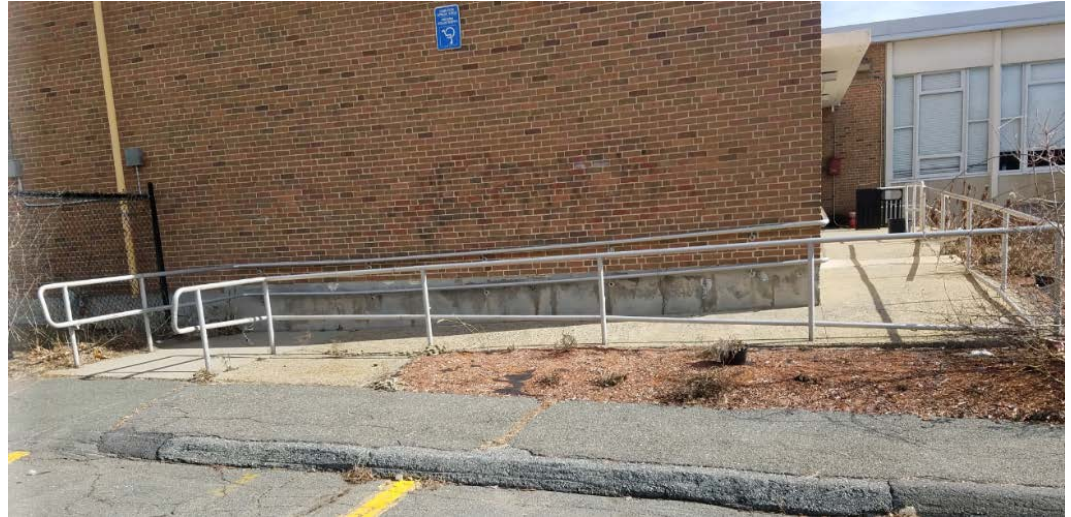
The ramp is not accessible. The cross slope is greater than 2%, the handrails do not comply with 521 CMR 24.5, and concrete is in disrepair on the ramp (521 CMR 24.6, 24.5, and 24.7).

*Handrail are not compliant and the ramp has a cross slope larger than 2%.*

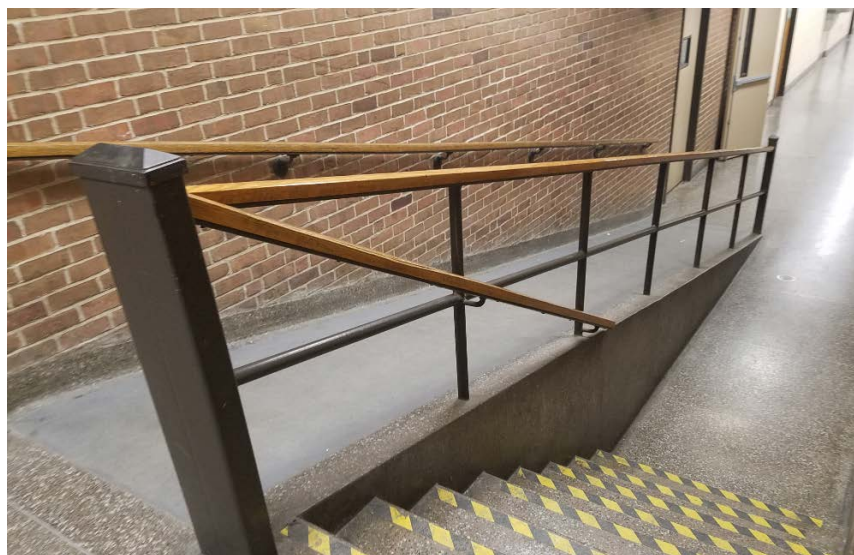
The ramp that connects the lower half of the first floor to the higher half of the first floor is not compliant. The slope of the ramp is greater than 8.3%, the handrails are not circular and do not extend properly at the bottom of the ramp (521 CMR 24.2.1 and 24.5).

*Steep ramp over 8.3% slope. The handrails are noncircular and do not extend.*

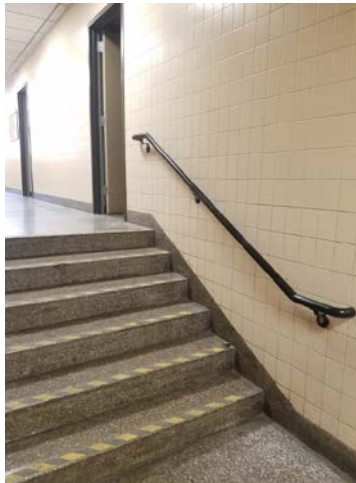
Classroom C-113 and Classroom C-112 are not accessible due to stair in the corridor.

*Stair causing a non-accessible route to the classrooms at the top of the stair.*

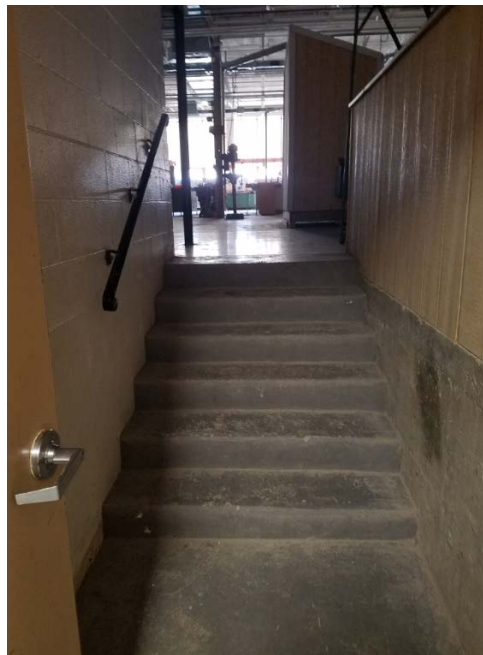
The carpentry classroom does not have an accessible route into the classroom due to the stairs.

*One of the stairs that is used to access this room.*

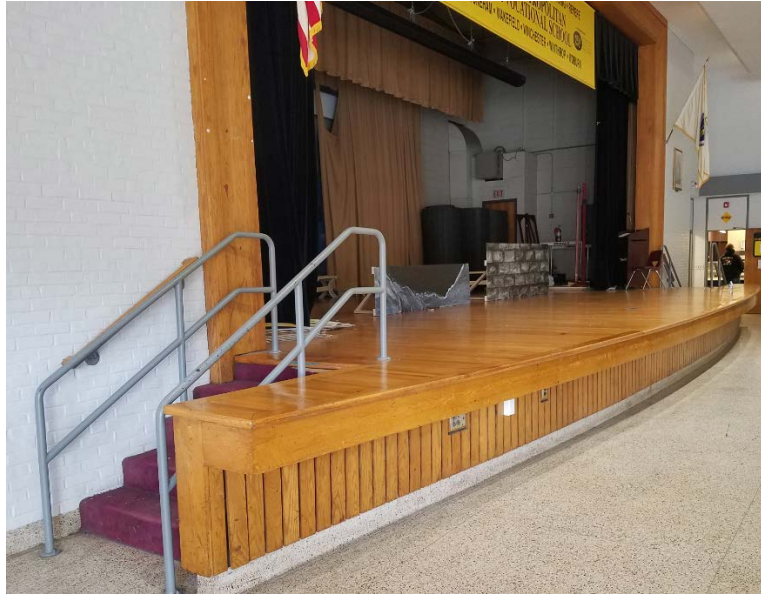
There is no accessible route to the stage.

*Stairs are the only way to access the stage.*

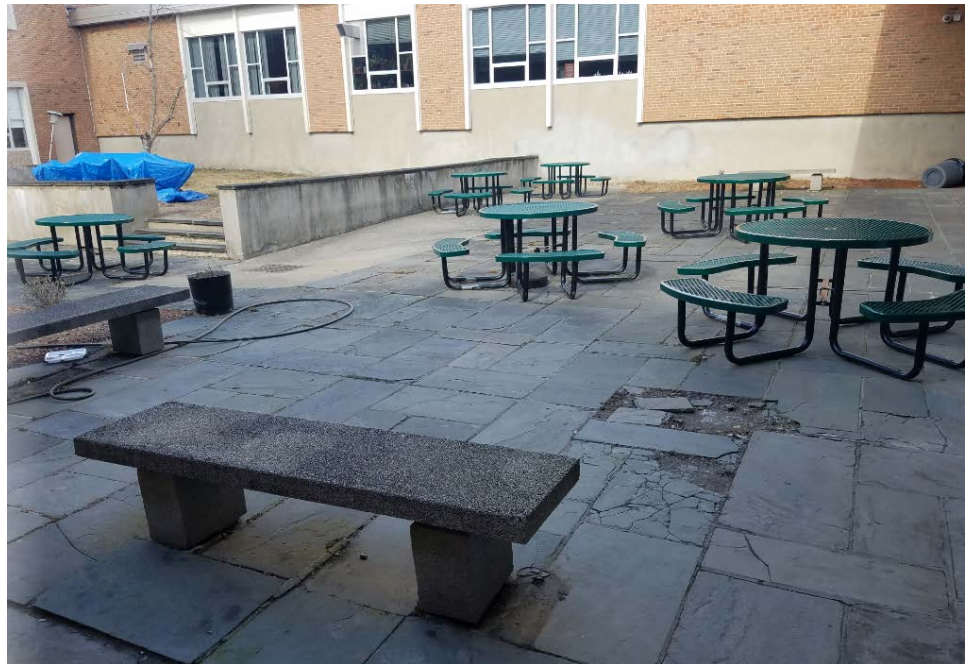
Portions of the courtyard are not accessible. There is a raised portion that cannot be accessed without stairs. Other parts of the courtyard have concrete missing causing it to not be accessible.

*Stairs to the raised portion of the courtyard and concrete in disrepair.*

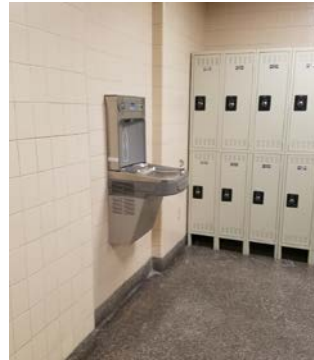
Drinking fountains throughout the building protrude into the corridor more than 4 inches (521 CMR 20.6.1). The pictures below show some, but not all, of the examples of drinking fountains protruding into the corridor.

*Protruding into the corridor more than 4 inches.*

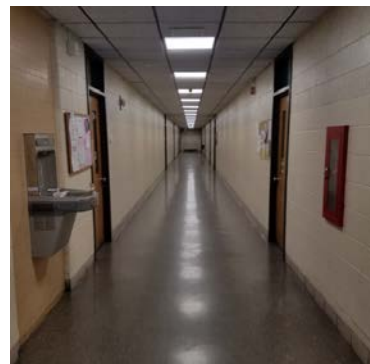
*Protruding into the corridor more than 4 inches.*

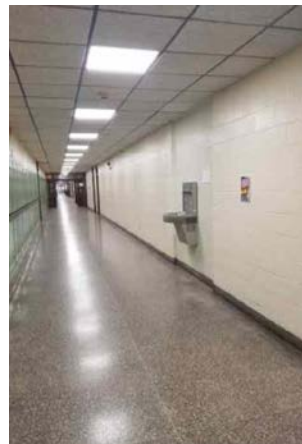
*Protruding into the corridor more than 4 inches.*

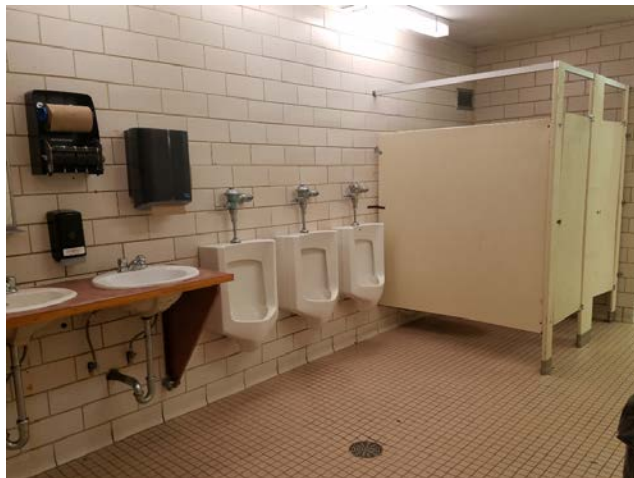
Toilet rooms throughout the building are generally not accessible. There are no accessible stalls that comply with 521 CMR 30.6. The size of the stalls are less than 60 inches wide and do not have grab bars complying with 521 CMR 30.8. The urinals do not comply with 521 CMR 30.10, the rim of the urinal is higher than 17 inches. The sinks do not comply with 521 CMR 30.9. The pictures below are some, but not all, of the examples of the noncompliant bathrooms.

*Toilet stalls too small, urinals too high, and sinks not compliant.*

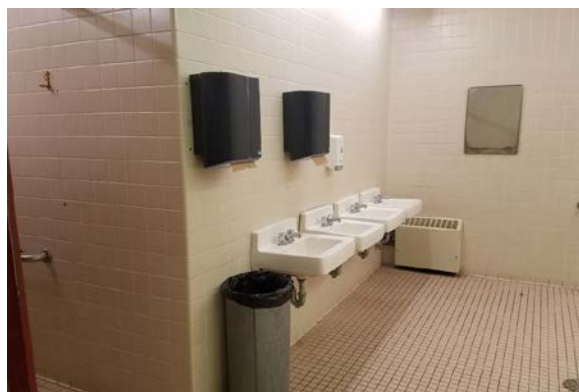
*Sinks not compliant.*

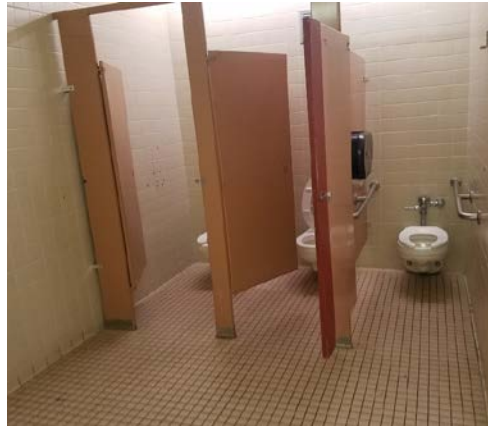
*Toilet stalls too small and grab bars noncompliant.*

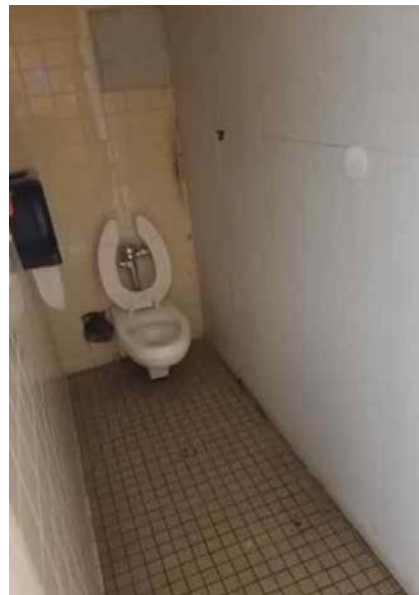
*Stall too small and no grab bars.*

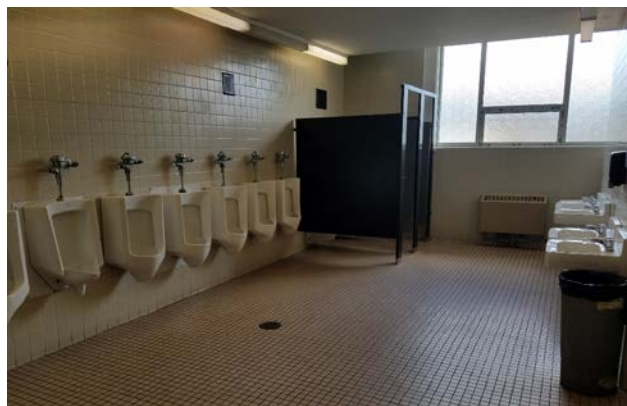
*Toilet stalls too small, urinals too high, and sinks not compliant.*

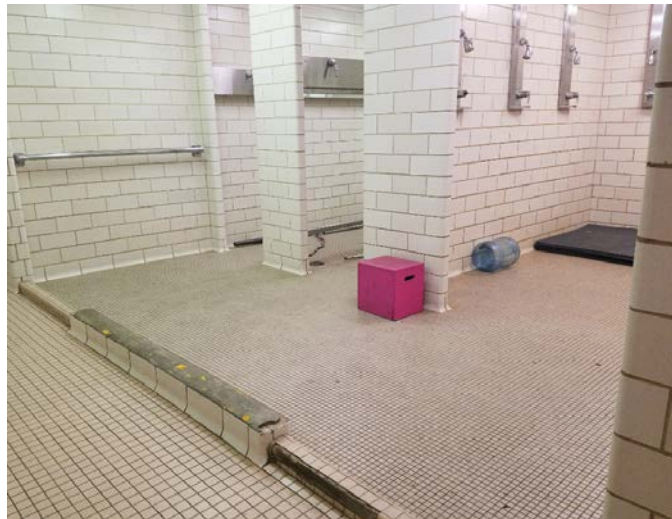
The men's bathing room shower is noncompliant. The fixtures are not accessible, and the shower has a 6" high barrier.

*Noncompliant fixtures and barrier in shower.*

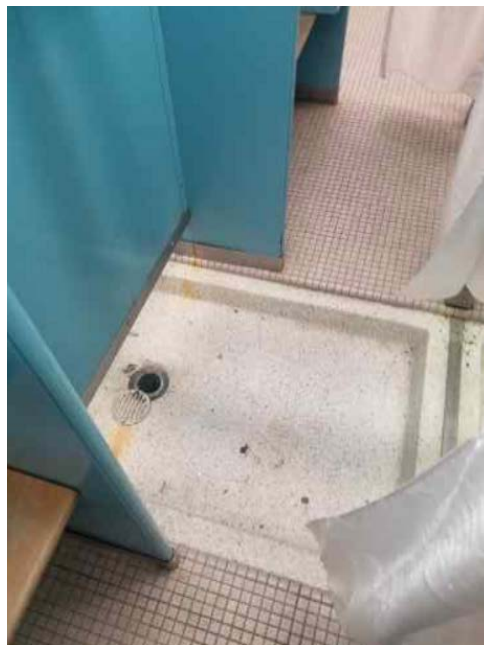
The woman's bathing room is generally noncompliant. The showers and changing rooms are not compliant.

*Shower is too small and has a barrier.*

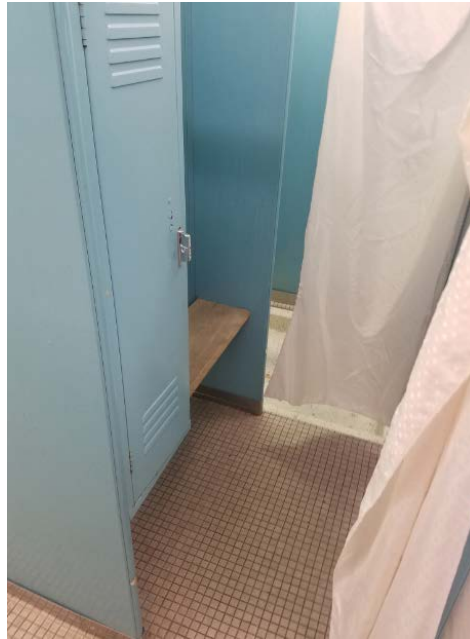
*Changing area is noncompliant.*

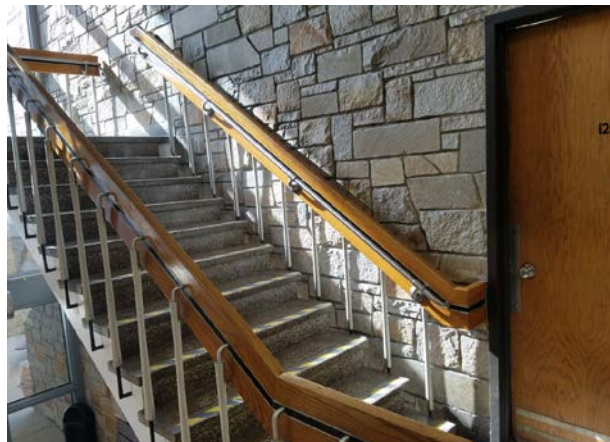
In general, most of the stairs are not compliant. In general stairs have one or more of the following issues (521 CMR 27.3, 27.4.4, 27.4.5, 27.4.3, 27.4.1, and 27.4.8). The pictures below are some, but not all, of the examples of the noncompliant stairs.

*Stair handrails do not extend at the top and the bottom of the stair.*

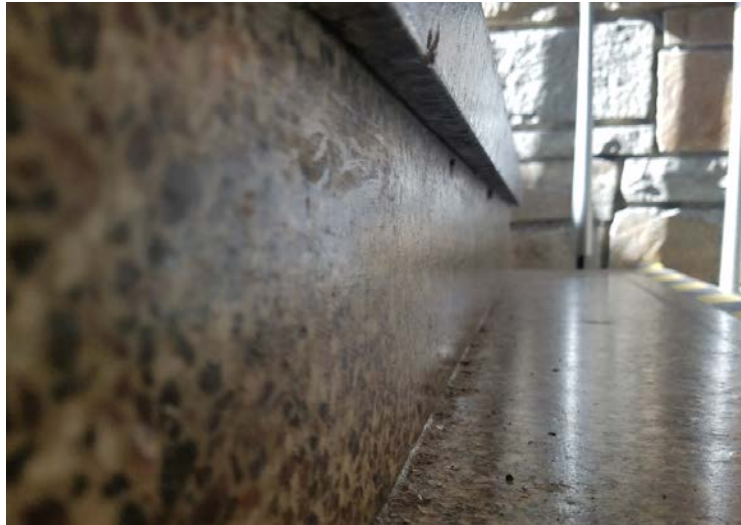
*Abrupt nosing on stair.*

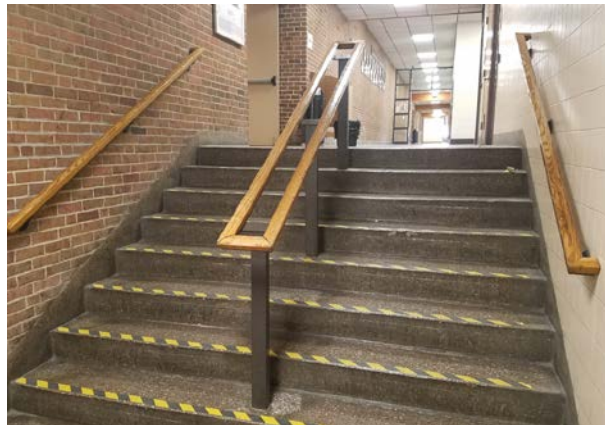
*Handrails are noncircular and do not extend at the top and bottom of the stair.*

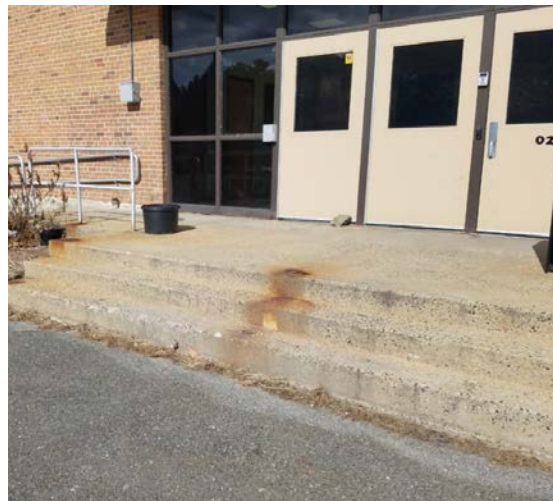
*Stair is missing a handrail.*

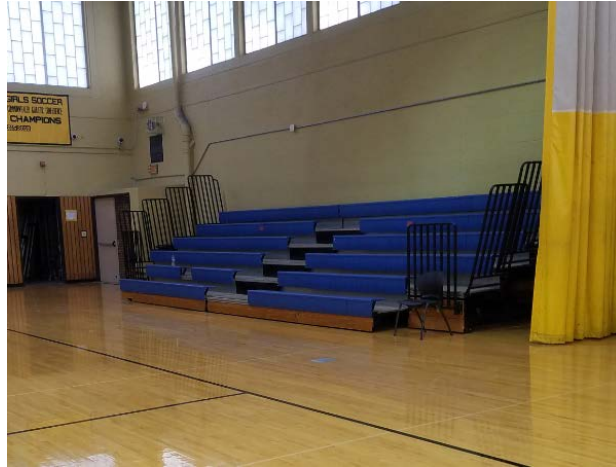
*Bleachers are missing handrails in the aisle.*

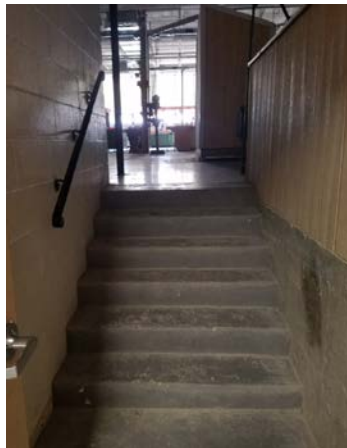
*Stair is missing a handrail.*

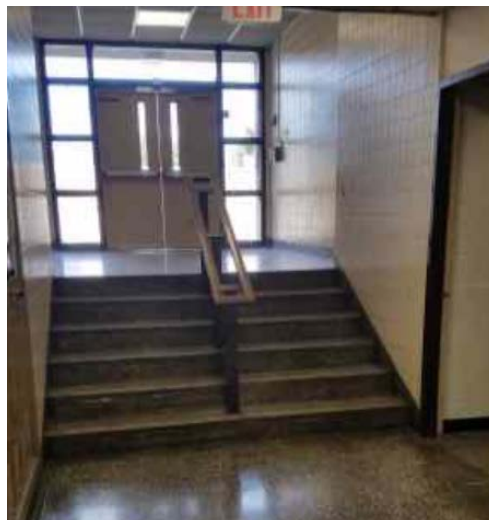
*Stair is missing handrails on the sides.*

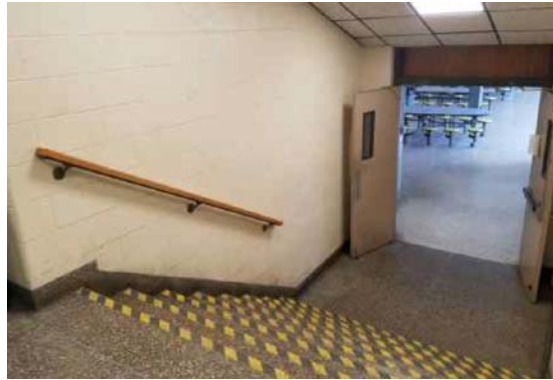
*Handrail is noncircular and does not extend at the top or the bottom.*

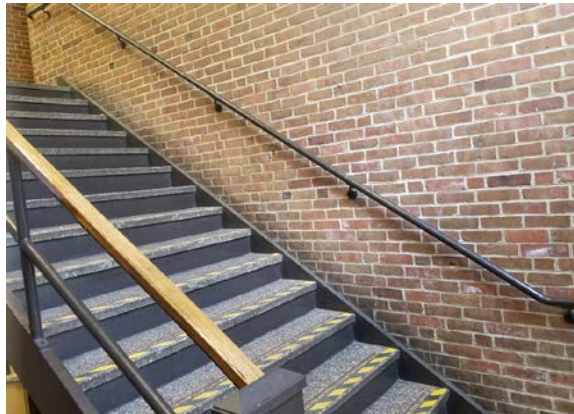
*Handrail is noncircular and is interrupted by post. Stair has abrupt nosings.*

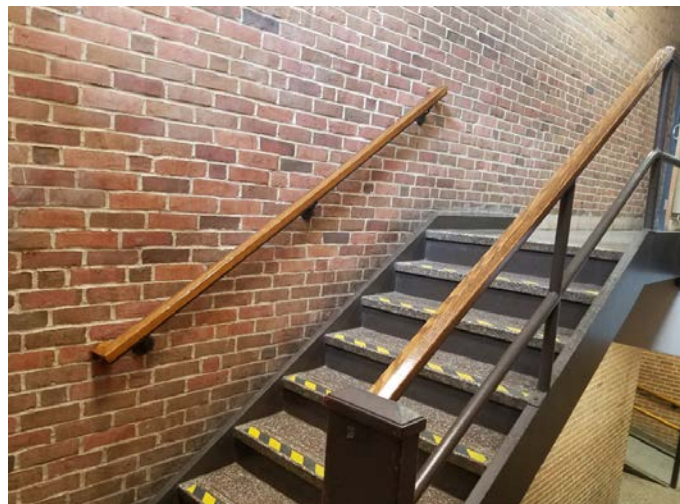
*Handrails are noncircular, do not extend at the top and bottom and are interrupted by post. Stair has abrupt nosings.*

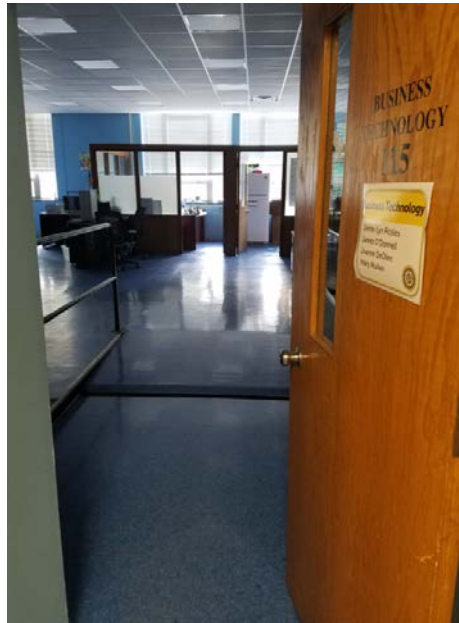
Throughout the building the doors have doorknobs on them which is not compliant hardware since it requires a person to twist their wrist (521 CMR 26.11.1). Also, a lot of the doors do not meet the door clearance due to the alcoves being deeper than 6" in the classrooms (521 CMR 26.6.2, 26.6.3, and 26.6.4). The pictures below are some, but not all, of the examples of the noncompliant doors.

*Door does not meet clearances  
and has doorknob.*

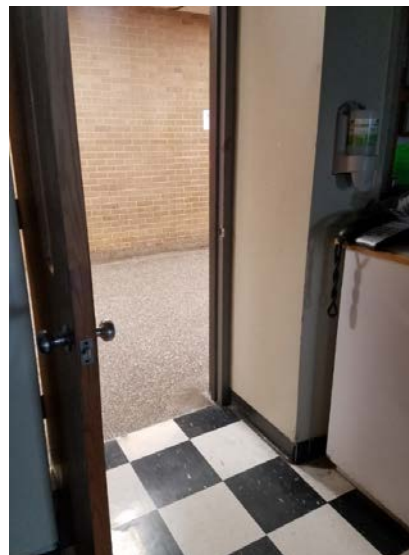
*Door does not meet clearances  
and has doorknob.*

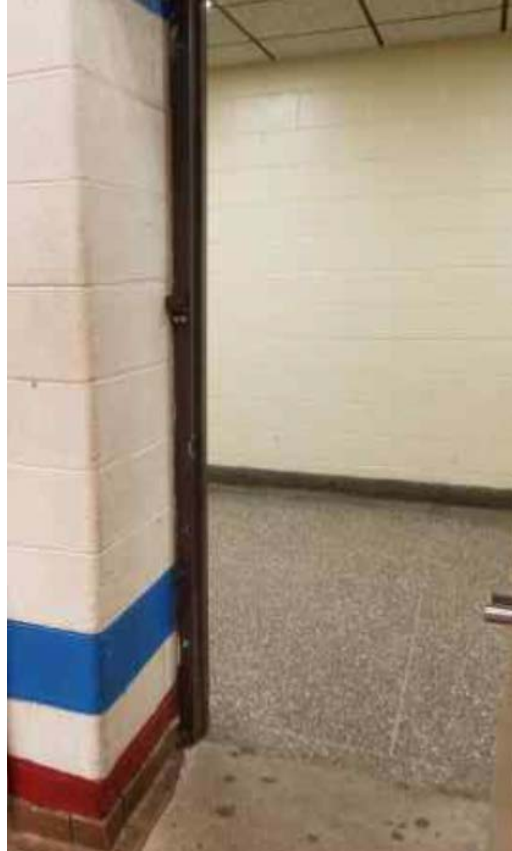
*Door does not meet clearances.*

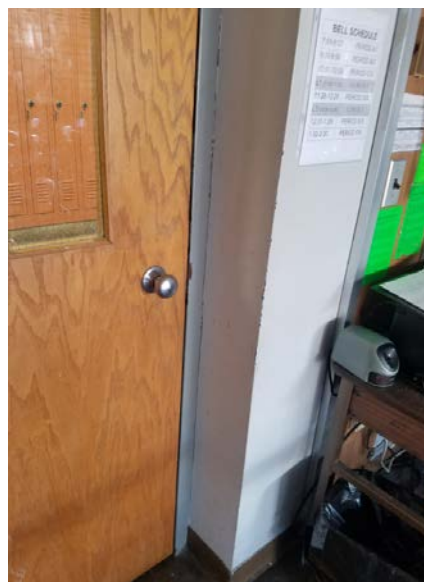
*Door does not meet clearances  
and has doorknob.*

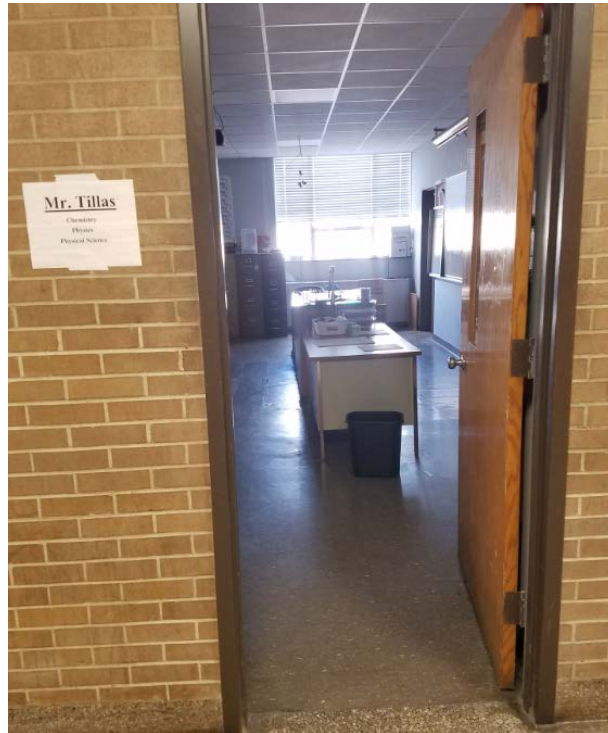
*Door has doorknob.*

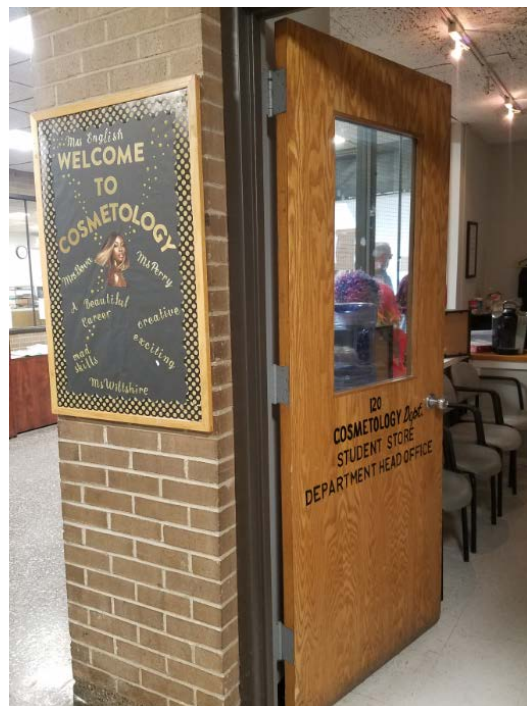
*Door does not meet clearances  
and has doorknob.*

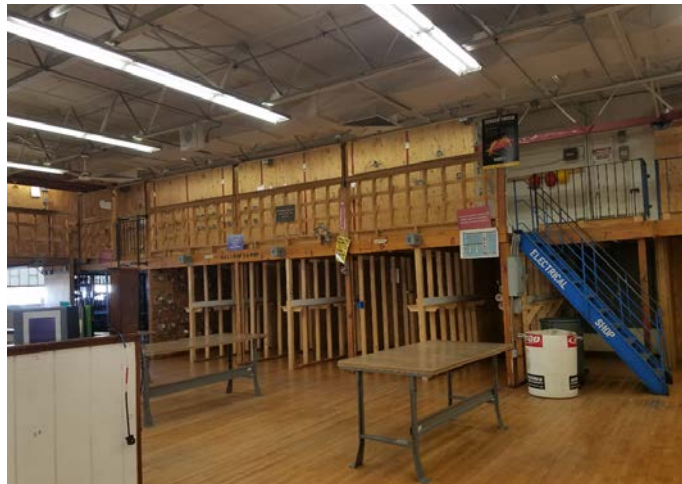
In general, the classrooms are accessible. The shops and the labs are not accessible. Some shops have non-accessible levels. The shops and the labs also have non-accessible sinks. The labs have non-accessible workstations. The pictures below are some, but not all, of the examples for non-accessible items in shops and labs.

*No accessible route to the upper level.*

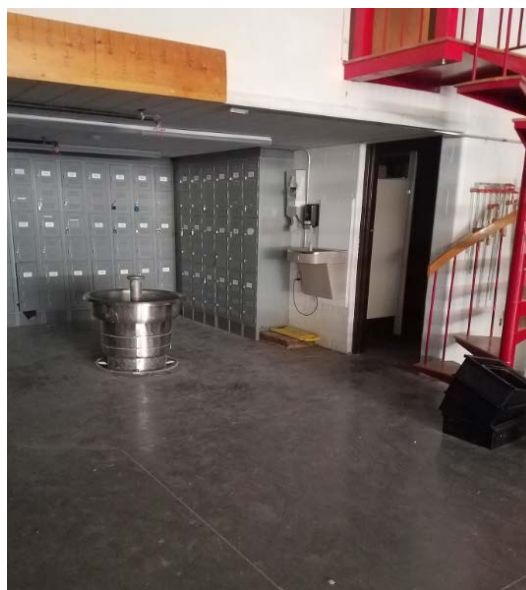
*No accessible route to the upper level  
and non-accessible sink.*

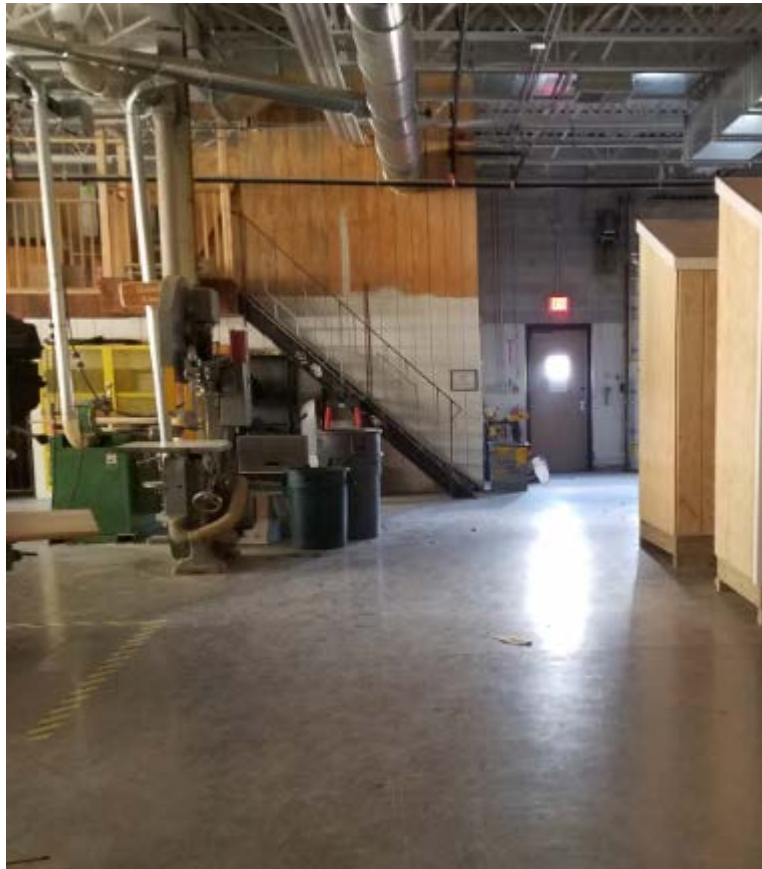
*No accessible route to the upper level.*

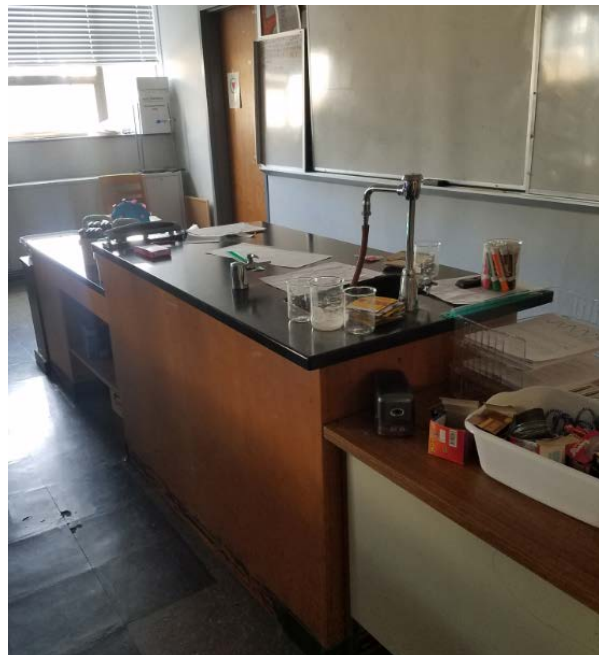
*Non-accessible sink and counter space.*

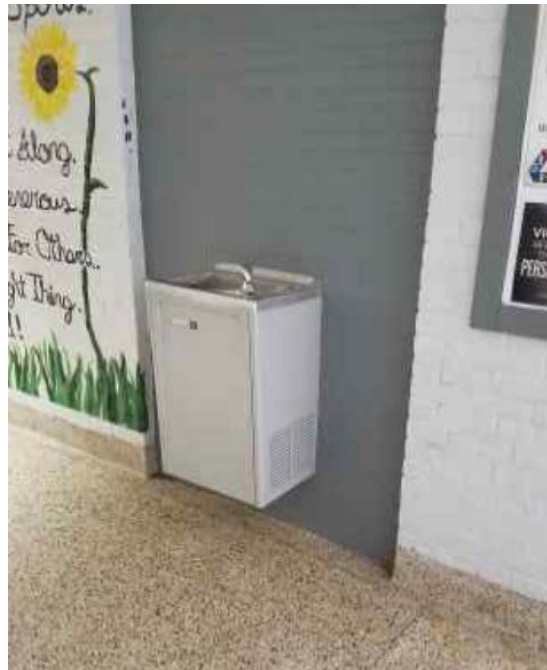
The drinking fountain is not compliant due to the controls, spout, height, and lack of kneespace.

*Non-accessible drinking fountain.*

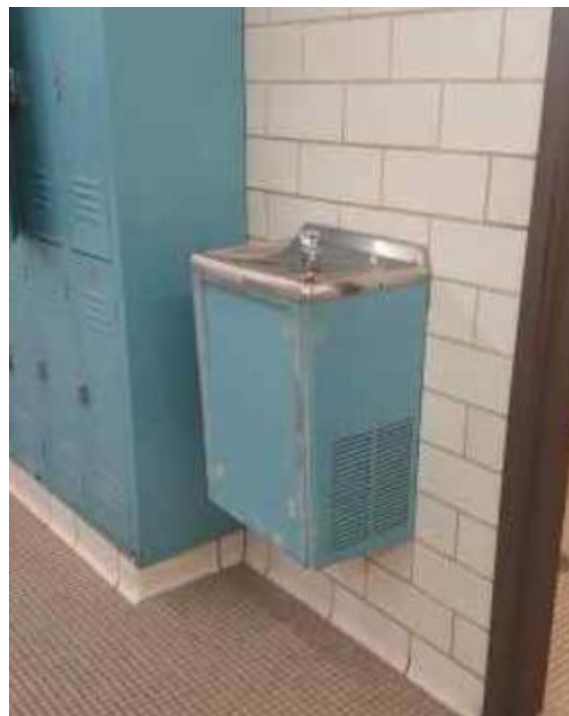
*Non-accessible drinking fountain.*

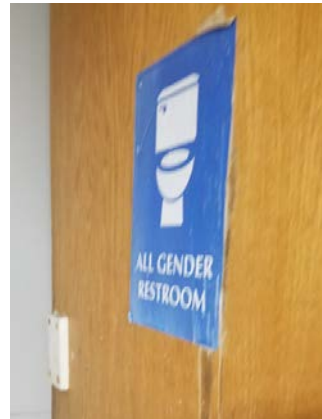
Throughout the building the signs do not comply. They are placed on the doors and do not have braille or raised lettering. Also, there are no signs that designate an accessible exit (521 CMR 41.2, 41.5, 41.6, and 41.1.3). The pictures below are some, but not all, the examples of non-accessible signs.

*Noncompliant sign.*

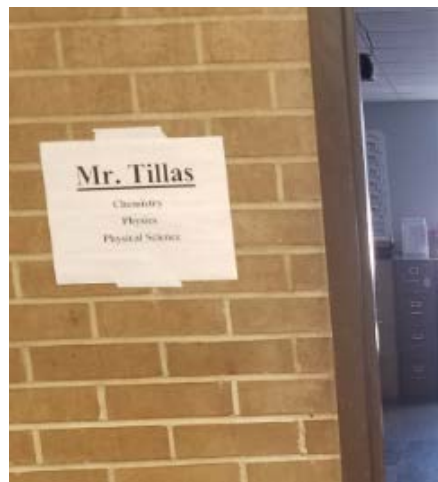
*Noncompliant sign.*
