## EXISTING CONDITIONS AND FEASIBILITY REPORT

### I. HEATING, VENTILATING, AND AIR CONDITIONING

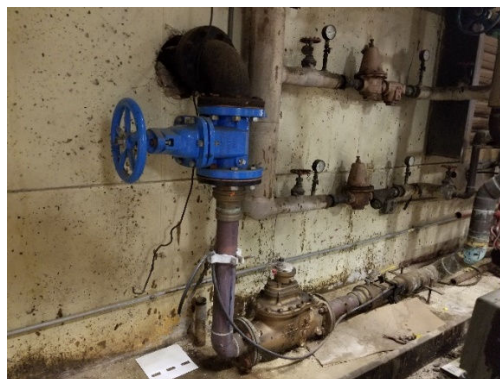
1. The site is fed by an eight inch municipal main that loops around the building and includes a six inch domestic water service entry located in the main Boiler Room. The line reduces to four inch to serve the building. The existing remote-read meter, pressure reducing station and uninsulated copper piping are in fair to good condition. Exposed copper piping is in good condition and the main service pressure reducing valve is in fair condition; pressure gauges provide inaccurate readings and are in poor condition.

Domestic Water Service, Meter and PRV station

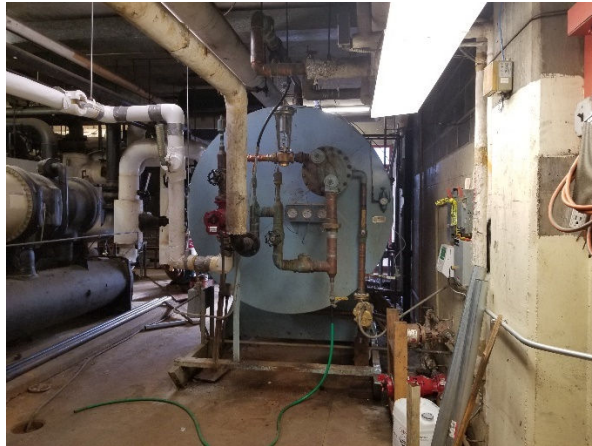
3. The existing water-to-water, 500 gallon domestic water storage heater is in the Boiler Room. Domestic hot and boiler water circulators appear to have been replaced recently; pipe and insulation are in fair condition. There are no mixing or tempering valves on the on the main hot water supply system.

Water-to-Water  
Domestic Water  
Heater

- b. Replace the domestic hot water plant with high-efficiency equipment, include a master mixing valve and add circulation pump and piping.
    - c. Review the roof drainage piping for proper sizing and replace non-compliant drains and piping.

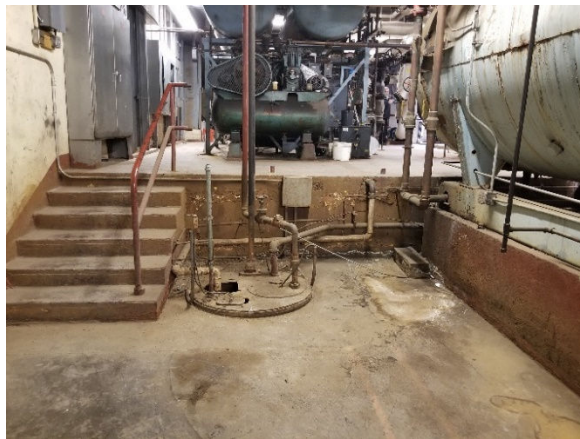
Existing deficient  
Sump Pump and  
Basin

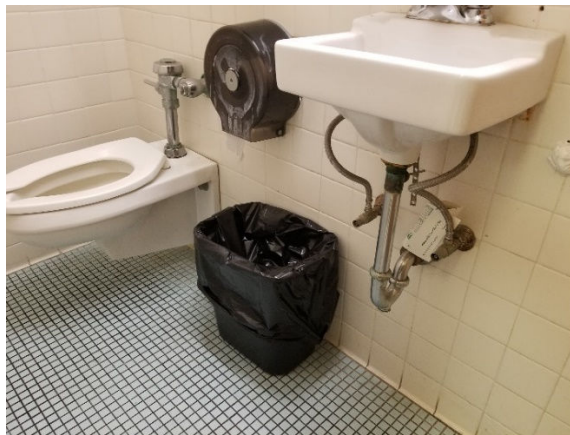
1. Most toilet room fixtures viewed are in good condition; few accessible fixtures were noted. Flush valves and lavatory fittings do not comply with current code requirements for water conservation or ADA accessibility. Some of the original drinking fountains have been replaced with accessible water coolers with bottle fillers.
2. Locker Room shower fittings are in fair to poor condition. It is unknown whether shower heads comply with current code requirements for water conservation. Custodial closet mop receptors and fittings are in fair to good condition.
3. Several Shops include a floor-mounted wash fountain, a wall-hung drinking fountain and a single-occupant, tagged "All Gender" toilet room.

Non-ADA compli-  
ant, single-occu-  
pancy Toilet  
Room

- d. Add trap primers and inserts to floor drains.
    - e. Replace toilet room fixtures and fittings to comply with accessibility and water conservation requirements.

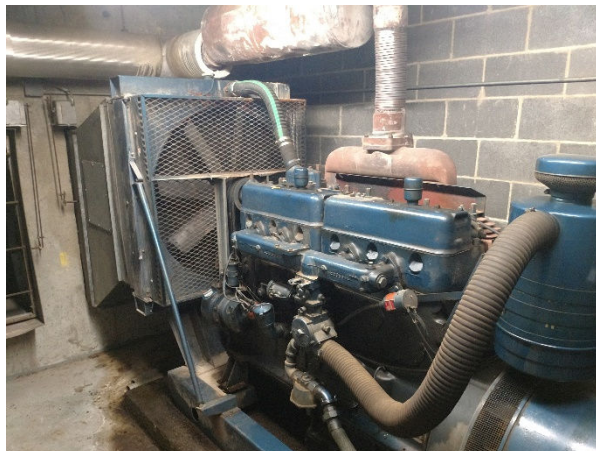
1. Emergency Electric Services
  - a. There is a 150KW, 120/208V, 3-phase, 4 wire, propane fired emergency generator located in a dedicated interior room. There is a single automatic transfer switch that serves selected emergency power panels throughout the school. Emergency egress lighting is supported from this generator. The generator due to age, appears well beyond its expected life.

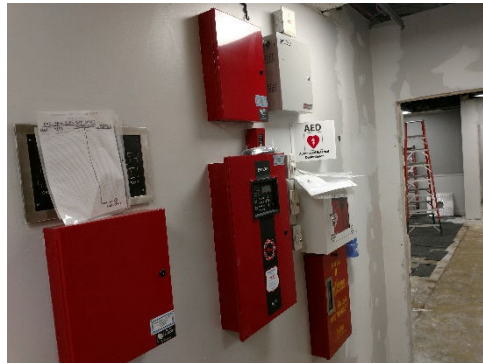
2. Fire Alarm
  - a. The main fire alarm panel is manufactured by Silent Knight and appears to be a recently upgraded addressable system. The panel is located in the school's front office area. There was no remote annunciator observed at the main entrance to the school. The building is not sprinklered, so there are smoke detectors installed throughout the building. Smoke detection coverage is fairly consistent throughout the school, however, is inadequate due non-code complaint spacing of devices. However, there were areas throughout the building that lacked adequate smoke detector or carbon monoxide coverage such as the kitchen,

carpentry and auto shop. Without fire protection sprinkler systems, the building requires full smoke detection coverage throughout the school, in all spaces. Manual initiation devices (pull stations) appear to be located at all egresses from the school. Notification devices (audio/visual) appear to be retrofitted speaker/strobe type and are located throughout the school. Kitchen hood did not appear to include a dedicated fire suppression system or appear to be connected to the fire alarm system. A red fire alarm beacon is located at the main entrance to the school. A fire alarm DACT communicator panel is located in the main office area of the school for fire alarm communication with the fire department.
