Tavares Design Associates, Inc.

Equipment Consultants • Facilities Planners

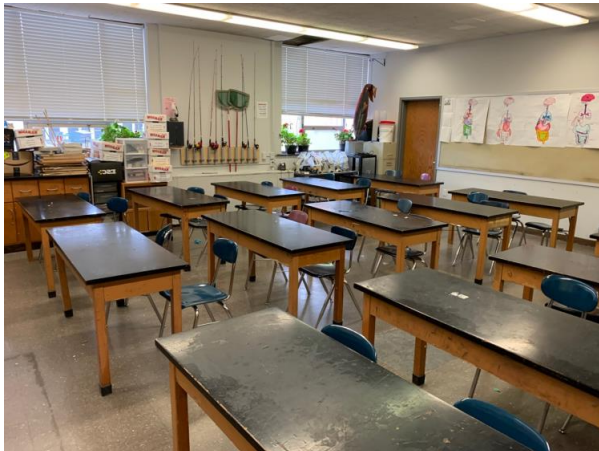
Science Classroom

- The science labs consist of two types. The full lab (lecture/lab) is very under sized for a full lab and today's standards. The labs appear to range around 900sqft.
- The main lab has center island lab stations. None of these are handicap accessible. They do not conform to the current Lab design for Massachusetts public schools.
- The lab includes one fume hood. This is not a pass thru which conflicts with the current MSBA guidelines. These fume hoods are not handicap accessible.
- There are additional classrooms used for lecture. These classrooms have a fixed demo island.
- The classroom tables have phenolic tops and are scratched and worn.
- The fixed teacher lecture benches are not handicap accessible.
- In general the counter tops are very worn and damaged. Many cuts and exposed underlayment were observed.

- *Revise labs to conform to the current MSBA guideline.*
- *No fixed lab benches*
- *Pass thru fume hoods*
- *Mobile tables with locking casters.*

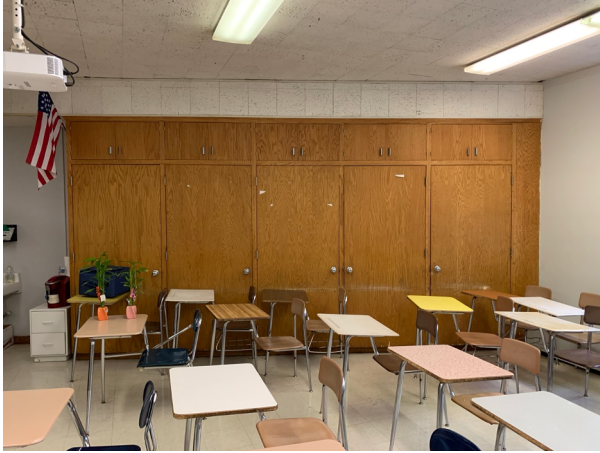
Classroom Furniture

- Classroom furniture is a mix of old and new. The student furniture is hard plastic with attached chair/desk unit. These do not allow for easy 21 century collaborative learning. See picture.
- Cafeteria furniture appears to be newer.

- *Update furniture to current educational standards. Movable desks and tables.*
- *Teacher desk to be updated to mobile worksurface.*

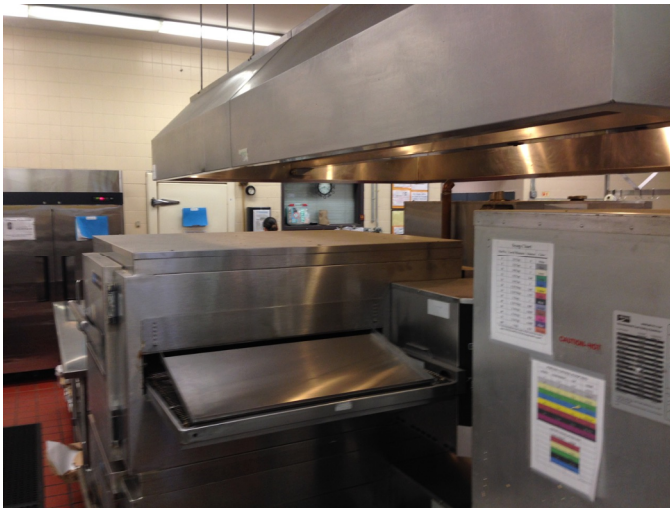
Hood

- Kitchen Equipment is generally older and rusted.
-
- Hand sinks require updated faucets and raised height. They are not accessible and don't meet health standards. No blade handles or sensors
- The main cooking hood does not cover the equipment and has no fire suppression system.
- The hood has no filler panel to ceiling and shows crease running on the vertical surfaces.
- The walk-in Boxes have replacement doors but no view windows or dial thermometers are apart of the package.
- Serving line component sneeze-guards do not meet current NFS standards.

- *Update entire kitchen.*
- *Bring kitchen to current NFS standards*
- *Hood to be updated to energy efficient model which covers cooking equipment.*

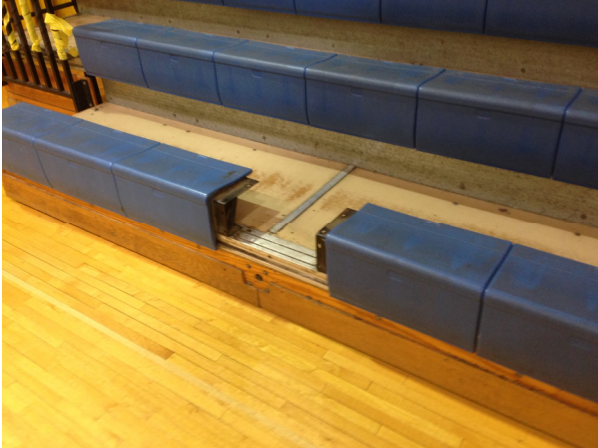
Bleacher

- Telescoping bleachers are older. They do not have distributed ADA positions.
- There are four side court, rectangular wood backboards. Ceiling mounted.
- There are two main court, glass back boards, ceiling hung. These appear newer.
- One main roll up curtain divides the space. The condition is dirty but functioning.

- Updated bleachers to current ADA and safety standards.

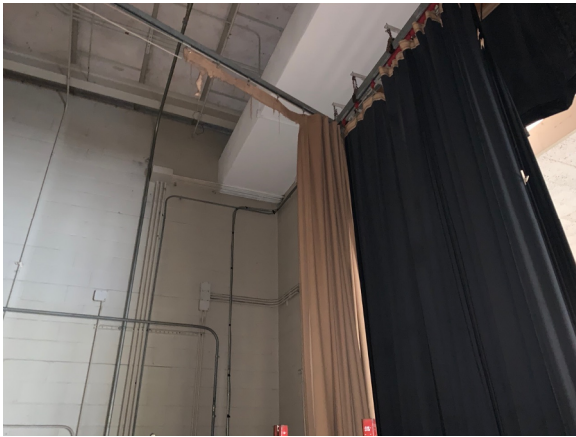
Leg Set

- Stage has a few curtains, including valance, main draw, intermediate valance, leg sets and a rear draw.
- Several curtains are ripped.
- There are no acoustical clouds on the stage which is seen in most modern projects.
- Most of the rigging is dead hung, not allowing for easy replacement of scenery or lights.

- *Replace all drapery.*
- *Add line sets for added pipe for scenery.*
- *Possible counterweight sets.*

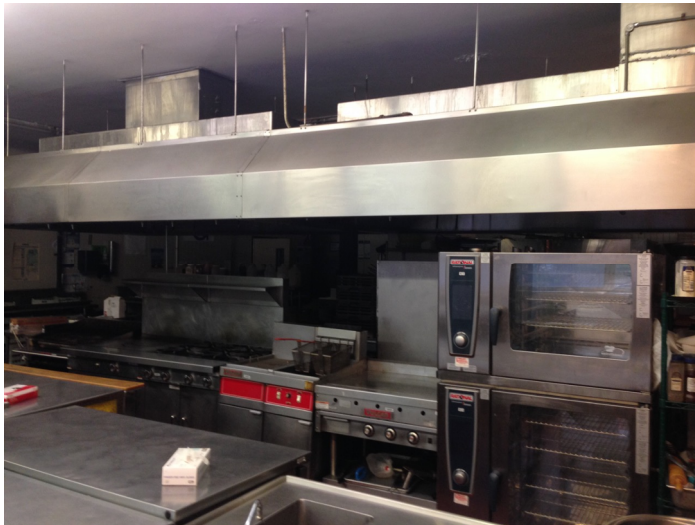
Hood

- Kitchen Equipment is generally older and rusted.
- Hand sinks require updated faucets and raised height. They are not accessible and don't meet health standards. No blade handles or sensors
- The hood has no filler panel to ceiling and shows crease running on the vertical surfaces.
- The walk-in Boxes have replacement doors, but no view windows or dial thermometers are apart of the package.
- Dishwasher empties into a hole. No grate. Rusted.

- *Update entire kitchen.*
- *Bring kitchen to current NFS standards*
- *Hood to be updated to energy efficient model which covers cooking equipment.*

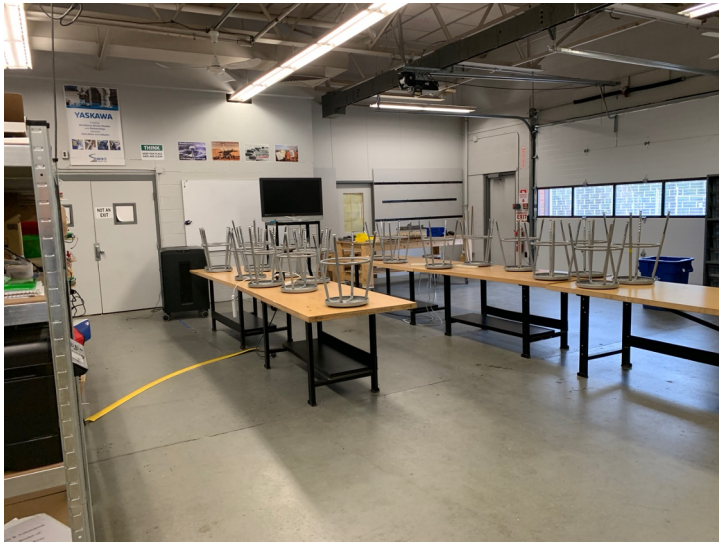
- Shop Space is divided into two spaces using cabinetry. One side a workspace and the other a classroom space.
- Many of the equipment items appear to be newer, including robotic arms and CNC router.
- Classroom space has newer workbenches with overhead power.

- *Create better storage and flow.*
- *Increase overhead power for flexibility*
- *Add ventilation for possible added equipment.*

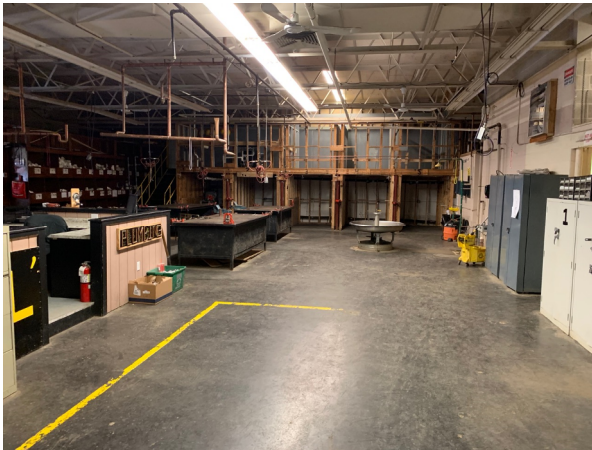
- Shop Space is a large open space .
- The worktables are well worn and tops are flaking off.
- The teacher space is raised and does not meet ADA code.
- Very little large equipment. One hot water heater and one furnace.
- There appear to be no floor drains in the plumbing shop.

- Add floor drains for equipment.
- Increase space for furnaces
- Increase booths on main level.

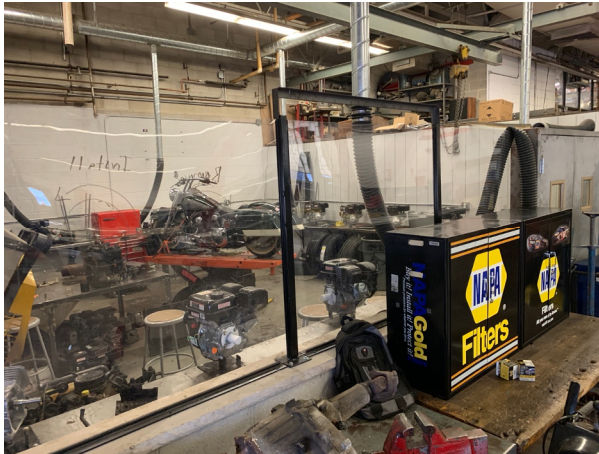
Small Engine Repair

- Very large shop space with well maintained equipment.
- The equipment includes 11 two post lifts and one alignment rack, tire changes, wheel balancer.
- A separate space within the overall shop has a small engine repair space.
- Some workbenches need replacement.

- Update workbenches and misc. equipment.
- Curtain off wash bay

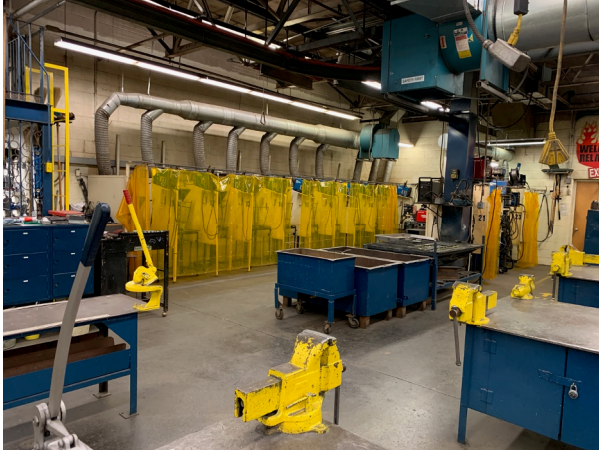
Shop

- Very large shop with many welding booths.
- Most equipment is newer with each welding station having its own welder.
- Some older equipment would need replacing, including drill press.
- Ventilation has been provided at each booth.
- Space is laid out well with safe travel lanes around equipment.

- *Replace some older welding equipment.*
- *Create better spacing around robotic welder*

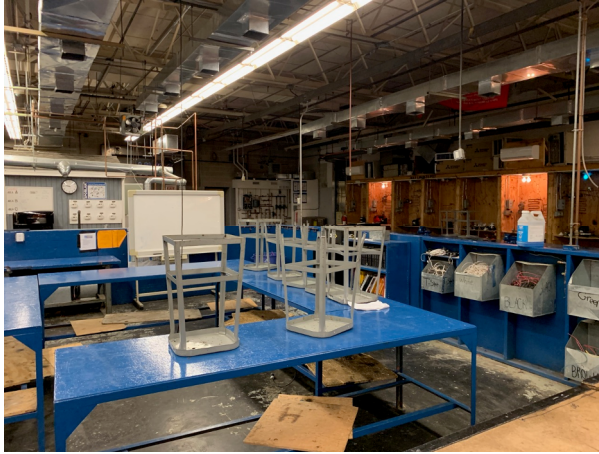
Classroom

- Very large shop with many wiring booths.
- Space has been devoted to Condensing units, boilers, etc.
- A central space for classroom work with older but in good shape worktables.
- A lack of storage requires parts and pieces being stored above booths.

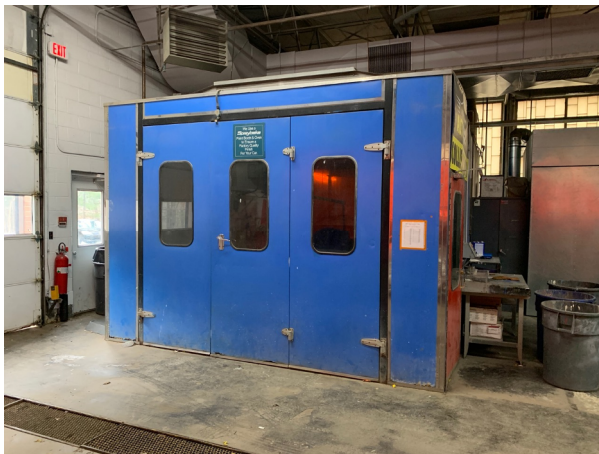
Older Booth

- Very large shop space.
- Several full car spray booths. One newer (GFS) and one older booth.
- Two parts booths. One open face and one closed door booth.
- A paint mixing room, not attached to any of the booths.
- Shop also includes a frame machine and two post lift.

- *Replace some older welding equipment.*
- *Remove older spray booth*
- *Add space around spray booths to allow for better access to panels.*

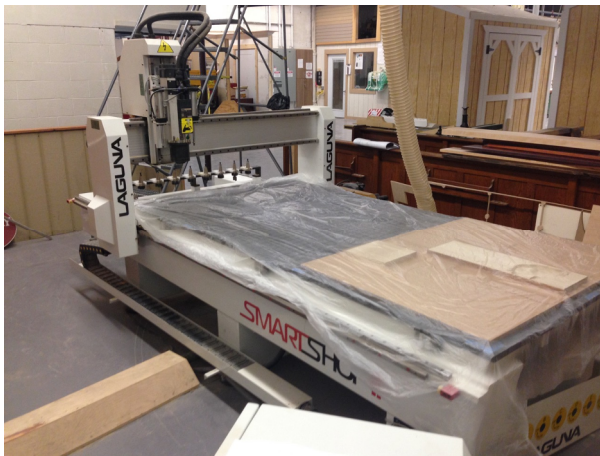
CNC Router

- Large shop space with a mix of new and old equipment.
- Floor markings with safety markings are in most areas.
- Dust collector attached to most equipment. Dust collector outside.
- Some workbenches need replacement.

- *Replace older drill press and saws equipment.*

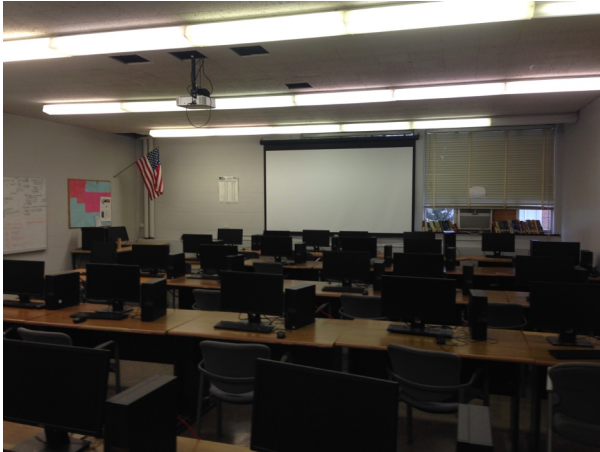
Computers

- Computer lab equipment on old tables.
- Several plotter/scanners, newer.
- Two separate labs with between 25 and 27 computers

- *Replace computer tables.*
- *Revise power locations and add data.*

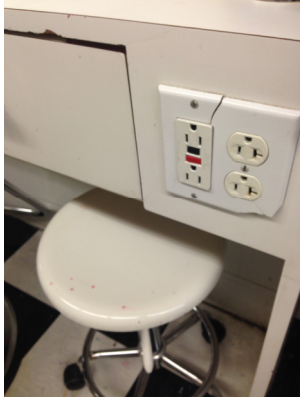
Styling Stations

- Two large lab spaces with older caseloads
- Most styling stations have chips and broken outlets.
- No separate space for facials
- No manicure space
- Dispensary very narrow and no storage cabinets for chemicals.

- *Replace all styling stations and wet stations.*
- *Increase dispensary*
- *Add manicure space with venting*
- *Create area for facials bed*

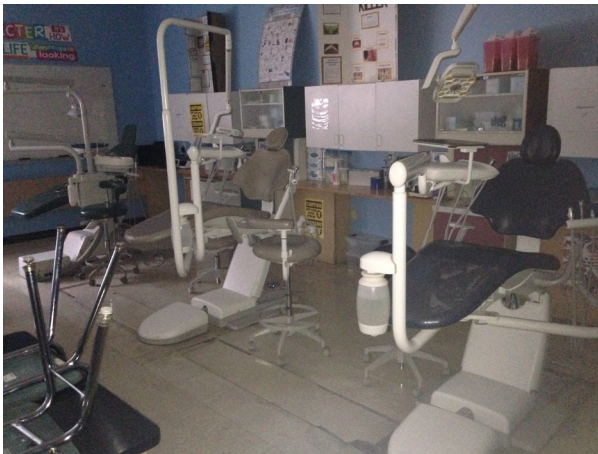
Chairs

- Overall space contains 5 dental chairs.
- Equipment includes, Pano X-ray, model trimmers, ultra sonic machine, heat dryer and arm xray.
- Two separate labs with between 25 and 27 computers
- Cabinetry is generally newer.
