Appendix E

WETLAND RESOURCE AREA ANALYSIS REPORT

Re: Wetland Resource Area Analysis Report
Northeast Metro Technical High School
100 Hemlock Road
Parcel ID: 40A-000-0RS
Wakefield, Massachusetts

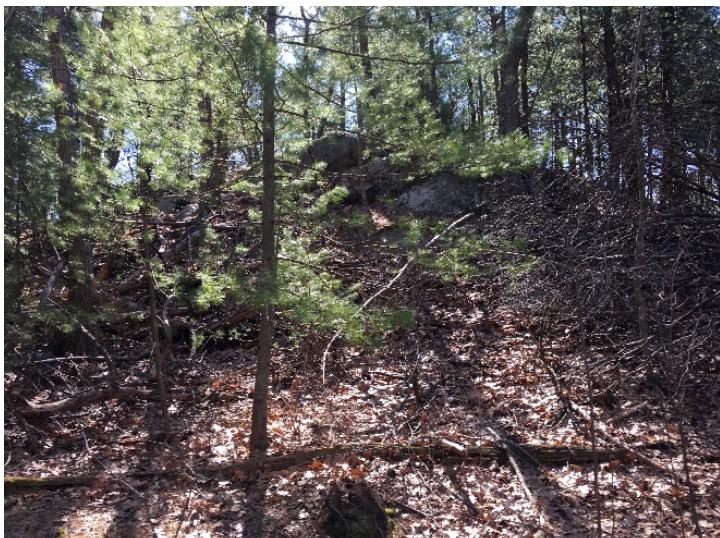
Photo 1. Representative photo of a rocky outcrop within the forested upland.

Topography within the developed portions of the site is generally flat. Topography descends steeply along a fill slope from the developed portion of the site to the west. Topography within the southern, undeveloped portion of the site is rolling, with topography generally descending northerly toward Hemlock Road and southerly into low-lying forested wetlands. Rocky outcrops occur throughout the forested uplands (see Photo 1.).

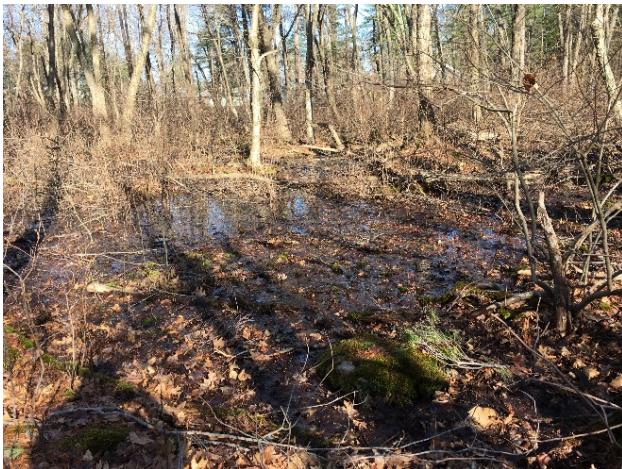
Photo 2. View of forested Series-1 BVW

Six (6) BVWs associated with intermittent streams, and one (1) BVW associated with the Saugus River are associated with the site. Wetland Series-1, Series-3, and Series-9 are characterized as forested, red maple swamps, and occur within the southern portion of the site (Series-1 and Series-3) and within the northern portion of the site (Series-9). The eastern boundary of Series-1 (see Photo 2.) generally occurs at the bottom of a rock fill slope. Surface water within Series-1 flows northwesterly into an intermittent stream which discharges off site into a culvert. During periods of high flow, surface water within Series-3 (See Photo 3.) overflows southerly into a manmade channel (intermittent stream) that dissipates further downhill. The Series-9 wetland receives roadway drainage from an upgradient culvert, which flows northwesterly into the forested wetland/intermittent stream located at the toe-of-rock fill slope to the western baseball field. The stream turns westerly and continues offsite.

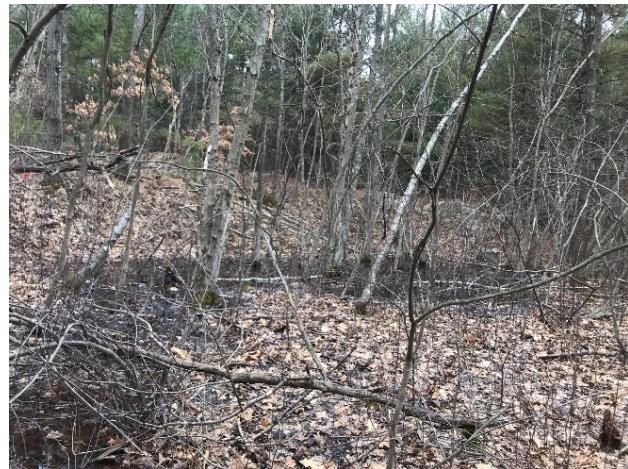
Photo 3. Northerly view of Series-3 BVW

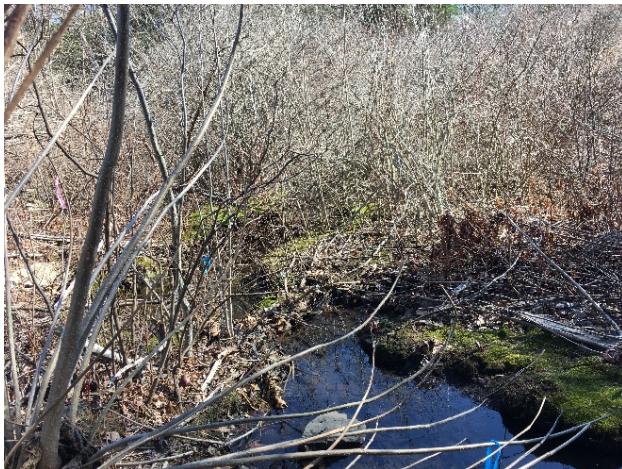
Photo 4. Easterly view of Series-7 scrub-shrub BVW and Intermittent Stream.

The remaining BVWs (Series-6, Series-7, Series-8, and Series-10) are characterized as scrub-shrub wetlands. Series-6 and Series-7 occur along the eastern site boundary and are associated with an intermittent stream which originates offsite to the east, flows westerly through Series-6 and into an underground culvert, before daylighting through a culvert to the north and flowing easterly through Series-7 (see Photo 4.). Series-8 is associated with the Saugus River. Immediately adjacent to the site, the Series-8 BVW is characterized as a forested and a scrub-shrub wetland (see Photo 5.). It occurs within the northeast corner of the site and continues offsite along the northern site boundary and to the east within Breakheart Reservation. It generally occurs along the toe-of-rock fill slope to the developed

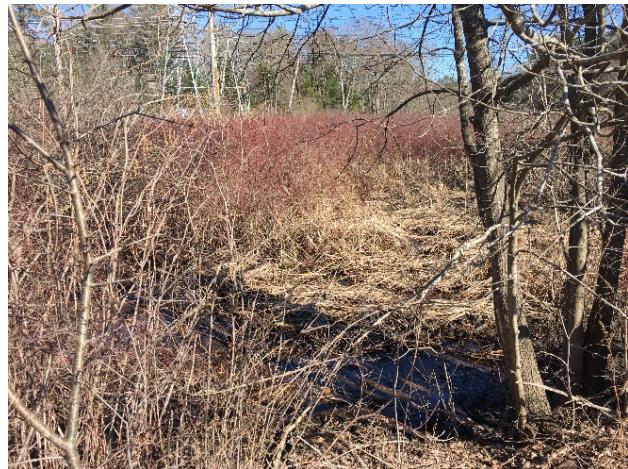
Photo 5. Easterly view of Series-8 scrub-shrub

Vegetation within the scrub-shrub wetlands includes a sapling/shrub layer of sapling red maple, sapling willow (*Salix* sp.), highbush blueberry, glossy buckthorn, speckled alder, sweet pepperbush, elderberry (*Sambucus nigra*), dogwood (*Cornus* sp.), northern arrowwood, winterberry holly, and maleberry (*Lyonia ligustrina*). The ground cover includes sensitive fern (*Onoclea sensibilis*), sheep laurel (*Kalmia latifolia*), wintergreen, and skunk cabbage. Vegetation within the forested portion of Series-8 is similar to the forested BVWs described above.

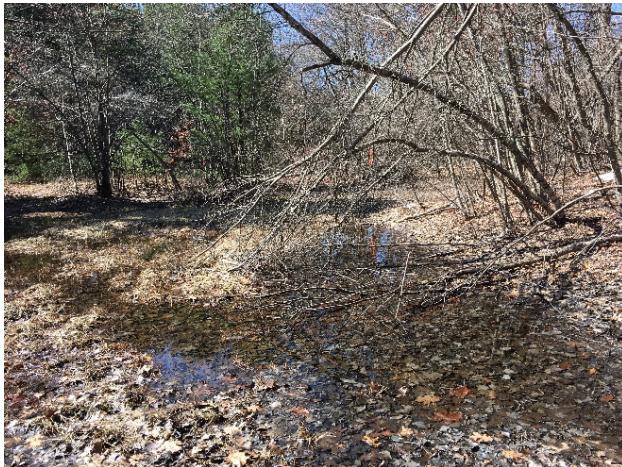
Photo 6. Southerly view of Series-2 wet meadow IVW.

Wetland Series-2 is characterized as a wet meadow and occurs along a shallow, concave area at the intersection of two (2) foot paths located along the southeastern site boundary (see Photo 6.). Vegetation within the wet meadow includes a sparse sapling layer of red maple and a few entanglements of oriental bittersweet along the perimeter. The ground cover includes sedge (*Carex* sp), rushes (*Juncus* sp), and sphagnum moss.

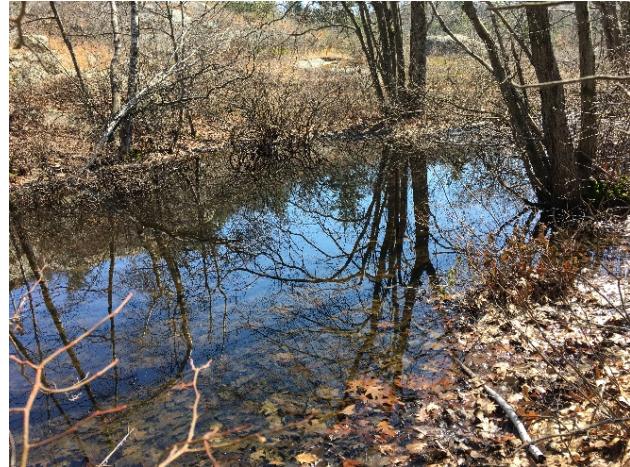
Photo 7. Easterly view of Series-5 scrub-shrub IVW.

Series-5 is a scrub-shrub IVW located at the bottom of a depression at the edge of the New England Power Company right-of-way along the eastern site boundary (see Photo 7.). At the time of LEC's evaluation, the IVW contained roughly 8 to 12 inches of standing water. Vegetation within Series-5 includes a sapling/shrub layer around its perimeter consisting of sapling red maple, highbush blueberry, and sweet pepperbush. The IVW is not vegetated in its center where standing water occurs.

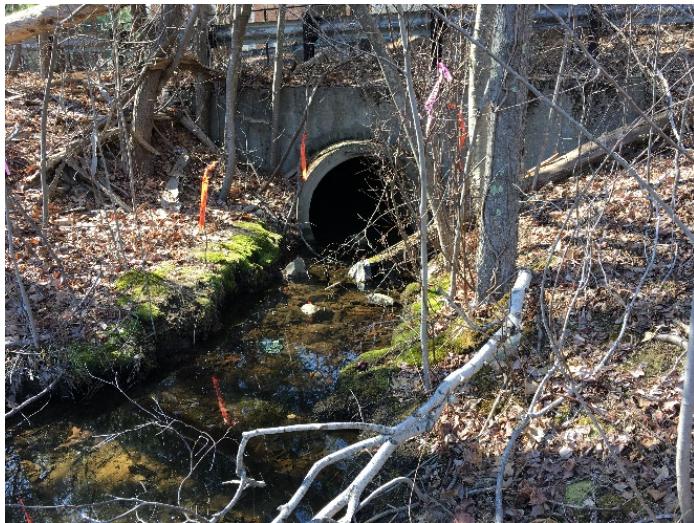
Photo 8. Westerly view of Intermittent Stream in Series-6 BVW.

LEC utilized the USGS water resources web application, StreamStats, to calculate the contributing watershed area and 99% flow duration for the stream associated with the Series-6 and Series-7 BVWs. This stream is tributary to the Saugus River (see Photo 8.). Based on the attached StreamStats Statistics Report, the contributing watershed area of 0.36 square miles is less than the minimum 0.50 square mile threshold required for a perennial stream determination. Therefore, the Intermittent Stream Status is confirmed.

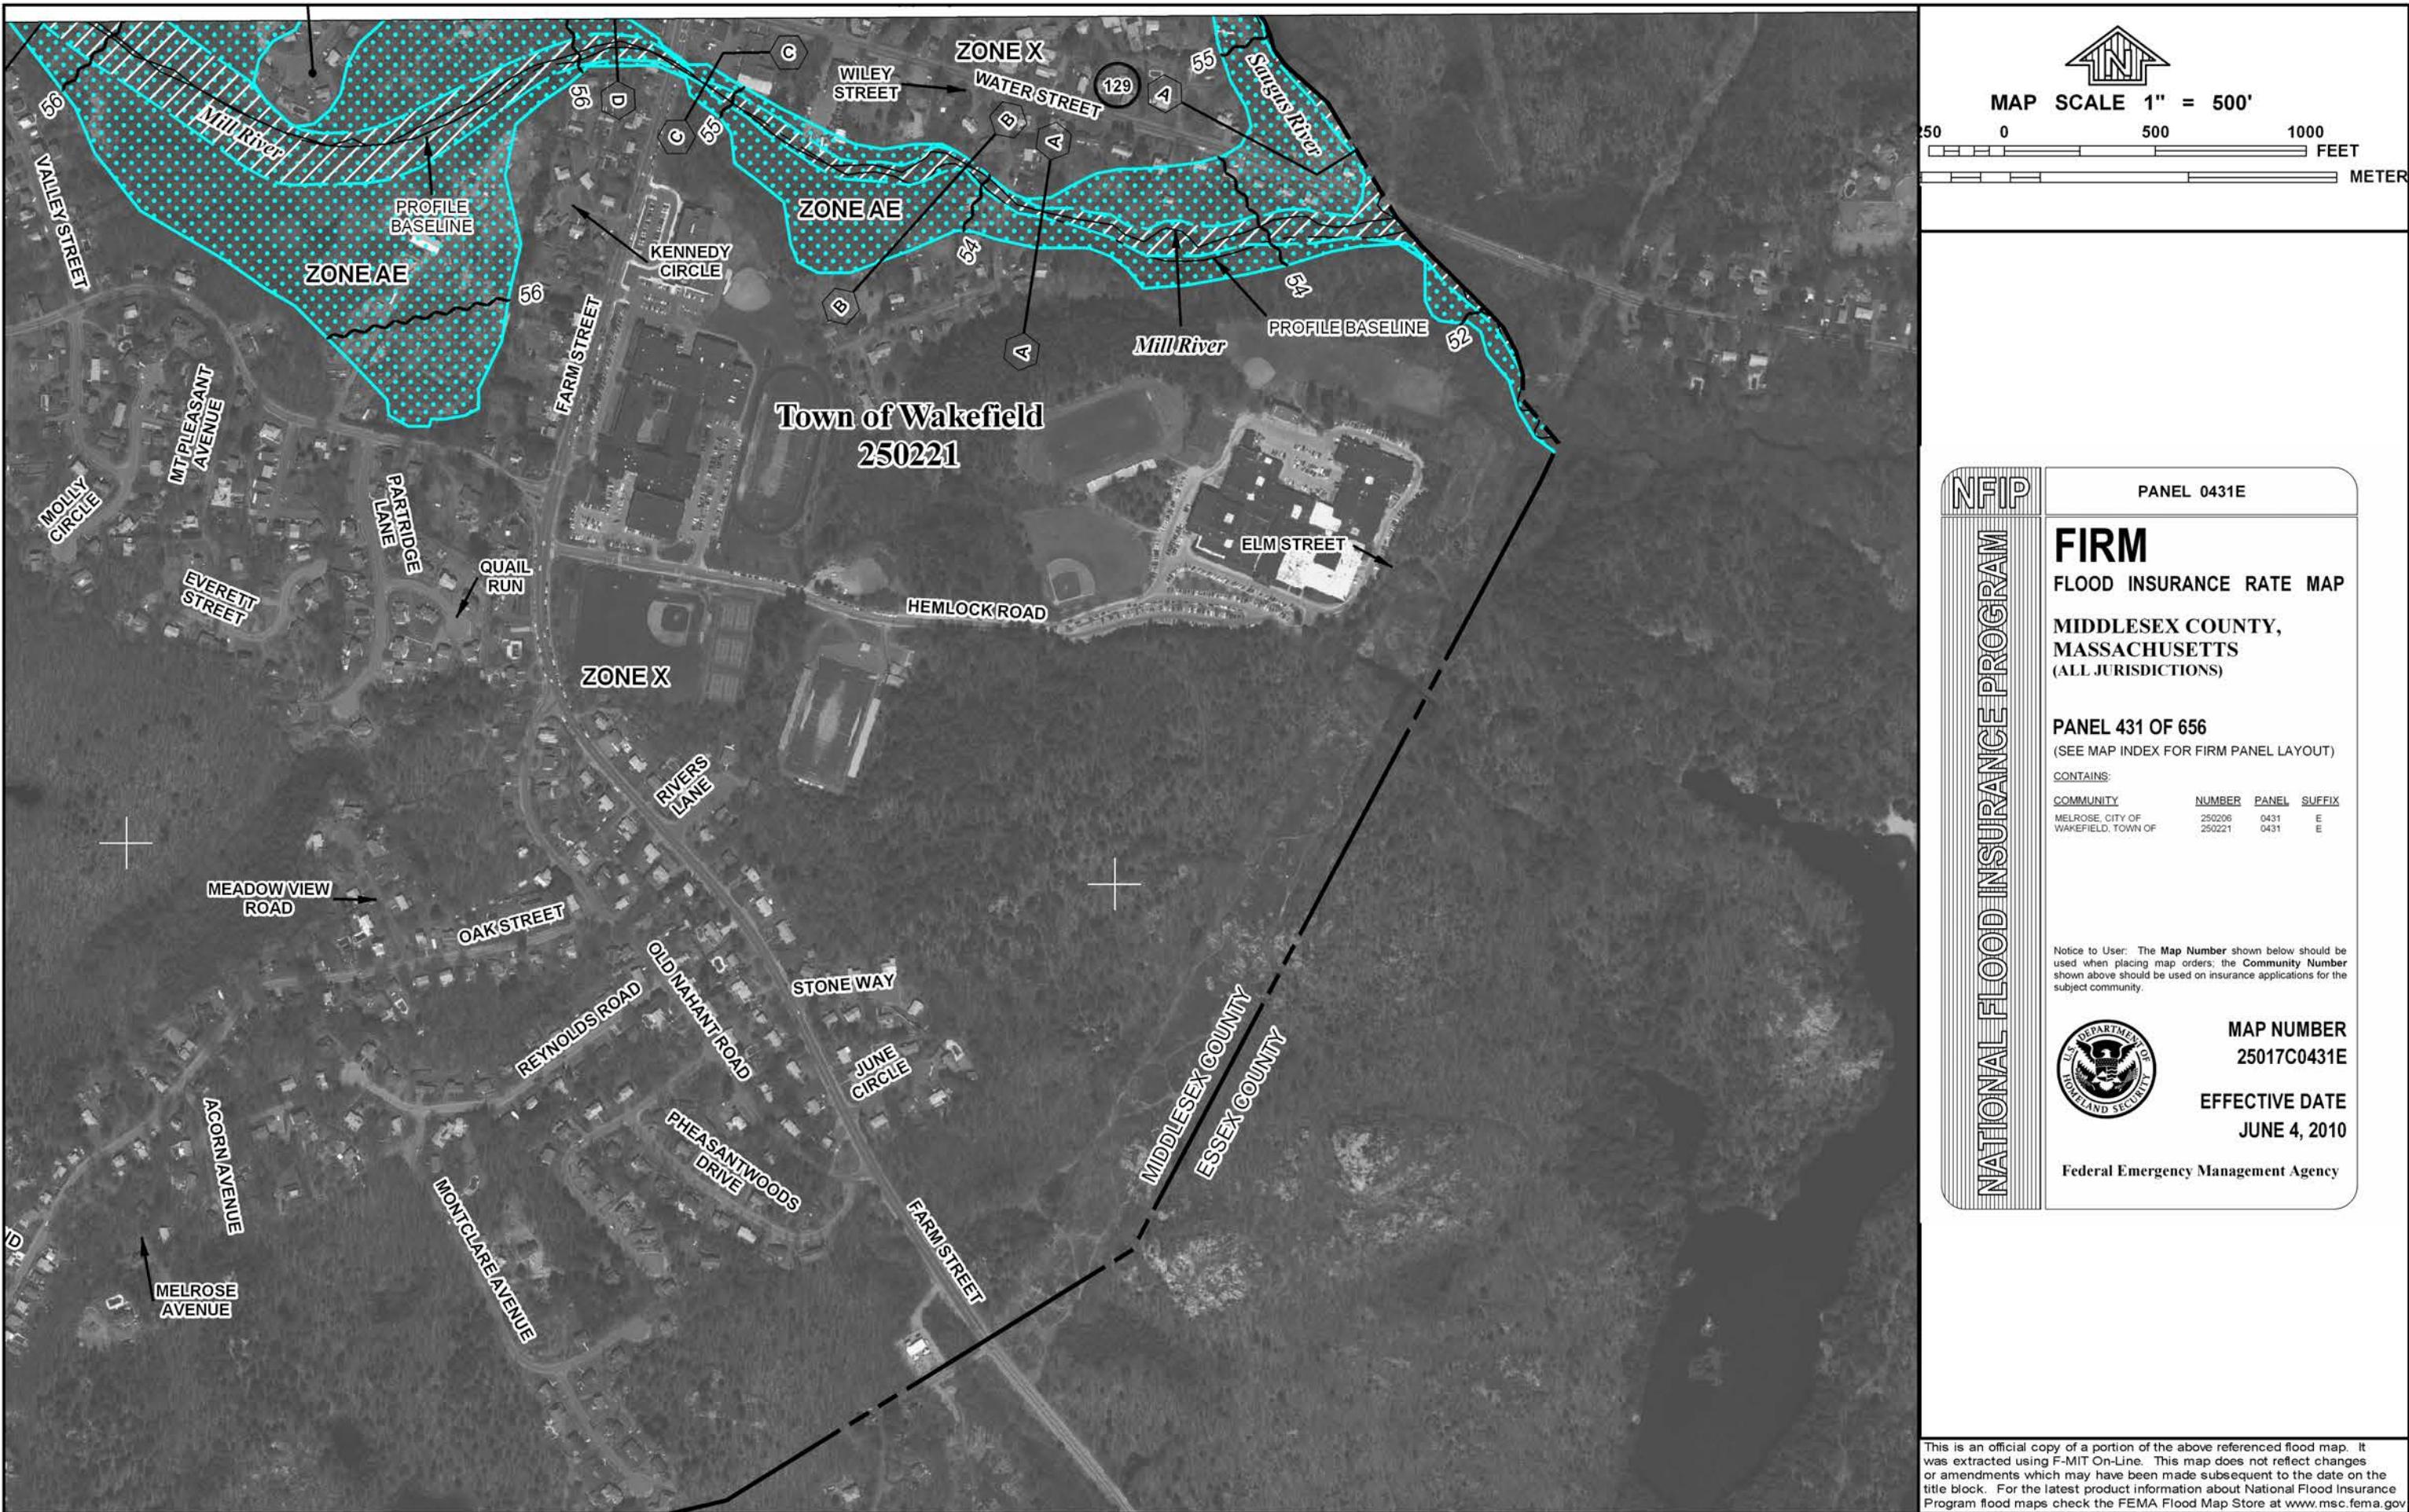
Figure 3. FEMA Flood Insurance Rate Map

According to the June 4, 2010 *Federal Emergency Management Agency Flood Insurance Rate Map* for Middlesex County, Massachusetts (Map Number: 25017C0431E), the site is located within Zone X

[unshaded]: *Areas determined to be outside the 0.2% annual chance floodplain* (Attachment, Figure 3). As a result, no portion of the site is located within the 100-year floodplain.
