# GEOTECHNICAL REPORT PROPOSED NORTHEAST METROPOLITAN REGIONAL VOCATIONAL TECHNICAL HIGH SCHOOL WAKEFIELD, MASSACHUSETTS LGCI Project No. 2025 August 12, 2022

#### LAHLAF GEOTECHNICAL CONSULTING, INC.

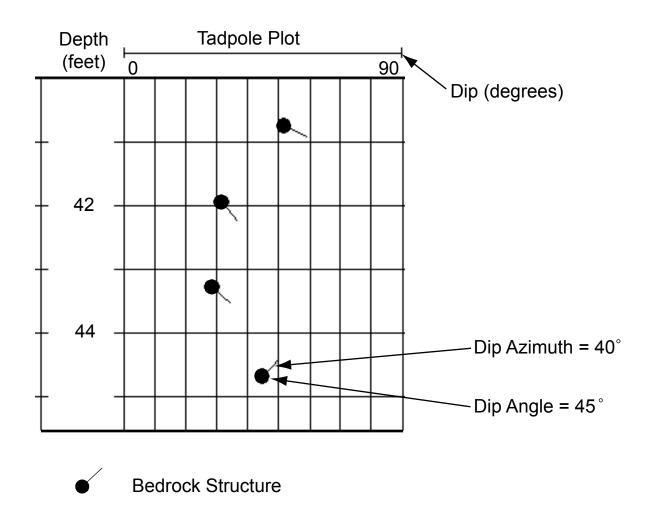
**Figure 2.** Tadpole plot explanation. The orientation of the bedrock structures is graphically displayed by a tadpole consisting of a circle, the head, and a line, the tail. The position of the head, left to right on the tadpole plot, gives the dip angle of the structure. The left side of the track indicates a dip angle of  $0^\circ$ , and the right side of the track indicates a dip angle of  $90^\circ$  from horizontal. The orientation of the tail gives the dip azimuth of the structure and can be read like a compass. The tail pointing directly up is  $0^\circ$ , north.

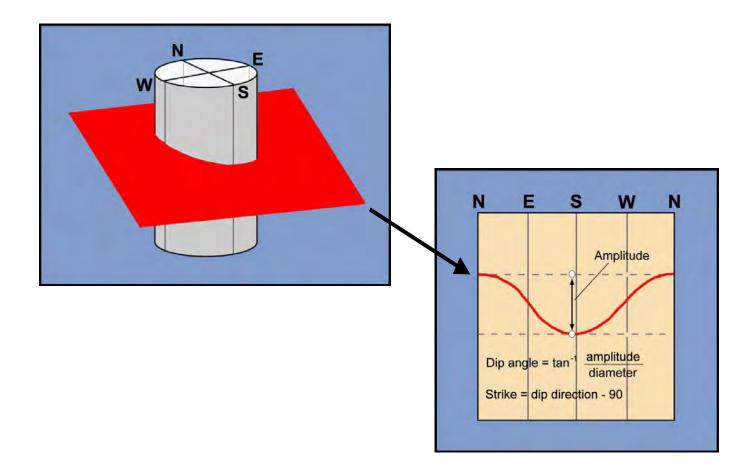
**Figure 3.** Televiewer Explanation Figure. The image on the left depicts a planar structure in red, such as a fracture or bedding plane, intersected by a borehole. The image on the right depicts the same structure unwrapped as it would be displayed in an optical televiewer (OTV) or acoustic televiewer (ATV) log.

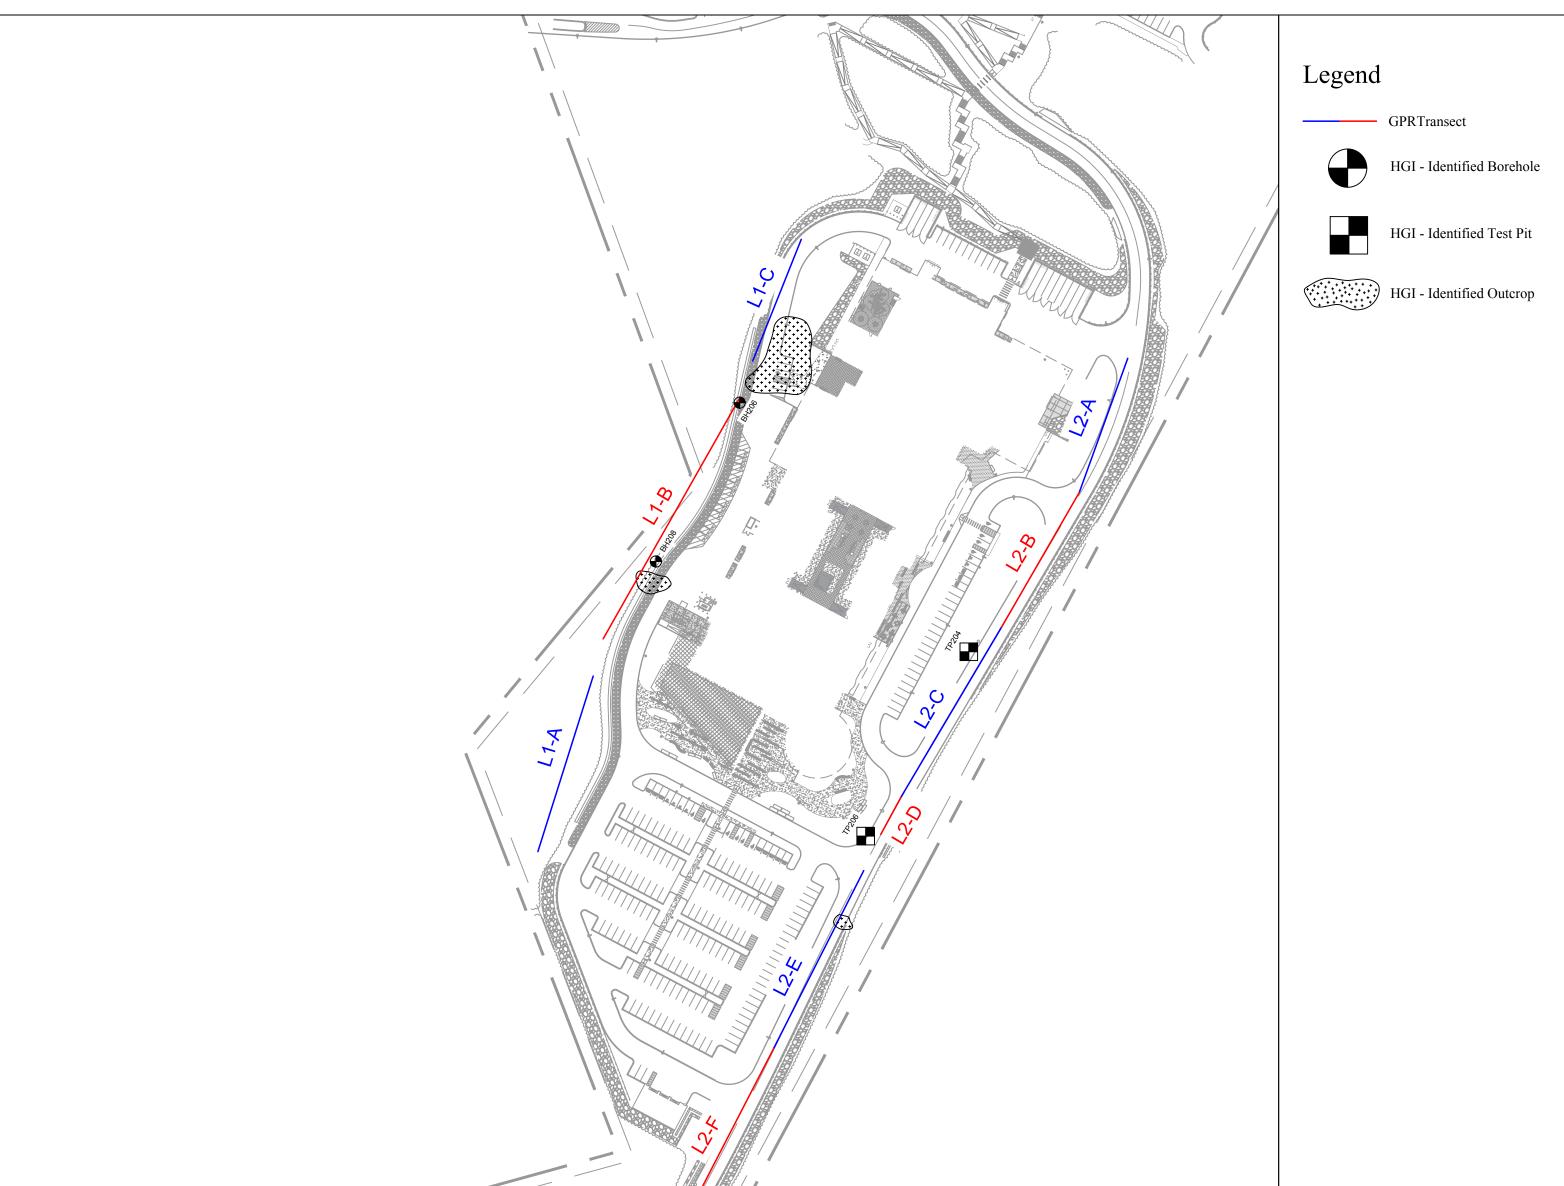
PLATE 1
	July 2022 File #2022031
	Bedrock Depth Investigation Northeast Metro Regional Technical High School Wakefield, MA Location of GPR Transects
NOTES: 1.) The base map was created from HGI field notes, GPS and the file "2022-07-01_NEMT_DD_Cost Est_Site Plan.dwg" provided by LGCI. 2.) HGI's contributions to the base map are listed in the legend. All other features are from the file listed above and have been grayed. 3.) Shape and extension of HGI's Identified Outcrops are approximate. 4.) Blue and red colors are been used to identify different GPR sections along Lines 1 and 2.	Hager GeoScience, A Collier Geophysics Company 596 Main Street, Woburn, MA 01801 (781) 935-8111 hgi@hagergeoscience.com

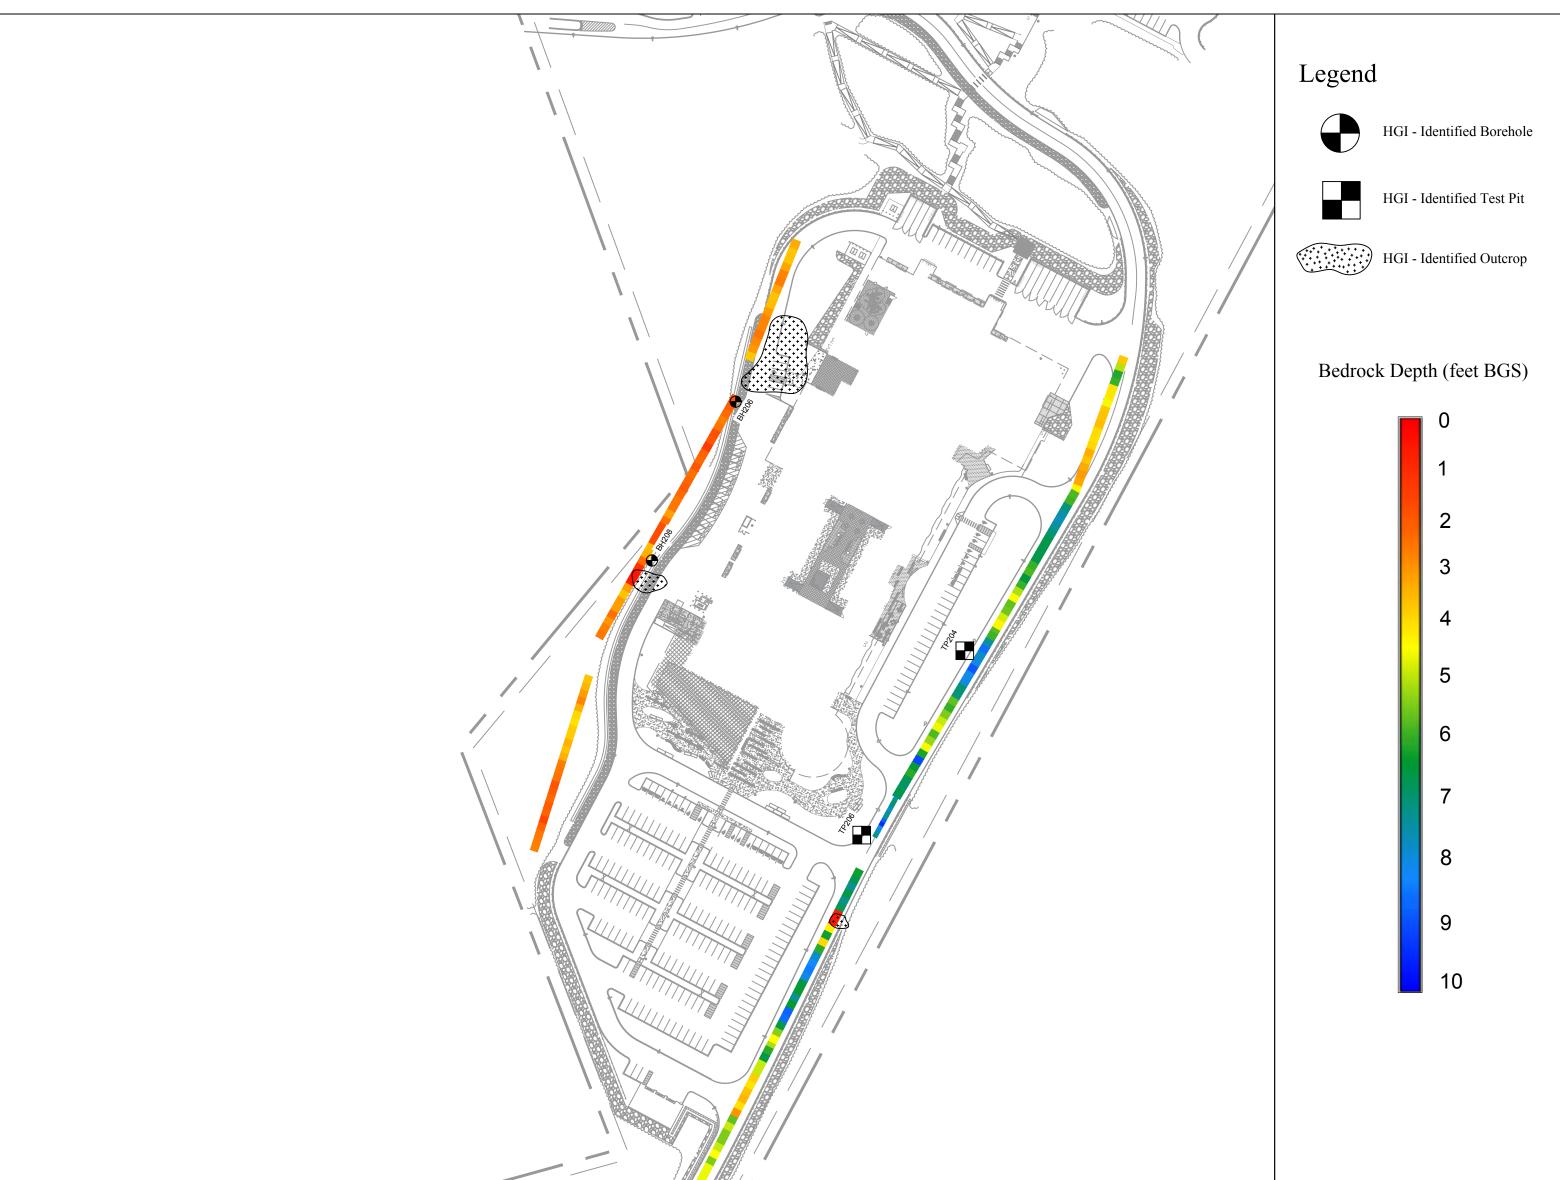
120 240 Feet	
	July 2022	File #2022031	
		Bedrock Depth Investigation Northeast Metro Regional Technical High School Wakefield, MA Bedrock Depth Plot	
NOTES: 1.) The base map was created from HGI field notes, GPS and the file "2022-07-01_NEMT_DD_Cost Est_Site Plan.dwg" provided by LGCI. 2.) HGI's contributions to the base map are listed in the legend. All other features are from the file listed above and have been grayed. 3.) Shape and extension of HGI's Identified Outcrops are approximate.	A Collier Geog 596 Main Street,	GeoScience, physics Company Woburn, MA 01801 @hagergeoscience.com

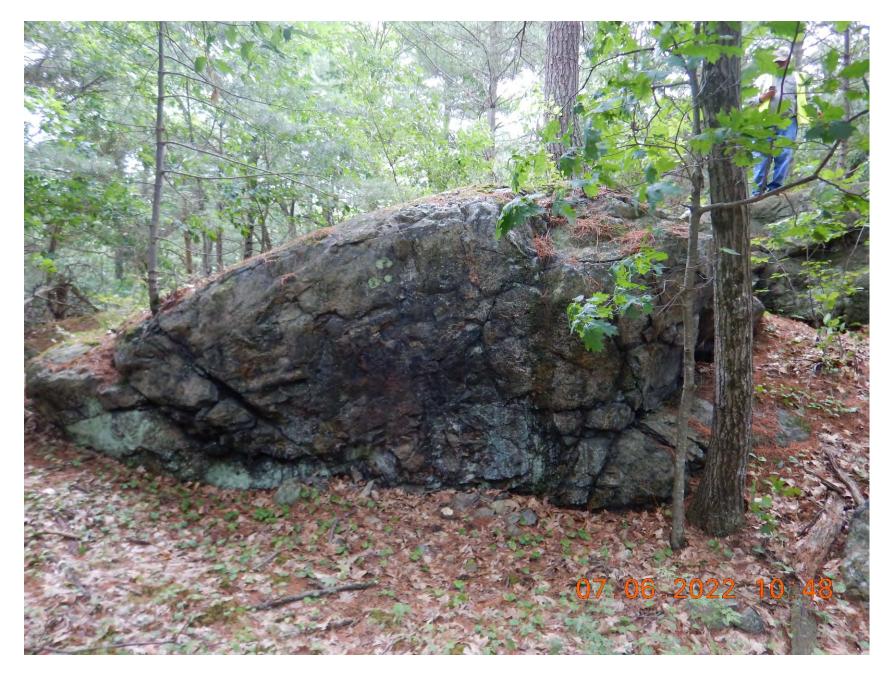
# FIG. 1E – OUTCROP LOCATION OC-5 ALONG EXISTING PARKING AREA AT SCHOOL

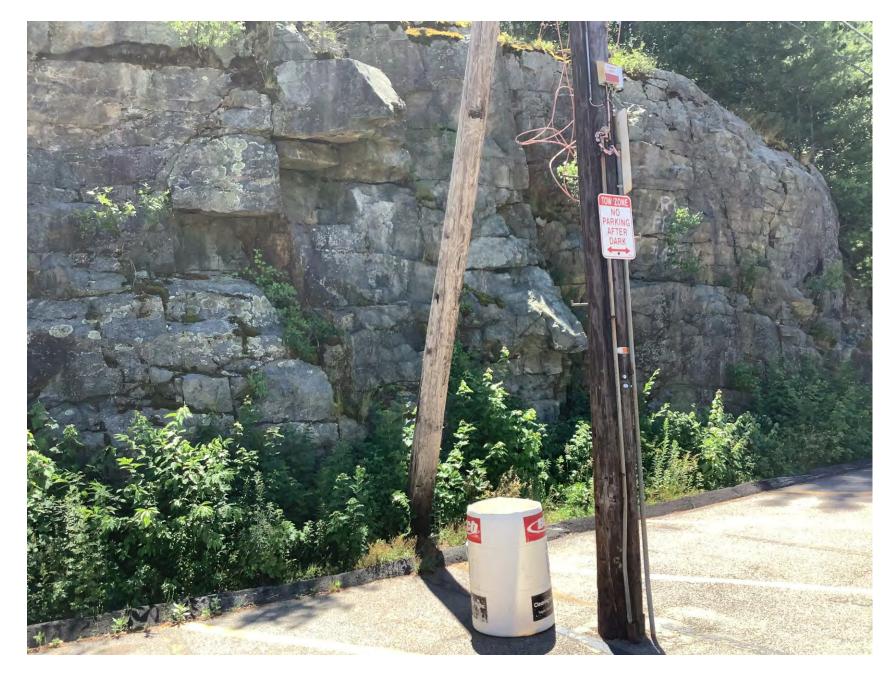
# FIG. 1F – OUTCROP LOCATION OC-5 ALONG EXISTING PARKING AREA AT SCHOOL

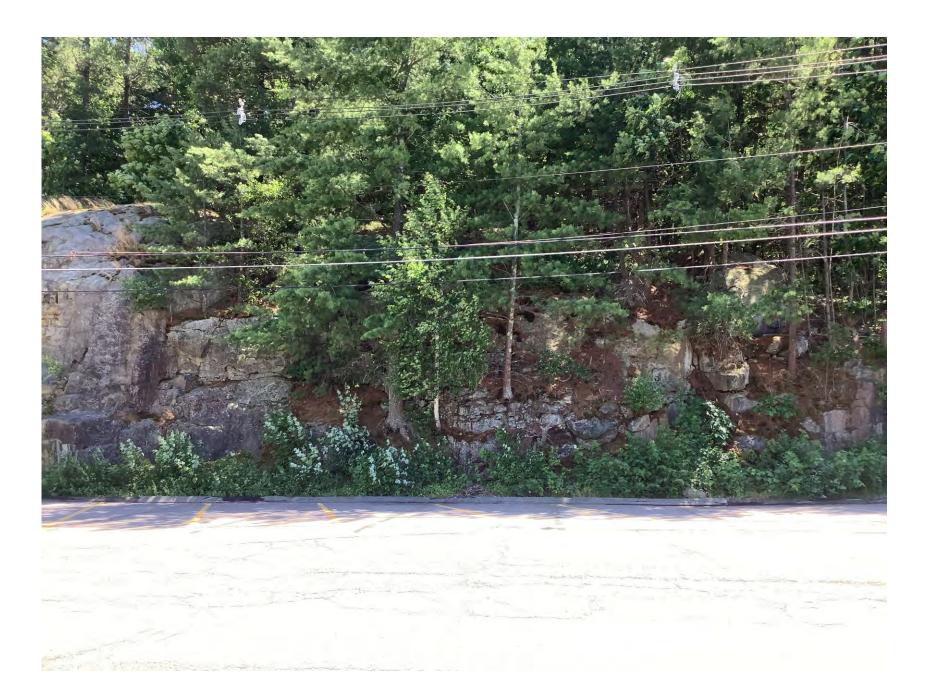
# FIG. 1G – OUTCROP LOCATION OC-5 ALONG EXISTING PARKING AT SCHOOL. NOTE UPPER PORTION OF SLOPE IS BROKEN BACK

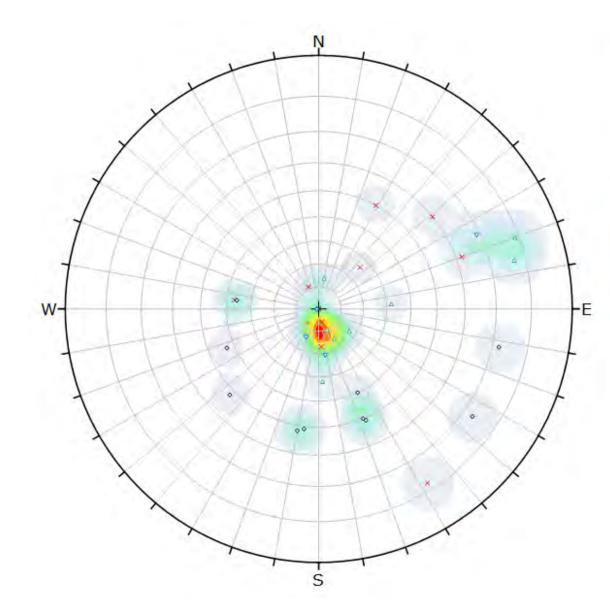
## FIG. 4B – STEREONET OUTPUT GRAPHICS: ALL DATA COMBINED (STRIKE ROSETTE)

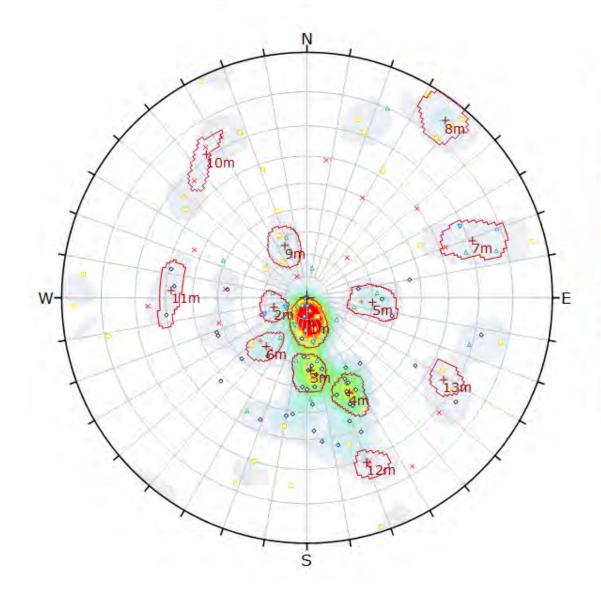
### FIG. 4F – STEREONET OUTPUT GRAPHICS: POSSIBLE SETS, NO CIRCLES

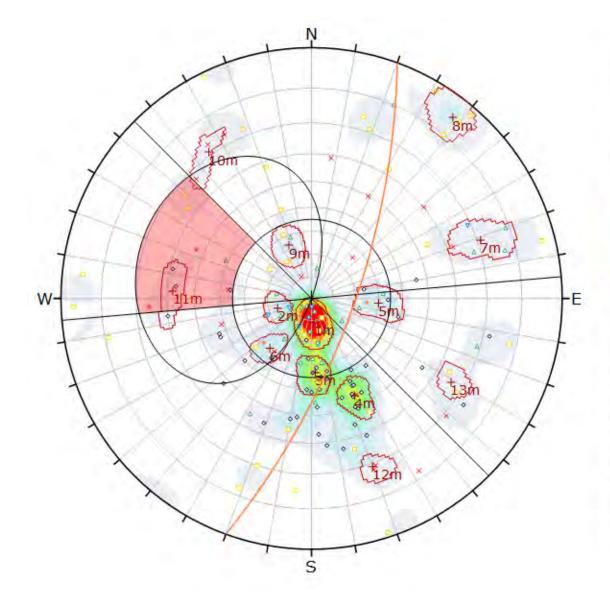
### FIG. 4G – STEREONET OUTPUT GRAPHICS: POSSIBLE SETS, NO CIRCLES

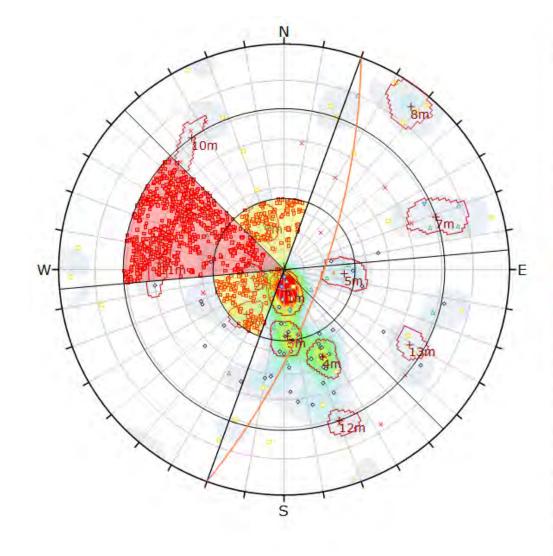
# FIG. 4J – STEREONET OUTPUT GRAPHICS: DIRECT/OBLIQUE TOPPLING AT CUT STRIKE AZIMUTH 20 DEG.

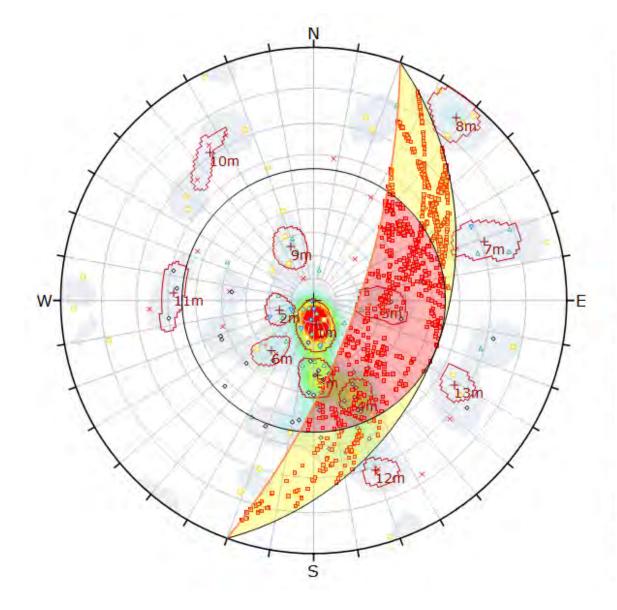
## FIG. 4L – STEREONET OUTPUT GRAPHICS: WEDGE INTERSECTIONS AT CUT STRIKE AZ. 20 DEG.

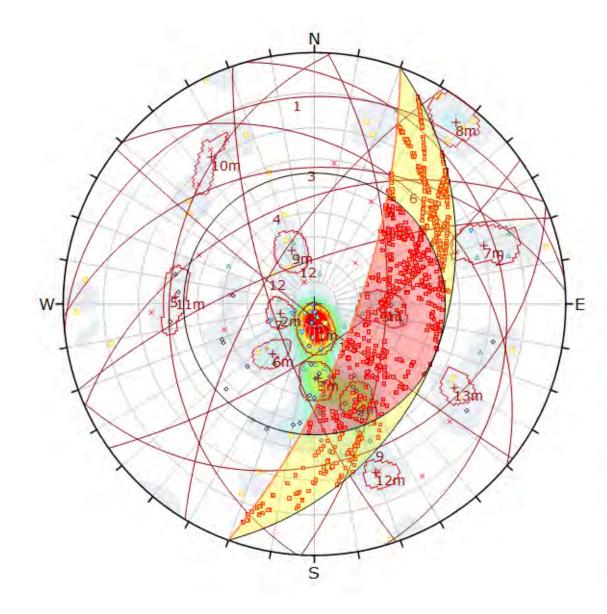
# FIG. 4M – STEREONET OUTPUT GRAPHICS: WEDGE INTERSECTIONS & PLANES AT CUT STRIKE AZ. 20 DEG.

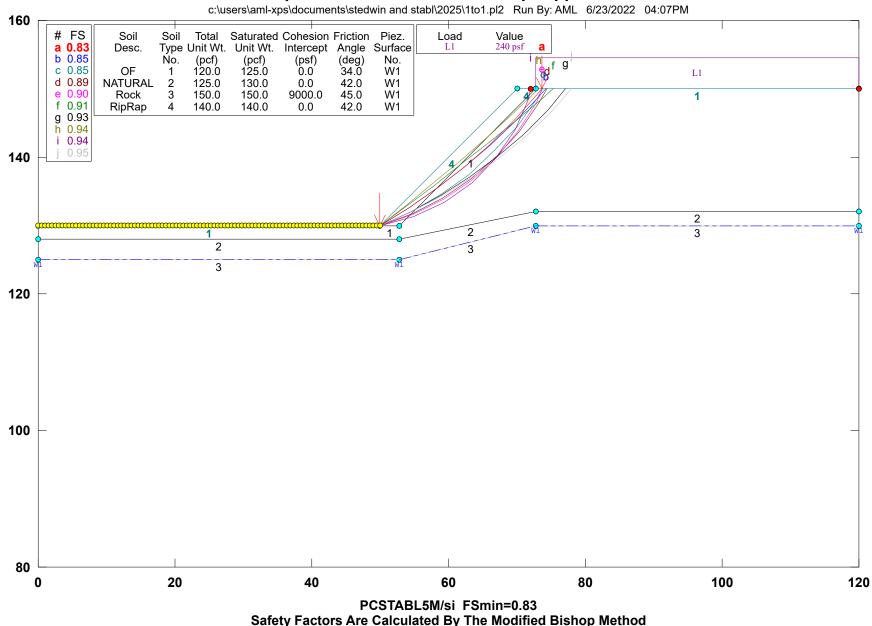
### Fill Slope on Eastern Side of Site Rip-rapped at 1H:1V

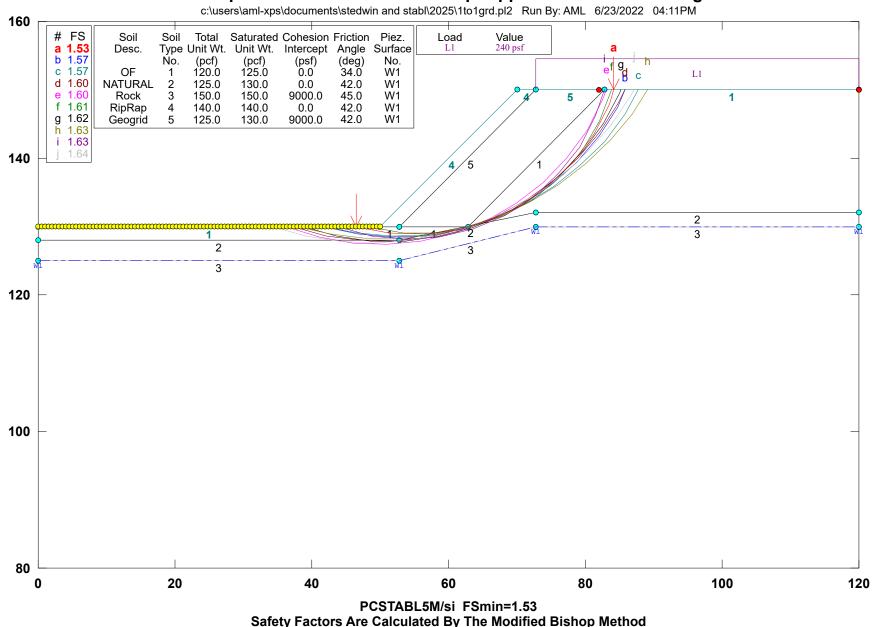
#### Fill Slope on Eastern Side of Site Rip-rapped at 1H:1V with Geogrid
