## Technology & Security | Existing Conditions Report

3Si visited the Northeast Metropolitan Regional Vocational High School on February 20, 2020 to review the Existing Conditions of the Technology and Security systems. 3Si met with the Director of Technology, and IT Staff.

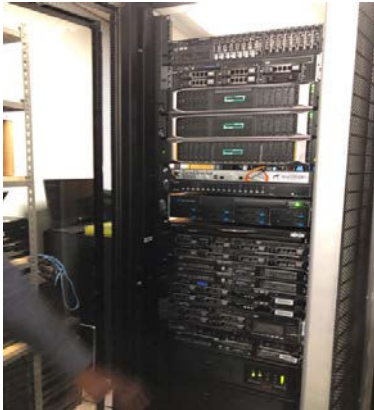
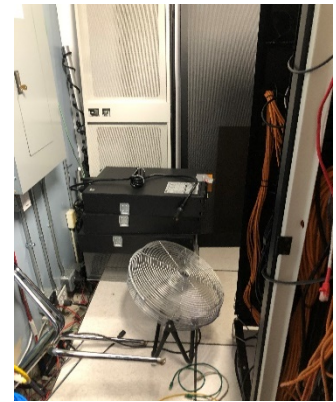
The main IT Room (MDF/Head End Room) consists of server racks, a data cabling patch panel rack, and individual UPS units (Images 1, 2 & 3). The Head End Room is where the school's Verizon 1 Gb ISP Internet fiber is terminated. HVAC environmental control is inadequate for the MDF/Head End Room and fans are used to compensate for cooling (Figure 3).

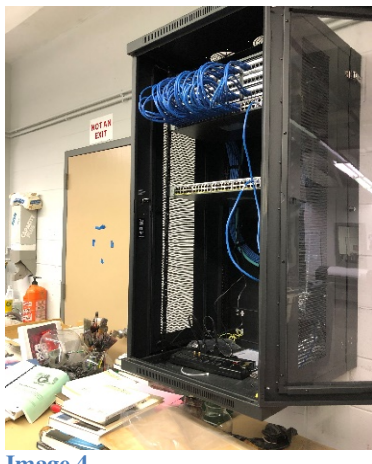
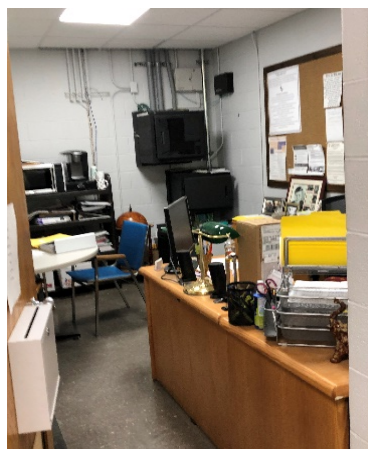
There are (12) Intermediate Distribution Frames (IDF) with an additional (2) planned. IDF's typically are wall-mounted cabinets/racks in various storage rooms, electrical closets, and in open areas in shops (Images 4, 5 & 6). New cabling and (2) IDF's are being added to accommodate the school's increased technology needs.

It is recommended that the existing premises data cabling be replaced with a structured premise Category 6 or most current cabling system installed to EIA/TIA and BICSI standards.

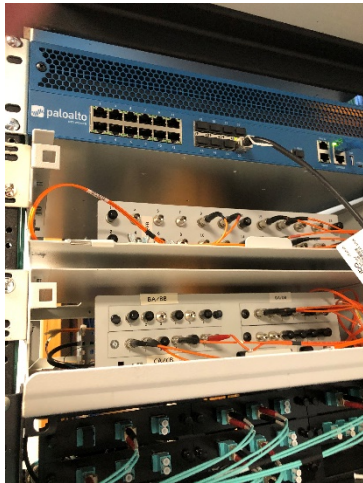
Image 7

There is an existing SonicWall firewall and Palo Alto Networks cybersecurity management system in the MDF/Head End Room (Images 7).

The equipment is in excellent condition and can be re-used.

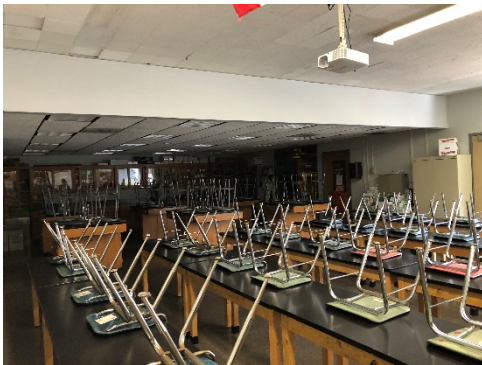
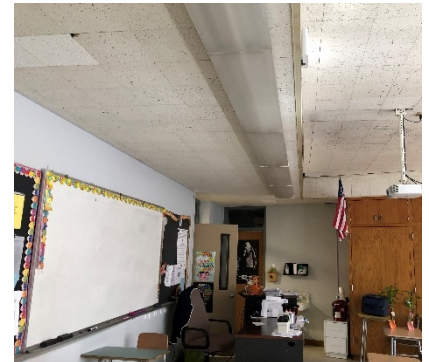
Typical classrooms have data outlets at the teacher location on the teaching wall, which are used in conjunction with audiovisual outlets for connection to overhead long throw video projectors (Images 12, 13 & 14).

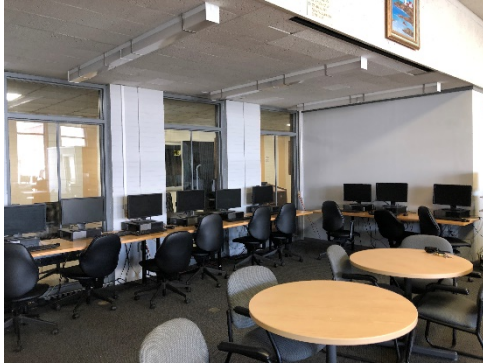
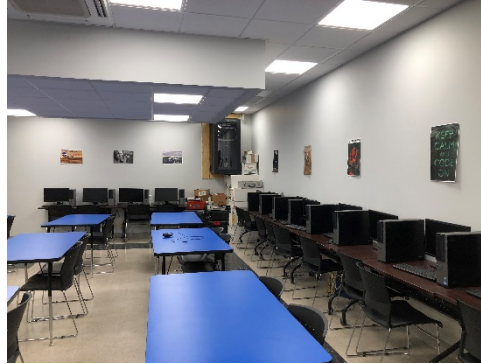
Computer Labs and computer clusters are hard wired to the school's data network. Use of power poles and/or dual channel raceways is typical in these locations.

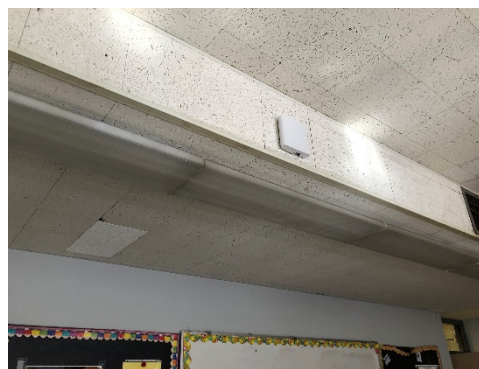
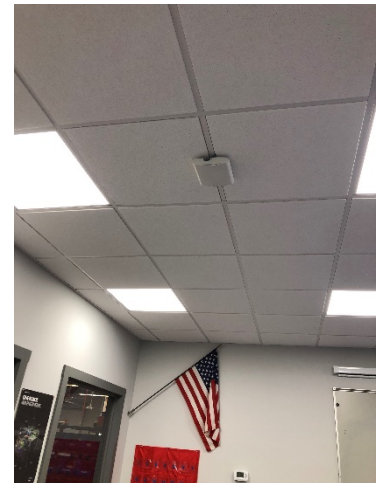
The school utilizes a Ruckus wireless controller and Ruckus access points. The school is in the process of upgrading the system to the latest version Ruckus ZoneDirector 3000 series wireless controller and upgrading and adding (88) more Ruckus Access Points. Access Points are installed on walls and on ceiling tiles.

The Wireless Network equipment is in excellent condition and can be re-used.

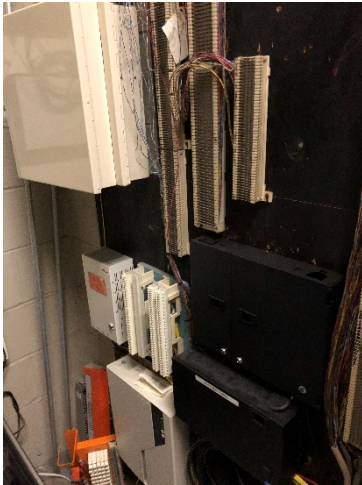
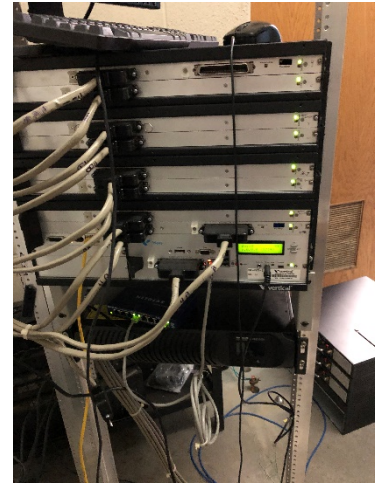
The existing voice system infrastructure consists of a combination Category 3, 5E, and 6 cabling. Telephone distribution frames are in various closets throughout the school (Images 21 & 22). The voice system is an on-premises Vertical Systems PBX (Image 23).

The existing PBX system should be upgraded to an all VoIP system. VoIP phone handsets should be installed in all administrative offices, classrooms, shops, and common areas. However, the school's data infrastructure would need to be upgraded as noted above.

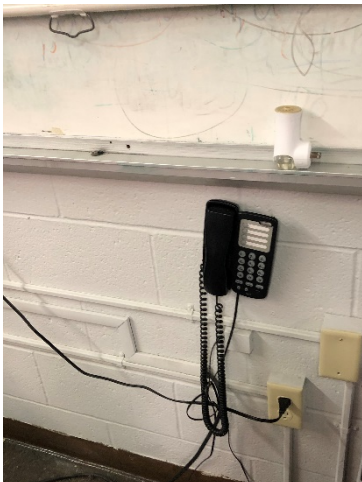
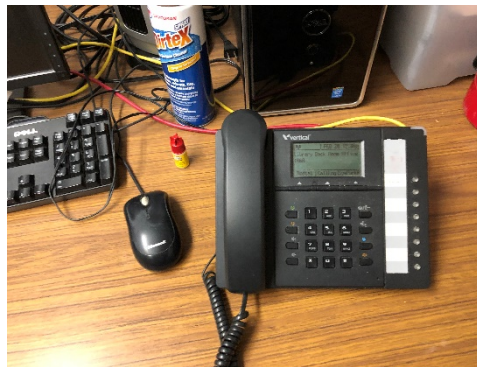
Phone handsets are Vertical VoIP and other manufacturers' digital and analog handsets. Phones are installed on desks in offices and on desks and on walls in instructional spaces (Images 24, 25, & 26).

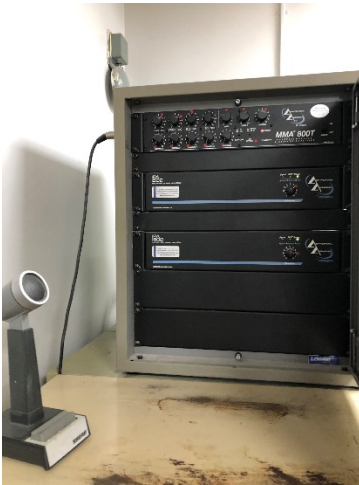
Image 27

The paging system head end located in the main office consists of general paging amplifiers, (2) 150 watt architectural acoustics amplifiers and an architectural acoustic MMA 800T 8-zone mixer with an adjacent Shure microphone for announcements (Image 27).

The system is located on top of filing cabinets and within a ventilated lockable enclosure. PA speakers are located throughout the building.

It is recommended that the PA system be replaced with a microprocessor-based paging system that will establish direct communications to the main office and between individual rooms. The PA system should be interfaced to the telephone system so that announcements can be made using any handset by authorized individuals.

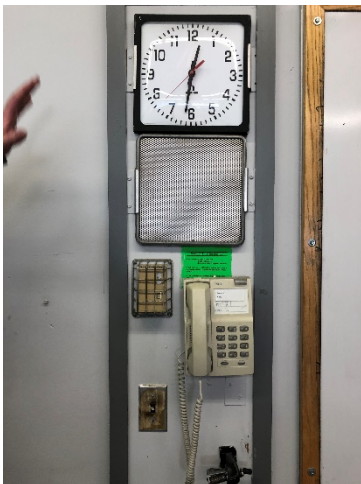
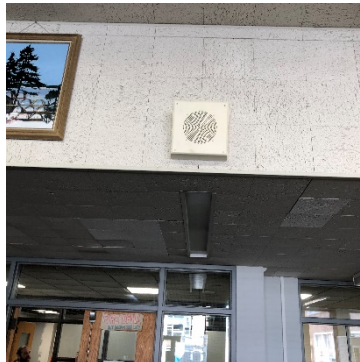
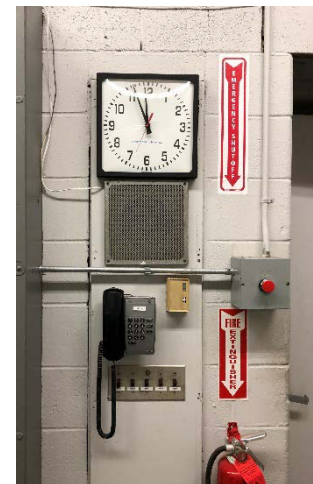
Most of the room PA speakers are wall-mounted within a clock/speaker panel. Some spaces have surface mounted PA speakers (Images 28, 29, & 30).

The existing PA system has a significant number of speakers not working due to equipment and cable issues. PA volume in shop areas is a problem resulting in many complaints. Maintenance of the existing system has become more and more expensive due to the age of the system.

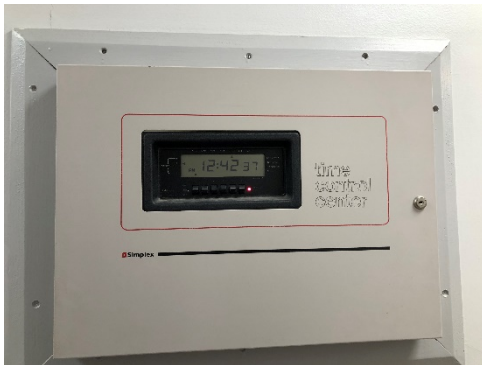
Image 31

The existing Master Clock system is original vintage and consists of a Simplex Master Clock located in the Main Office (Image 31) and analog secondary clocks. Field devices are American Standard analog clocks installed in clock/speaker panels or stand-alone on walls (Images 32 & 33).

The master clock system is operational but beyond its useful life. The Simplex time controller is obsolete.

It is recommended the Clock system be upgraded due to its age to a wired or wireless GPS/LAN based clock system.

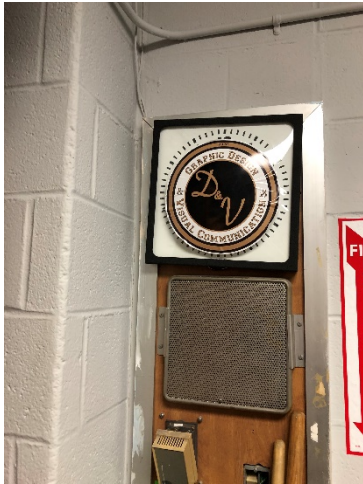
Image 34

Most classroom clocks are functional; however, some are not (Image 34) and have been replaced with battery type stand-alone clocks (Image 35).

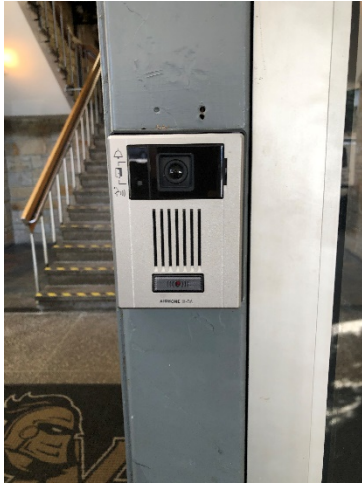
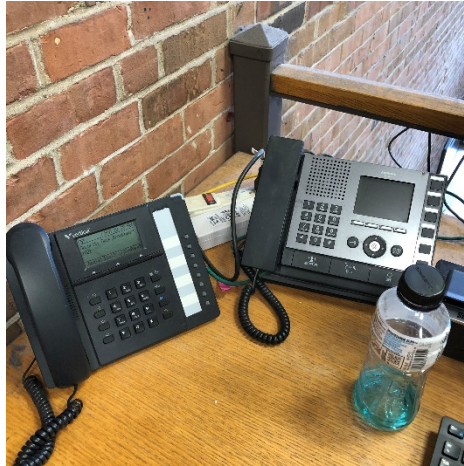
Master stations are located at the security/welcome desks in the main entry lobbies (Images 37 & 38). The Aiphone system is in good condition and can be re-used.

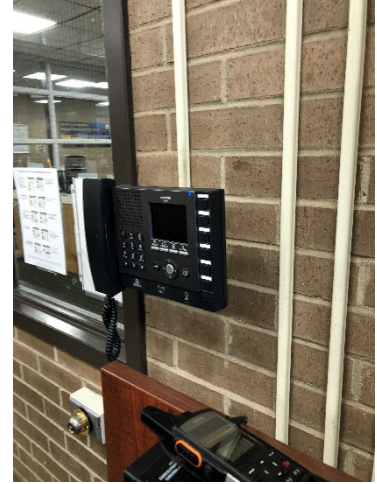
Image 36

There is an existing visitor door entry system consisting of video/audio Aiphone IX series door stations at the main entrances (Image 36) with electronic door latch hardware for remote door release.

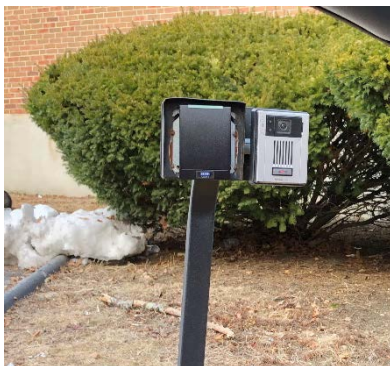
Image 39

There is an existing card/prox reader and an Aiphone audio/video station (Image 39) at the barrier gate to the Breakheart Reservation., a 640-acre hardwood forest located west of the site, which is accessed via the school's parking area.

The existing Access Control card/prox reader system is functional and the components could be reused. However, it is recommended that the Genetec CCTV system noted below be upgraded to the Genetec Security Center version so that CCTV and Access Control are fully integrated.

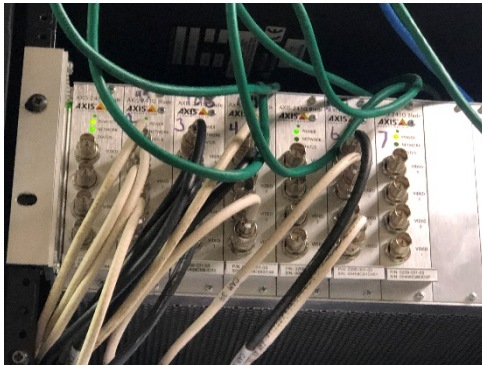
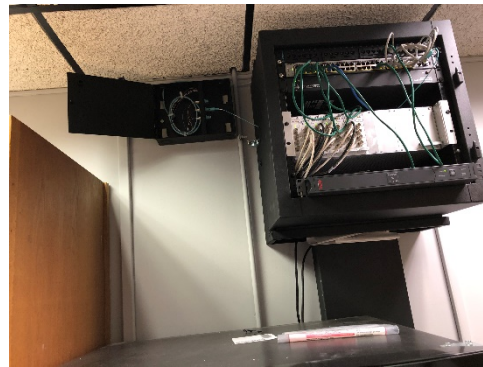
The CCTV system is a physically separate security network with separate racks and fiber run to each IDF for the network (Images 40 & 41).

The Video Management System (VMS) is a Genetec system. Genetec is a leading VMS system and if constantly upgraded to the latest versions can be re-used. The legacy CCTV cameras should be replaced with High Def IP cameras. The older IP cameras should be replaced with higher pixel/resolution cameras.

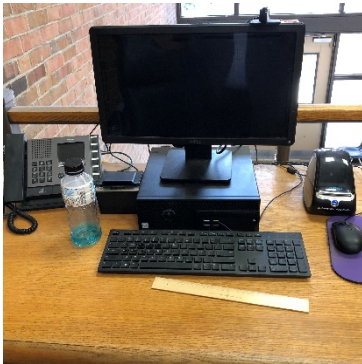
Image 42

There is an existing Hall Pass visitor management system. The system consists of the software data base, computer, license scanner, and badge printer. (Image 42).

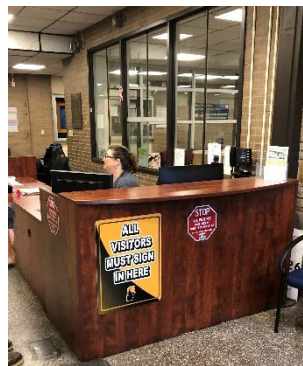
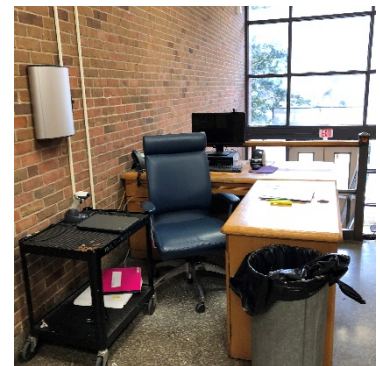
Sign-in and sign-out takes place at the security/welcome desks at the main entrance lobbies (Images 43 & 44). The system can access national data bases to check on a visitor's criminal history. The Hall Pass system and hardware are in good condition and likely can be reused.

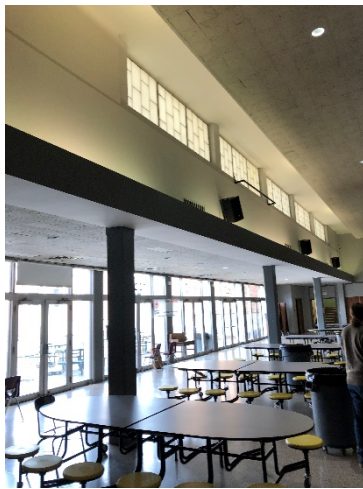
Image 45

The Cafetorium has a Local Large Venue Sound Reinforcement system. The system has fixed speakers mounted high on the side walls (Image 45).

The equipment is in fair condition.

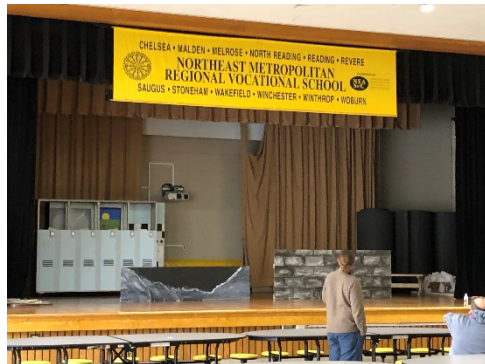
Image 46

There is a video projector located on the back wall of the platform (image 46).

The video projector appears to be interfaced to the live sound reinforcement system.

The existing equipment is in fair condition.

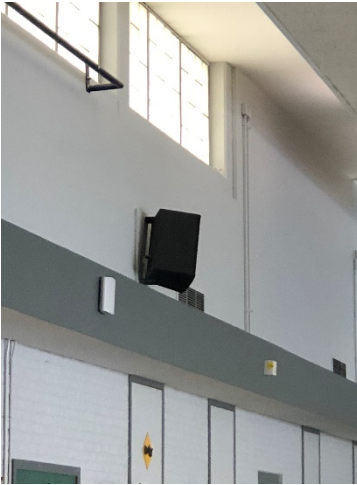
Image 47

The Gymnasium has a recently installed Large Venue Local Sound Reinforcement system. Speakers are wall-mounted (Image 47).

The equipment is in good condition.
