**WETLAND RESOURCE AREA  
ANALYSIS REPORT**

April 3, 2020

**Re: Wetland Resource Area Analysis Report  
Northeast Metro Technical High School  
100 Hemlock Road  
Parcel ID: 40A-000-0RS  
Wakefield, Massachusetts**

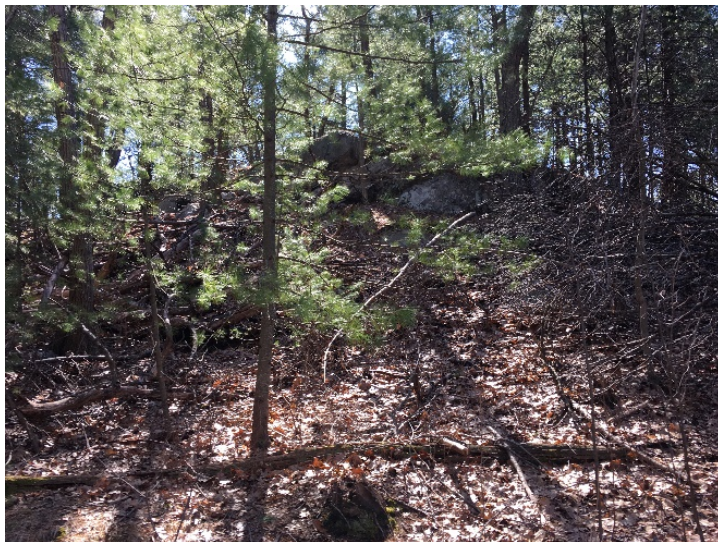
Topography within the developed portions of the site is generally flat. Topography descends steeply along a fill slope from the developed portion of the site to the west. Topography within the southern, undeveloped portion of the site is rolling, with topography generally descending northerly toward Hemlock Road and southerly into low-lying forested wetlands. Rocky outcrops occur throughout the forested uplands (see Photo 1.).

Photo 1. Representative photo of a rocky outcrop within the forested upland.

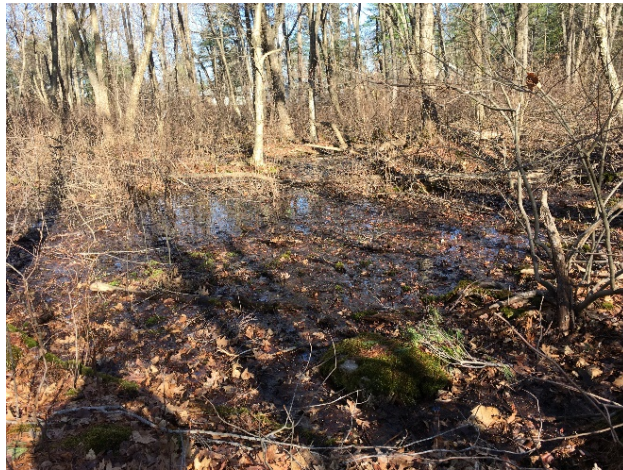
Six (6) BVWs associated with intermittent streams, and one (1) BVW associated with the Saugus River are associated with the site. Wetland Series-1, Series-3, and Series-9 are characterized as forested, red maple swamps, and occur within the southern portion of the site (Series-1 and Series-3) and within the northern portion of the site (Series-9). The eastern boundary of Series-1 (see Photo 2.) generally occurs at the bottom of a rock fill slope. Surface water within Series-1 flows northwesterly into an intermittent stream which discharges off site into a culvert. During periods of high flow, surface water within Series-3 (See Photo 3.) overflows southerly into a manmade channel (intermittent stream) that dissipates further downhill. The Series-9 wetland receives roadway drainage from an upgradient culvert, which flows northwesterly into the forested wetland/intermittent stream located at the toe-of-rock fill slope to the western baseball field. The stream turns westerly and continues offsite.

Photo 2. View of forested Series-1 BVW

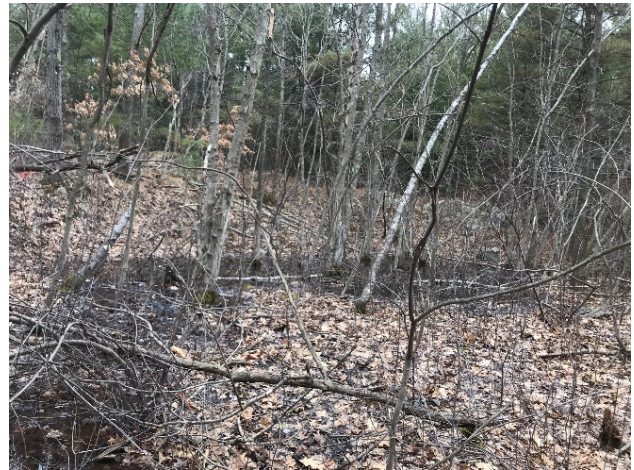
Photo 3. Northerly view of Series-3 BVW

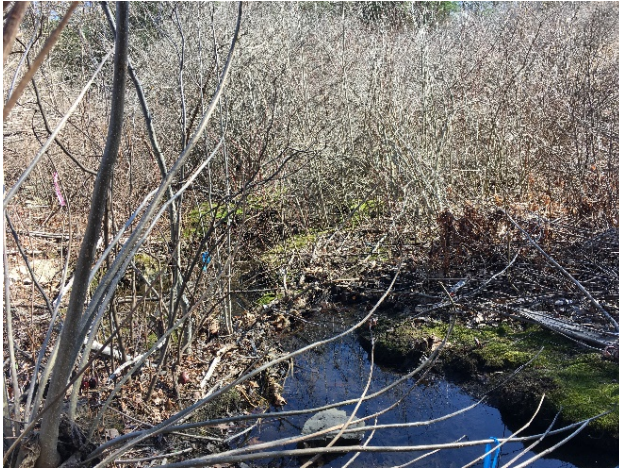
The remaining BVWs (Series-6, Series-7, Series-8, and Series-10) are characterized as scrub-shrub wetlands. Series-6 and Series-7 occur along the eastern site boundary and are associated with an intermittent stream which originates offsite to the east, flows westerly through Series-6 and into an underground culvert, before daylighting through a culvert to the north and flowing easterly through Series-7 (see Photo 4.). Series-8 is associated with the Saugus River. Immediately adjacent to the site, the Series-8 BVW is characterized as a forested and a scrub-shrub wetland (see Photo 5.). It occurs within the northeast corner of the site and continues offsite along the northern site boundary and to the east within Breakheart Reservation. It generally occurs along the toe-of-rock fill slope to the developed

Photo 4. Easterly view of Series-7 scrub-shrub BVW and Intermittent Stream.

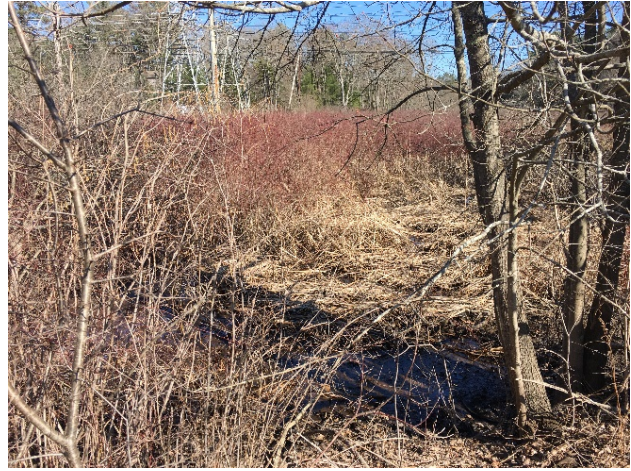
Photo 5. Easterly view of Series-8 scrub-shrub

Vegetation within the scrub-shrub wetlands includes a sapling/shrub layer of sapling red maple, sapling willow (*Salix* sp.), highbush blueberry, glossy buckthorn, speckled alder, sweet pepperbush, elderberry (*Sambucus nigra*), dogwood (*Cornus* sp.), northern arrowwood, winterberry holly, and maleberry (*Lyonia ligustrina*). The ground cover includes sensitive fern (*Onoclea sensibilis*), sheep laurel (*Kalmia latifolia*), wintergreen, and skunk cabbage. Vegetation within the forested portion of Series-8 is similar to the forested BVWs described above.

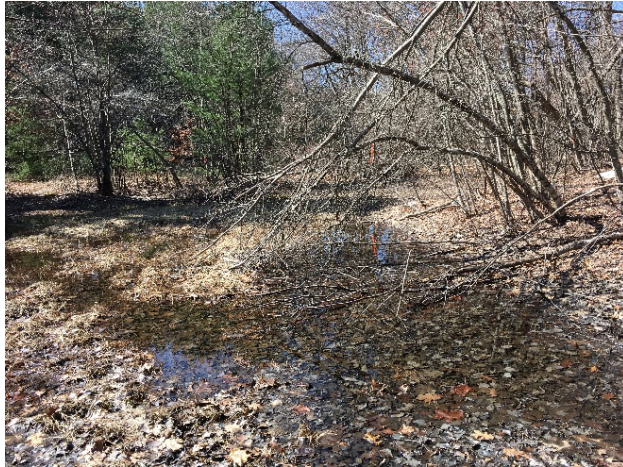
Wetland Series-2 is characterized as a wet meadow and occurs along a shallow, concave area at the intersection of two (2) foot paths located along the southeastern site boundary (see Photo 6.). Vegetation within the wet meadow includes a sparse sapling layer of red maple and a few entanglements of oriental bittersweet along the perimeter. The ground cover includes sedge (*Carex* sp), rushes (*Juncus* sp), and sphagnum moss.

Photo 6. Southerly view of Series-2 wet meadow IVW.

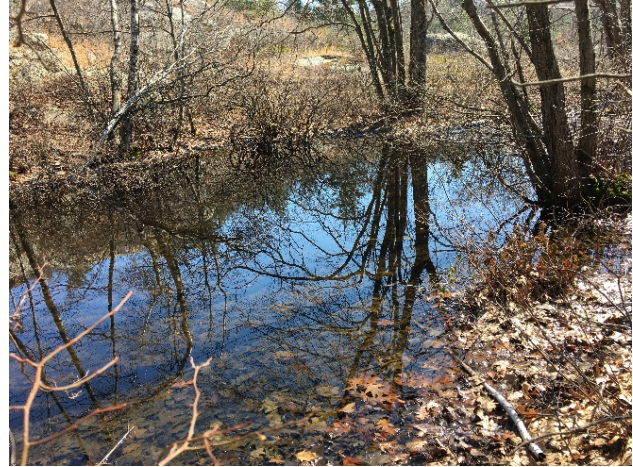
Series-5 is a scrub-shrub IVW located at the bottom of a depression at the edge of the New England Power Company right-of-way along the eastern site boundary (see Photo 7.). At the time of LEC's evaluation, the IVW contained roughly 8 to 12 inches of standing water. Vegetation within Series-5 includes a sapling/shrub layer around its perimeter consisting of sapling red maple, highbush blueberry, and sweet pepperbush. The IVW is not vegetated in its center where standing water occurs.

Photo 7. Easterly view of Series-5 scrub-shrub IVW.

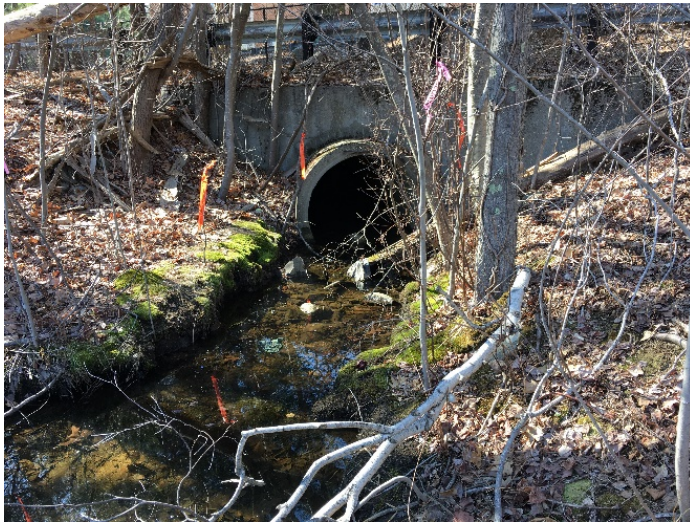
Photo 8. Westerly view of Intermittent Stream in Series-6 BVW.

LEC utilized the USGS water resources web application, StreamStats, to calculate the contributing watershed area and 99% flow duration for the stream associated with the Series-6 and Series-7 BVWs. This stream is tributary to the Saugus River (see Photo 8.). Based on the attached StreamStats Statistics Report, the contributing watershed area of 0.36 square miles is less than the minimum 0.50 square mile threshold required for a perennial stream determination. Therefore, the Intermittent Stream Status is confirmed.

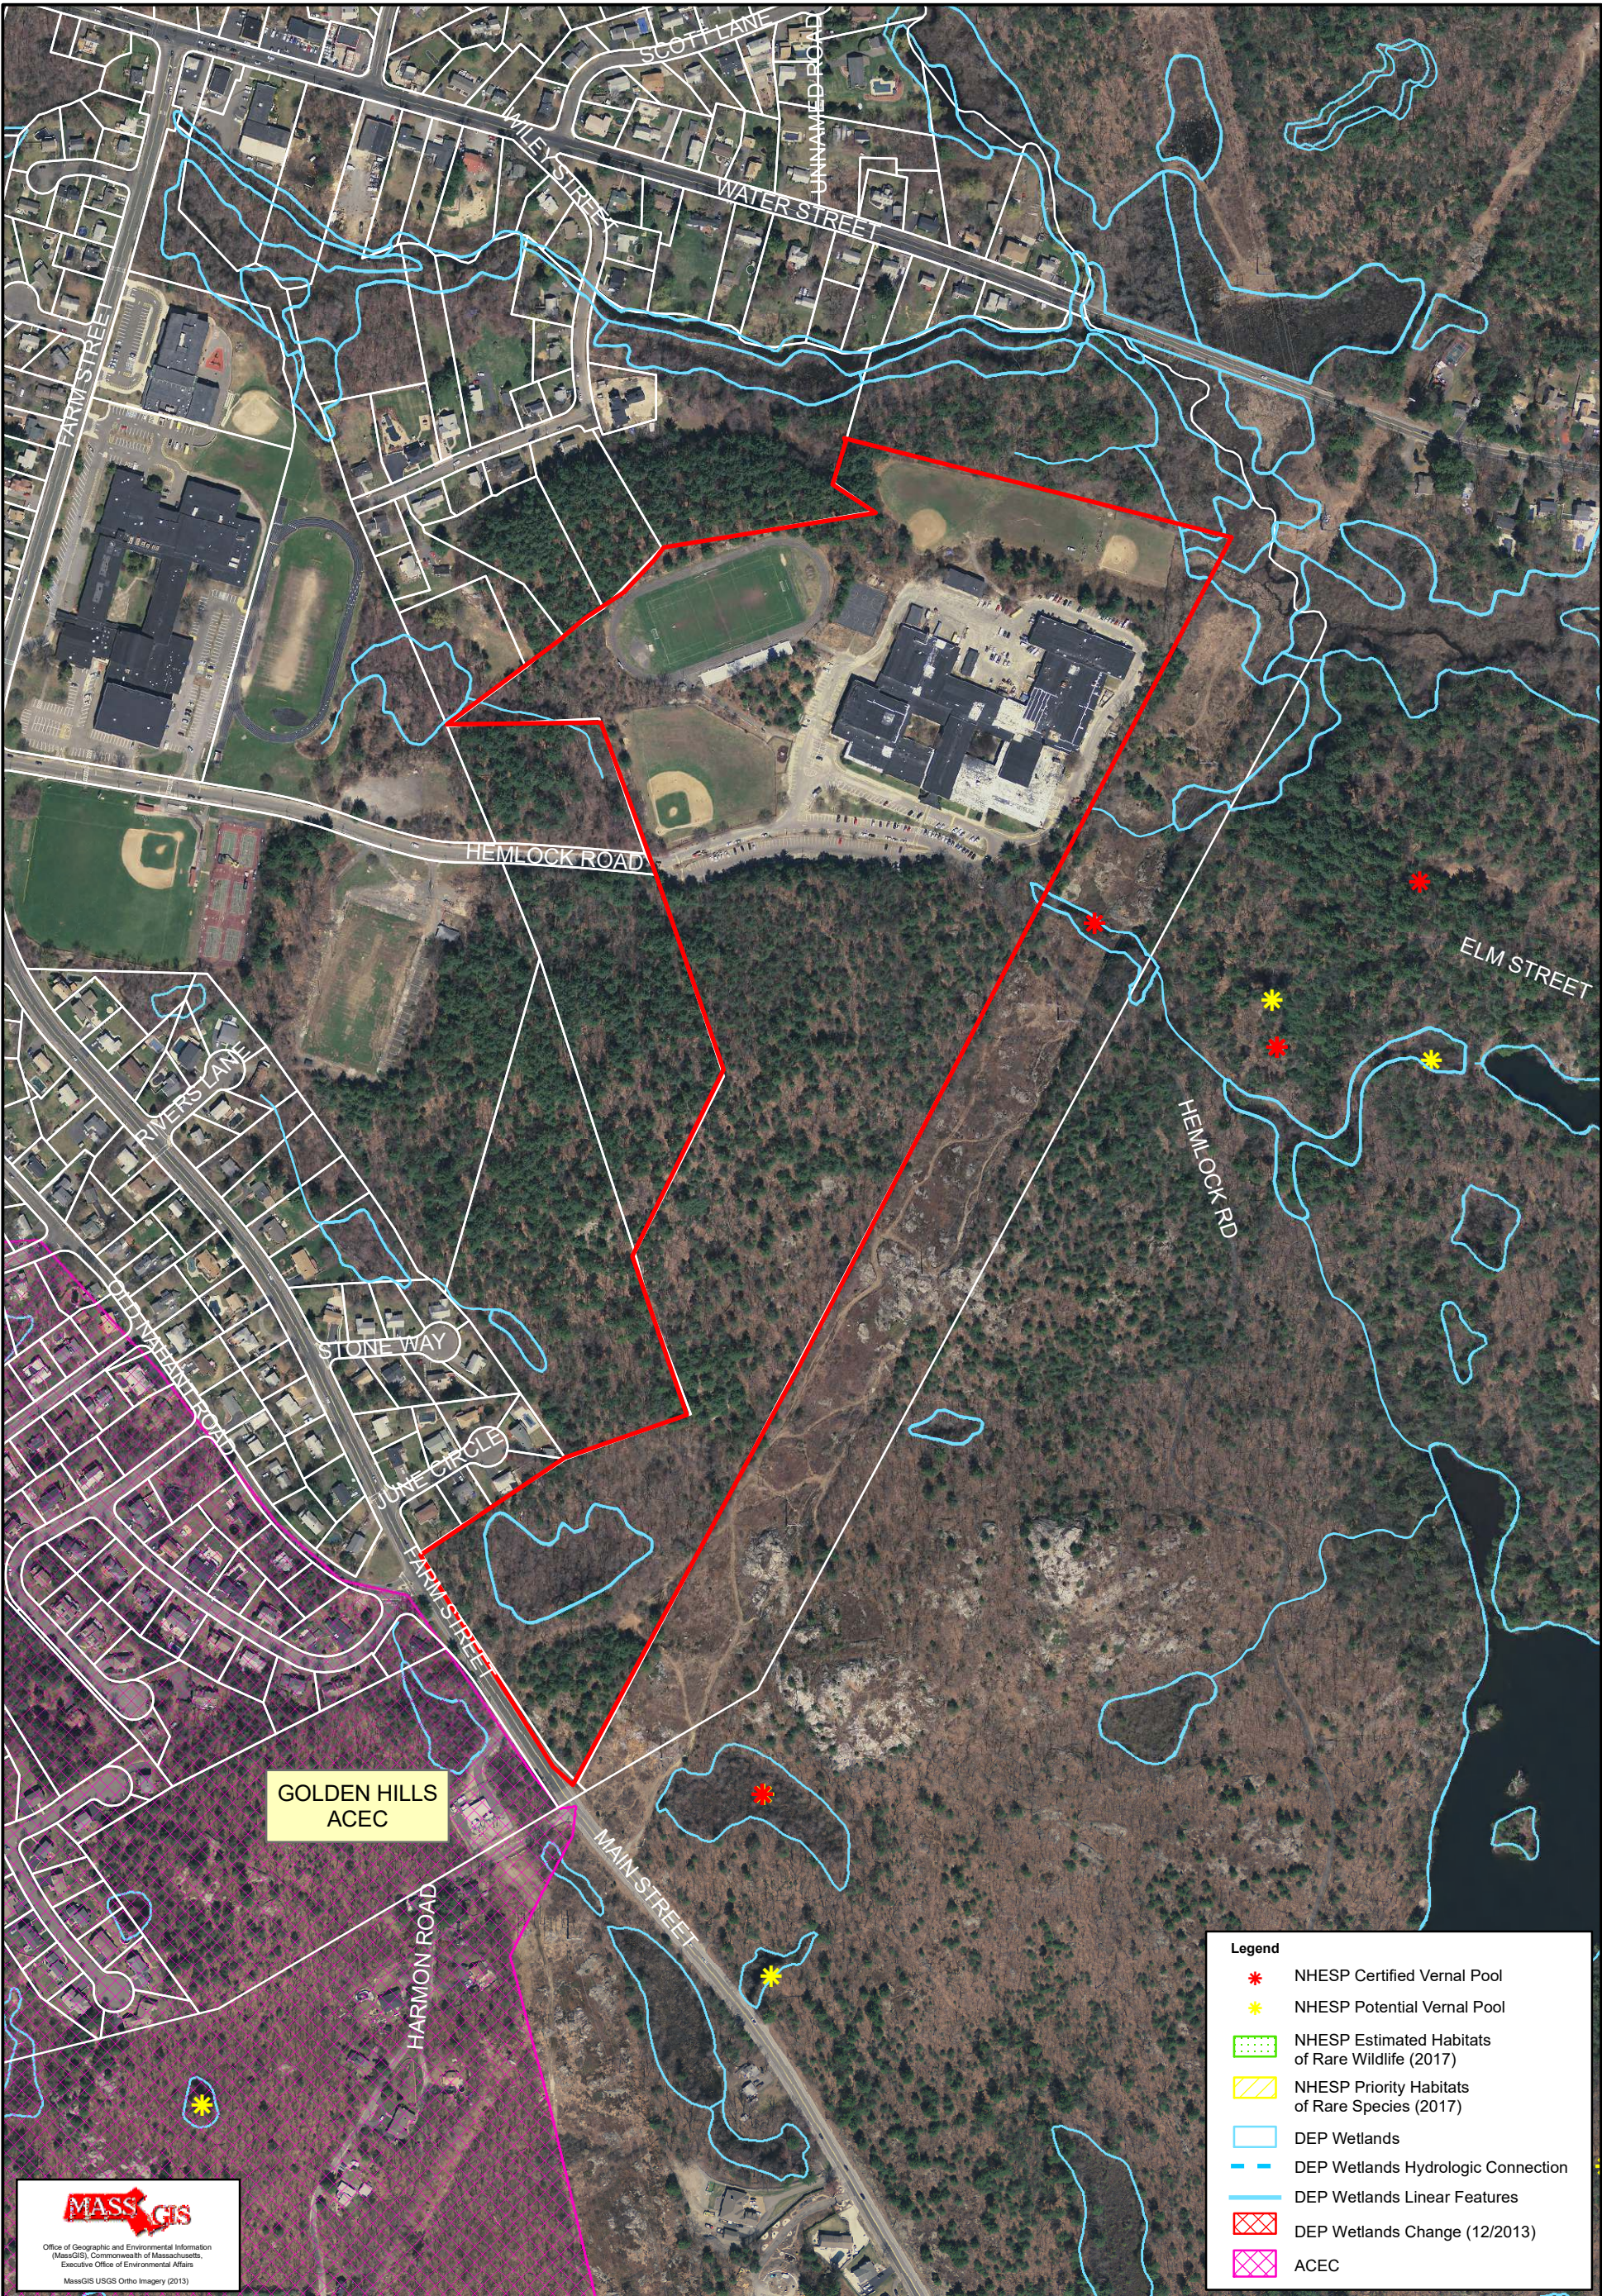
1:25,000 USGS Topographic Images - April 2001

Office of Geographic and Environmental Information  
(MassGIS), Commonwealth of Massachusetts  
Executive Office of Environmental Affairs
