**NORTHEAST METROPOLITAN  
REGIONAL VOCATIONAL HIGH SCHOOL**  
*Wakefield, Massachusetts*

**PRE-FEASIBILITY STUDY:  
EXISTING CONDITIONS INVESTIGATION AND  
EDUCATIONAL VISIONING REPORT**

**February 1, 2016**

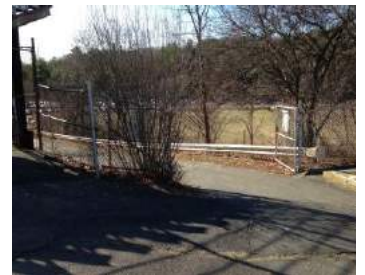
Image 1

The football field and running track are located to the north west of the existing school building on a ridge above the school. There are two walkways to access the track, as seen in Images 1 and 2, with many accessibility issues. Both paths have deteriorating and settled pavement causing large cracks and an uneven walking surface. Neither path appears to meet accessibility guidelines with regard to pavement slope, and one includes a small stairway. The bleachers for spectators also do not have an accessible ramp.

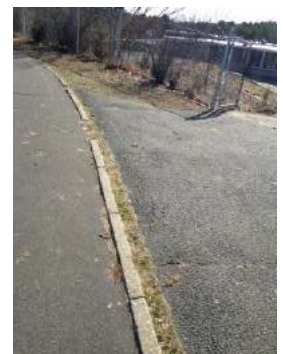
Image 3

The football field holds competitions for the school and would benefit from new sod and maintenance to maintain the sod. The running track is made of asphalt pavement and is not used for competition because of its poor quality. The pavement would require repaving or replacement of material to allow for track competitions to take place. The curb around the track is uneven and missing portions and should be reset if not replaced in full (Image 3).

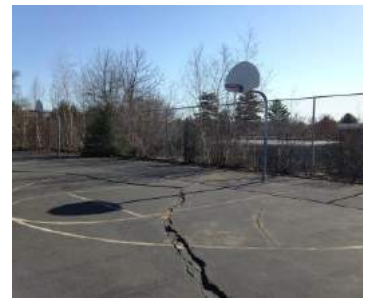
Image 5

The basketball courts adjacent to the track also site on the ledge at a higher elevation than the existing building. The paved ramp to access the courts are in poor condition and have a slope that does not meet accessibility guidelines (Image 4). The basketball courts are in need of general maintenance; replace or reset the chain-link fence; cleanup of debris on the court; replace nets for

the basketball hoops. The pavement has multiple cracks and uneven surfaces that are potential tripping hazards. (Image 5).

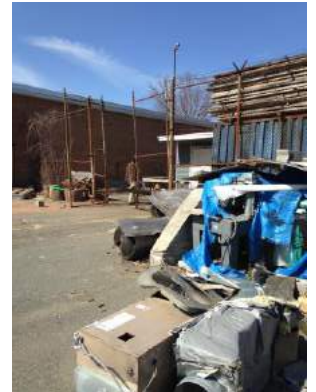
Image 11

In general, there are many clean up opportunities throughout site including debris of scrap metal and wood from school projects and site work. The debris is located most heavily towards the rear of the school building. It can give the impression of disorganization and clutter and can also become a hazard to users and visitors of the school (Image 11).

- Clean up of excess material on site
- Improvement to existing playground surface. Provide either new/additional hardwood chips or install a new resilient play surface

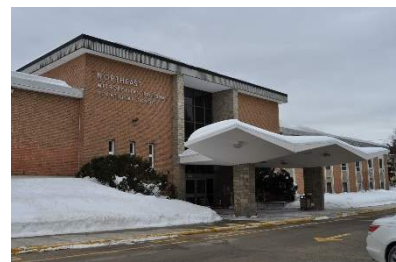
Image 1

The school (Image 1) was designed by Korslund, LeNormand & Quann, Inc. in 1967 and constructed in 1968. Some minor improvements and modifications within the building were designed and/or constructed through class projects. A fire in the woodshop approximately two years ago required some shuffling of programs and is unusable until repaired. Some structural work and a new roof has been completed for the space. Overall the school is relatively untouched. There is a 4,000 SF storage building, also designed by KLQ, Inc. in 1975 at the rear of the site, built into the slope between the parking lot and the athletic fields. Current enrollment is approximately 1,267 students in grades 9-12, and gross floor area is 240,138 ± SF. During the day peak staff numbers are approximately 190 people.

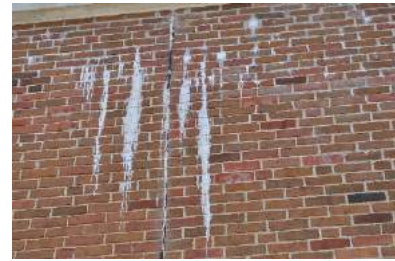
Image 7

1. West wall of the Pool Area: Significant efflorescence (white, chalky staining) was noted at the upper part of the exterior brick wall at the pool. Refer to Images 7 and 8. This condition is not uncommon to older natatoriums, and indicates the presence of moisture in the wall cavity and significant vapor drive pushing moisture-borne salts out through the mortar joints, which are then deposited on the brick surface. Based on the original 1967 drawings, we believe there is no vapor barrier in the wall. The interior finishes include a large area of unfinished masonry which would permit a significant amount of water vapor to pass through the wall causing the efflorescence. The pool is currently not in use, however if the pool was repaired and in use again, we recommend applying an interior vapor barrier to the unfinished CMU wall to limit water vapor from passing through the wall and sealing any gaps where the exterior wall meets the roof and around windows to avoid air moving into the brick cavity. Once the issue is mitigated, we would recommend cleaning the exterior brick.

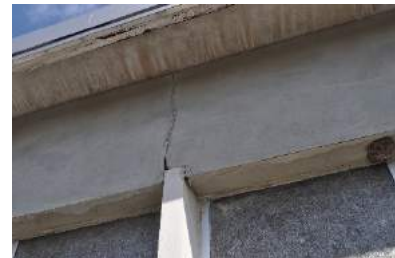
Image 10

2. Mortar deterioration was noted in isolated locations. At the pool wall, it was noted that some mortar repair was attempted (Image 9). A noticeable crack below the fascia was noted at the south elevation of the pool as well (Image 10).

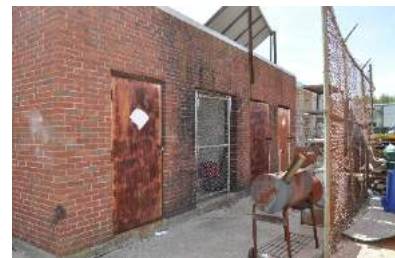
Image 11

3. A brick structure for flammable storage (Image 11) was added just outside of the Maintenance Area on the north side of the building. It is assumed this structure was added at a later time based on the darker shade of red brick. Smoke stains indicate there was a fire at one time.

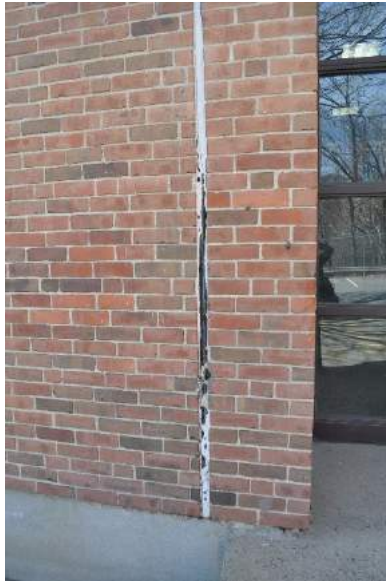
Image 12

5. We observed significant expansion joint failure (Image 12) on the east side of the building, near door 23. This appears to be related to the settling floor issue just inside the corridor. Refer to structural assessment for more information. Flashing is visible where deteriorated concrete wall meets the brick at this same area (Image 13).

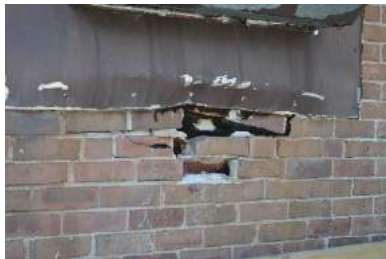
Image 14

6. Damaged masonry under a vent on the east side of the building should be repaired (Image 14).
7. Precast concrete mullions in the building elevations define window wall areas. The wall type is precast concrete panels over CMU back-up below, and depending on the location, (Image 17) above window openings. A decorative precast panel was used below some windows and above some doors. Existing drawings refer to the panels as “3 inch Mosai panels”. The panels are in relatively good condition, except at a few isolated locations.

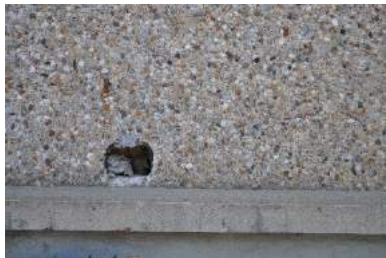
Image 15

8. Holes were punched in the precast panels at a few locations on the north and east sides of the buildings, likely to allow for access for equipment connections at shop spaces. (Image 15)

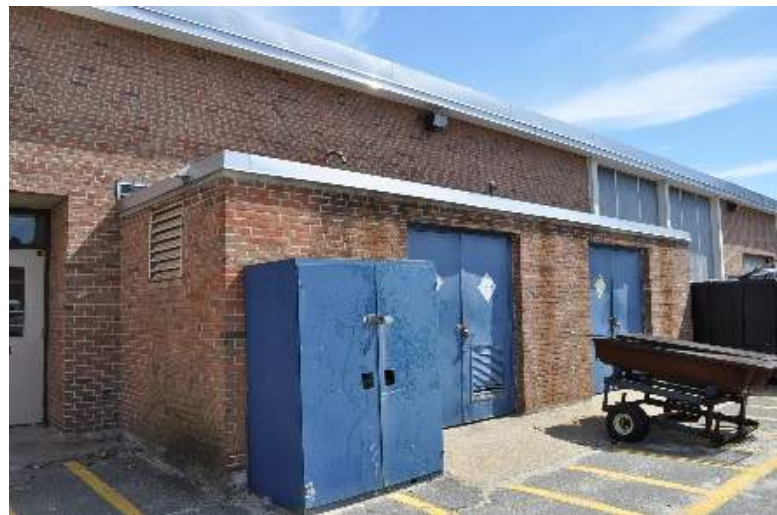
Image 16

4. A second brick flammable storage structure (Image below) attached to the building has multiple areas of discoloration, indicating sheet drainage and near-constant wetting on the face of the brick. It is likely the low points on the roof are not as designed or the amount of drainage on the roof is more than the scupper can handle.

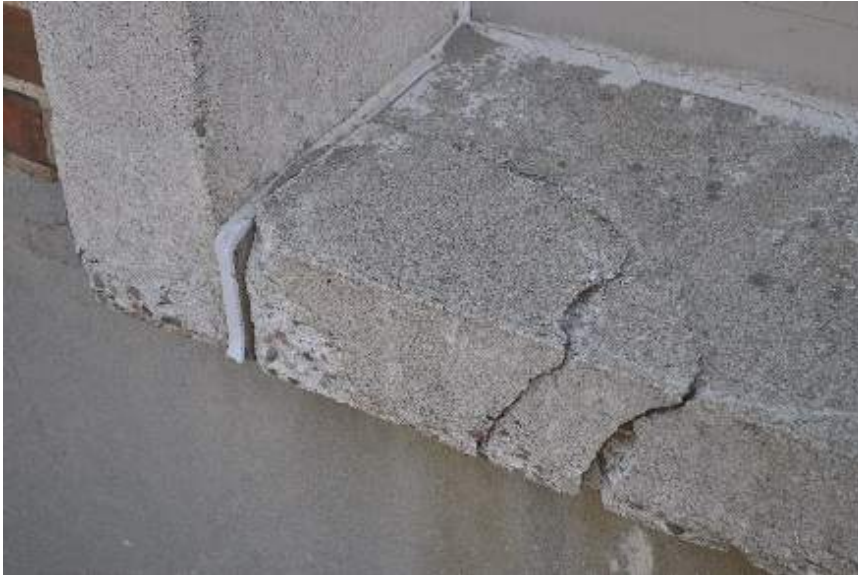
Image 20

9. Precast concrete sills are in good condition given their age. Little distress was noted other than a few isolated areas of cracking or spalling (Image 20).

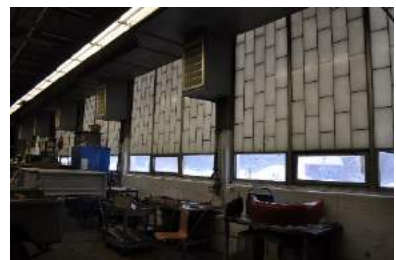
Image 23

Typical windows throughout the building are aluminum frames with a hopper-style, operable sash and non-insulated single pane glass. They are the original windows (Image 23) based on record drawings. Thermally inefficient but otherwise in fair condition, some operable sections were modified to fit an air conditioning unit. In some shop locations, lower venting sash have been replaced with fixed panes of plastic sheet or various other materials. Damaged screens were noted at a few locations.

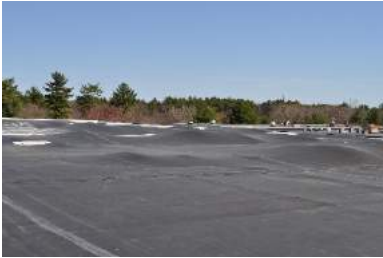
Image 37

5. Flashing at equipment varies in condition from fair to poor (Image 37).
6. Some roof drains are rusted or broken but appear to be draining as no visible ponding was noted except the center of section A (Image 38).
7. Gutters are broken and missing splash guards in many locations (Image 39).
8. Grout has deteriorated at the brick chimney and is in need of repointing (image 40).
9. Trees overhang the roof and should be trimmed to prevent damage to the membrane surface, and prevent accumulation of rotting leaves on the membrane and in drains.

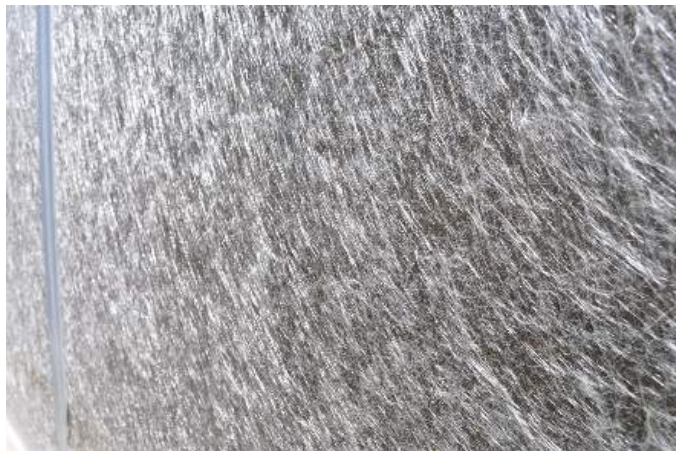
Image 42

11. The membrane at the high roof of Area B above the gymnasium/pool areas has significant bubbling of the EPDM (Image 42). This may be due to evaporation of water trapped within the roof assembly.

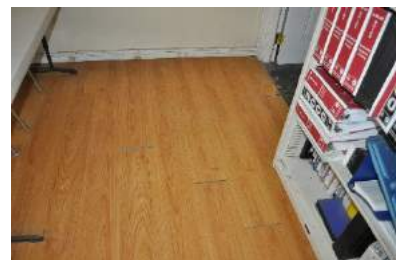
Image 54

- VCT under chairs in the Office Technology Classroom are severely worn (Image 54); padding under chair legs is recommended at these location to prevent further damage to the flooring.

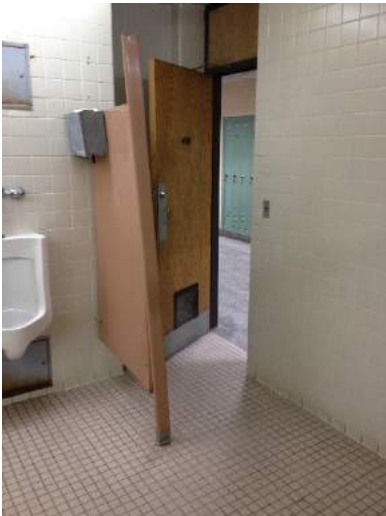
Image 100

Partitions in student gang toilet rooms and lockers/showers are typically painted metal, many of which are damaged with scratches, dents, or graffiti/discoloration and lack overhead bracing of any kind (Image 100, 101). Urinals lack privacy screens throughout.

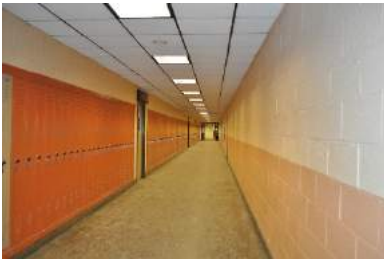
Image 107

Built-in Casework in classrooms consists primarily of wood bookshelves and a tall wood cabinet in fair condition. Classrooms with original wood casework are in poor condition with doors sagging, broken drawers and/or handles. Padlocks have been placed on some in lieu of hardware replacement (Image 107).

There are numerous other areas of built-in wood millwork and casework at kitchenettes and storage rooms that vary in condition from fair to poor (Image 107).

Corridor lockers and some lockers within shop spaces are too thin to realistically fit a standard backpack. It is unclear how often the hallway lockers are utilized (Image 107). The lockers within shop spaces are relatively dirty and have some graffiti, and in poor condition overall (Image 108).

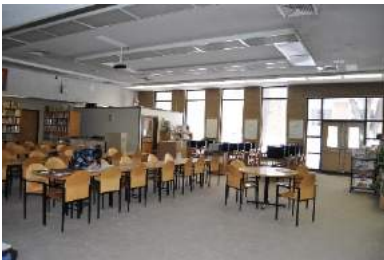
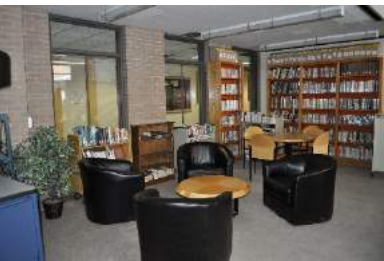
The Library (Image 109, 110) is primarily equipped with high wood shelving in good condition. Wood reading and computer tables and matching chairs are generally in good condition, but are dated. Soft seating looks fairly new, and is in very good condition. The circulation desk appears cramped in its design (not enough room for basic critical tasks and reasonable storage), but is in good condition.

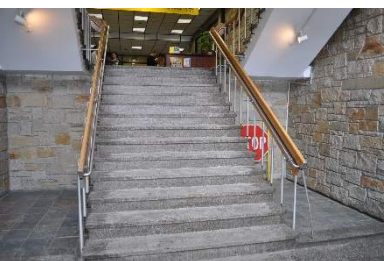
Image 111

The main entrance is not accessible, as one must ascend stairs upon entering the main doors (Image 111). Most exterior

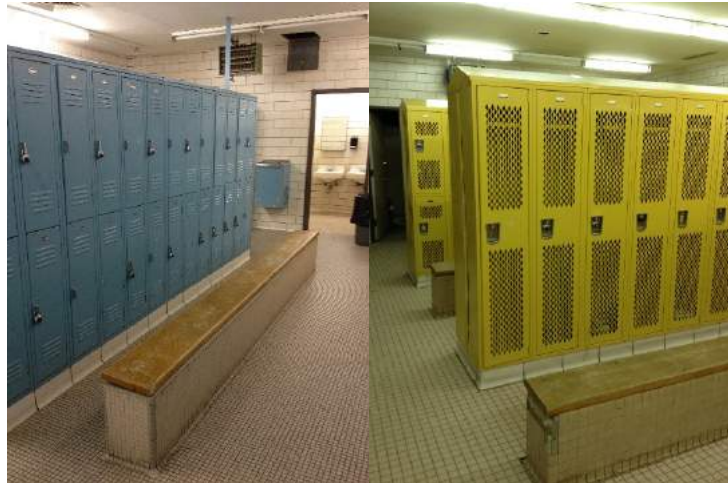
Image 112

The Boys' and Girls' locker rooms have banks of single and double tiered lockers with sloped tops in fair condition. Most lockers that were open had rusting bottoms. The built-in benches have tile finish which is often damaged, and the wood seat cover is worn and coming apart in some instances (Image 112).

The locker rooms (Images 112, 127) have a long list of accessibility issues, including but not limited to: maneuvering clearances at doorways; no accessible toilets, sinks, showers, lockers, or drinking fountains; and PE offices are not accessible. Both male and female lockers are similar.

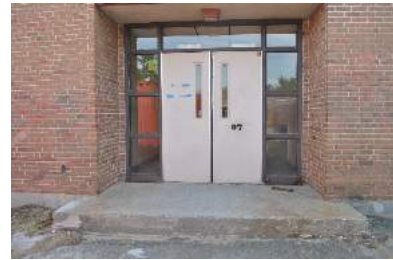
Image 113

doors have an elevated concrete pad or single step/riser with no ramp (Image 113). The building does not have an elevator and a single stair-lift is inoperable. A new platform lift (appears to be a Limited Use/Limited Access—LULA—type) was in the process of being installed at the time of our visit. It is located in a storage room adjacent to the cafeteria, which will give access to the lower academic level (Image 114). Though a positive step, the addition of this lift does not create an accessible route that is equivalent to the route experienced by the general public.

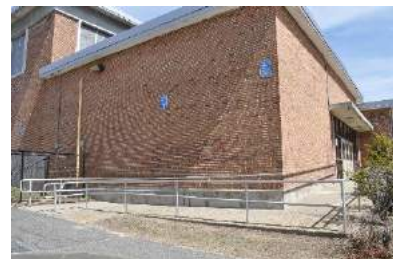
Image 115

The ramp outside the entrance to the pool is the only apparent entrance a wheelchair-bound individual can use to access the facility (Image 115). This would give access to the main level corridor system, but access stops at a grade step at the rear third-point of the building of some eight risers. At that step point, there is one interior ramp at Corridor A, north of the science labs, but it is too steep and is non-compliant (Image 116).

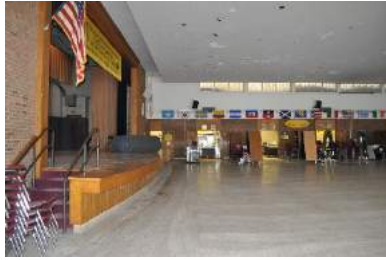
Image 117

The “cafetorium” platform is not accessible to people in wheelchairs from the audience. It is also three risers down from the upper corridor level running behind it. The steps to access the stage have been retrofitted with handrails that appear compliant (Image 117).

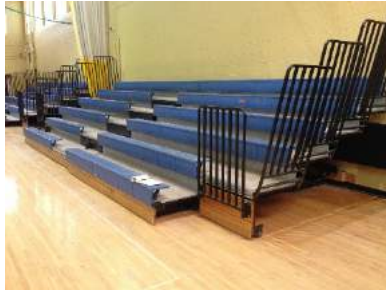
Image 118

In the gym, the bleachers have accessible seating positions, as well as required guards for fall protection (Image 118).

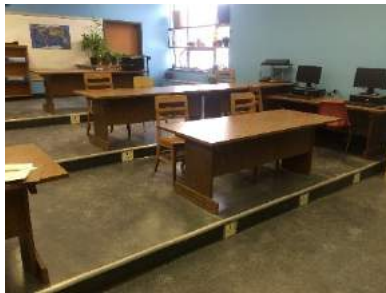
Image 119

on the floor at the front of the classroom. (Image 119)

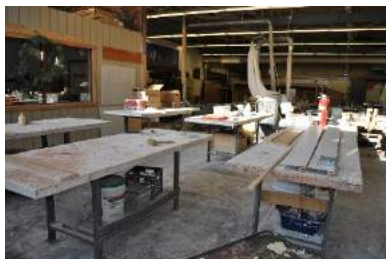
Image 121

Most classrooms, due to their small size and crowded furniture conditions, do not have an accessible route from the door to the teacher's desk, to accessible student desk(s), and to the front of the class and board area. Furthermore, many desks are the one-piece combination seat and desk which are not accessible (Image 120). Standing height tables were noted in most lab-type or workshop spaces – there are no accessible furniture accommodations in these spaces (Image 121).

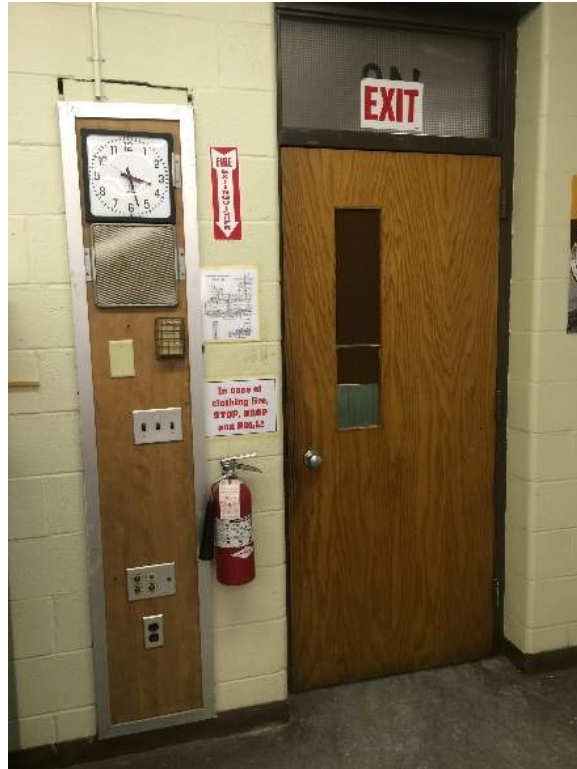
Image 122

Many of the interior doors do not feature the required floor clearances for wheelchair approach to the latch side of the door, due to adjacent wall configurations, permanently built-in items, or heavy/ non-movable furniture. Eighteen inches of clearance is needed at the pull side of each door, and twelve inches at the push side, as well as other minimum areas for approach to, and operation of doors. Also many doors throughout the building feature hardware with knobs, instead of accessible lever handles. Furthermore, many doors are placed in deep-recessed masonry openings of more than six inches between face of door and face of surrounding wall (Image 122 shows many of these issues).

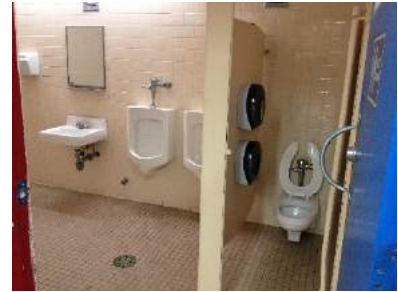
Image 123

In general the toilet rooms throughout the building lack the necessary clearances and fixtures to provide full use by physically challenged users (Image 123). Some accommodations have been made, such as providing grab bars in a toilet stall or lowering of a sink, but we did not see any fully-compliant facilities (Image 124).

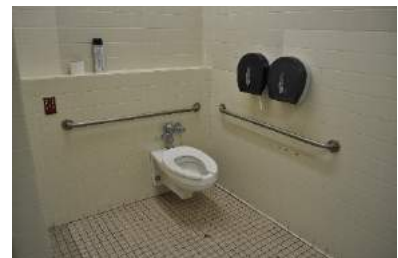
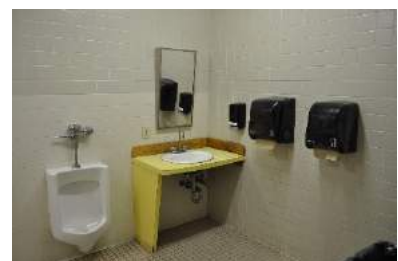
Single toilet rooms off the cafeteria foyer have been modified for accessibility. However the urinal lacks a urinal screen and once added, may impact the maneuverable space for a clear turning radius (Image 125, 126).

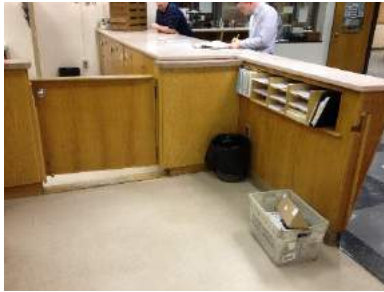
Image 128

The Main Office does not have an accessible-height countertop (Image 128) in the public area for the transaction of school business and its dedicated toilet room is not accessible.

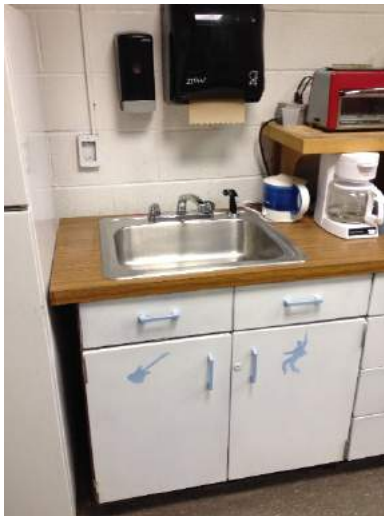
Image 129

Kitchenettes and classroom sinks in the building typically do not have the correct countertop height, and may be required to have knee space for wheelchair users under the sink (Image 129).

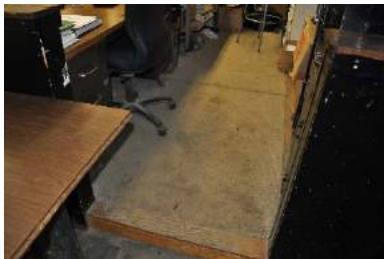
Image 130

Mezzanine areas, elevated instructor platforms (Images 130, 131) and offices within shop and maintenance spaces are not accessible as they have stairs, ladders or a step up to access. In some shops, mezzanines are used as instructional space, not storage, denying access to the mobility-impaired.

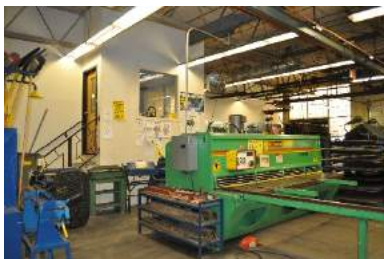
Image 131

Stairs in the classroom wing do not have compliant handrails (Images 131-134). See Health and Safety section below for other issues with stairs.

The building stairwells must be reviewed for width as related to egress capacity; they are somewhat narrow and suspected of being under-capacity. There is some damage to stair treads and nosings on some stairs, which is a trip hazard. Railings and guards do not comply with codes related to continuous railing requirements, railing locations, the 4" sphere rule for guard balusters, guard height minimums, and dimensions of treads and risers. This is true at building stairwells as well as mezzanines in shop spaces. (Refer to Images 131-134)

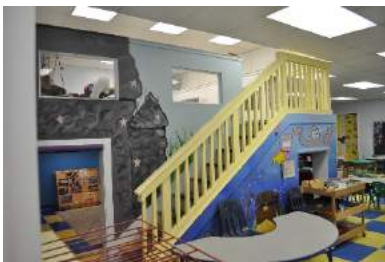
Image 136

Head clearance below and/or above mezzanine spaces are typically inadequate and do not meet the code minimum. Many mezzanines do not have the appropriate means of egress (number, type, and/or location) (Image 136, 137).

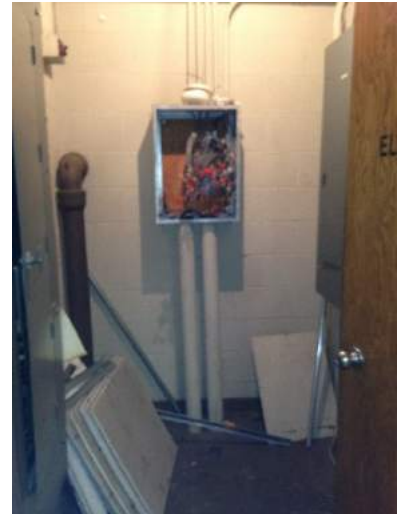
Image 139

Rooms with electrical panel equipment should be carefully checked for compliance as they are governed by strict dimensional rules. Open panels and improper storage were observed (Image 139).

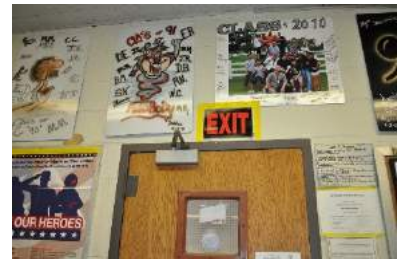
Image 140

The unit ventilators located throughout the building probably do not meet fresh air supply requirements required by current mechanical code for schools. The Print Shop has particularly bad, even hazardous, air quality issues with lack of mechanical exhaust and fresh air makeup (Image 140). Refer to mechanical assessment for more information.

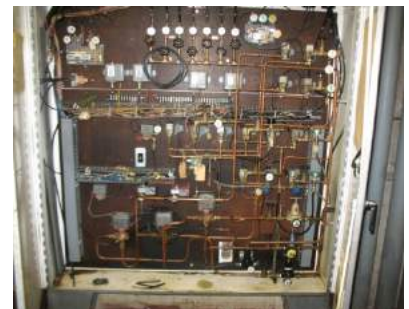
Pneumatic Controls Station - Image 3

The automatic temperature control system is of the Barber Coleman pneumatic type and is provided with an air storage tank and two (2) 5 HP tank mounted compressors, an auxiliary air storage tank and a stand-alone main compressor. It appears that the compressors are operating and maintaining adequate compressed air to the control system. The system is provided with a refrigerated air dryer, as well as, an oil/water separator. (Image 2 & 3) The control system is manually switched between summer and winter operation. The control system is in rough condition. The control stations located throughout the building have experienced multiple failures. The controls system has outlived its useable life and is one of the biggest maintenance issues in the facility.

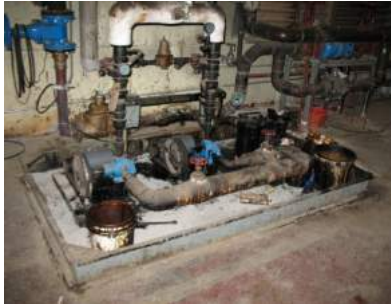
Fuel Oil Transfer Pumps - Image 5

It is our understanding that the underground fuel oil tank is original to the building. The tank has a Veeder Root TLS350 leak detection and monitoring system. The viscous number 4 fuel oil is heated in the tank via a hot water coil to allow the oil to be more easily pumped. It is our understanding that the fuel oil suction line that runs between the building and the tank was recently replaced. A portion of the tank was uncovered during this repair and the tank appeared to be sound. Some sludge was observed in the bottom of the tank during this repair. It is our understanding that the fuel oil transfer pumps were recently replaced and the internal parts of the duplex strainer were replaced last year. (Image 5)

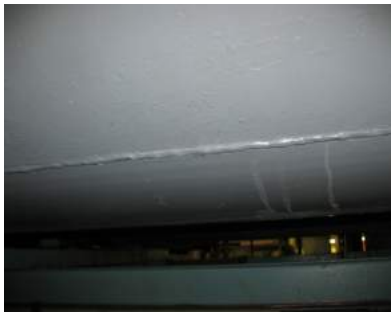
Expansion Tank - New Welded Bottom – Image 6

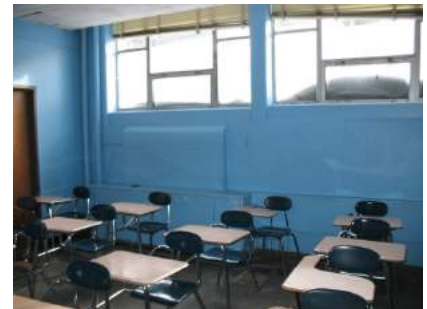
The partially below grade ground floor level has experienced poor air quality. The graphics area design and visual lab has no direct ducted ventilation. There are some wall openings that communicate with adjacent areas that have ventilation. (Images 8-9)

Ground Floor Unit Ventilator - Image 8

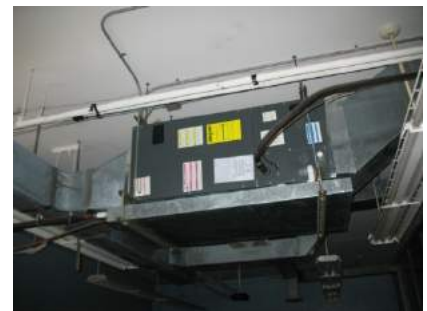
Graphics Area Dx Air Conditioner – Image 9

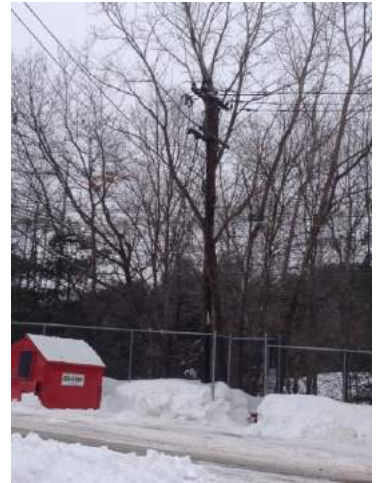
Image 1

The primary service runs overhead along the entrance roadway where it transitions to underground at the last pole near the old Maintenance Building. (Image 1) The underground primary runs into a vault where the transformer is housed.

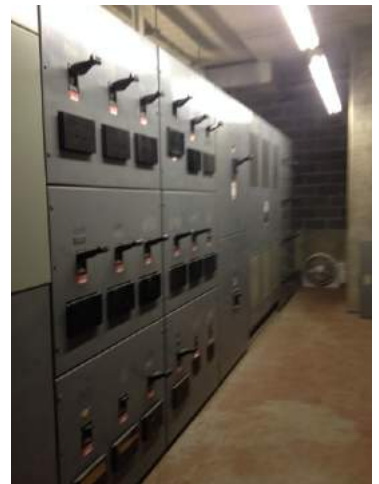
Image 2

The switchgear consists of a 4000A, 277/480V, 3Ø, 4W switchboard with a main/CT section and three distribution sections. The distribution sections are full. The integral 1000 KVA dry type transformer with 120/208V, 3Ø, 4W secondary feeds two distribution sections, also full. (Image 2)

The switchgear with the exception of the recently installed main bolted pressure switch, replaced due to failure, is original to the building and is obsolete and in poor condition. The switchgear was manufactured by Federal Pacific, FPE.

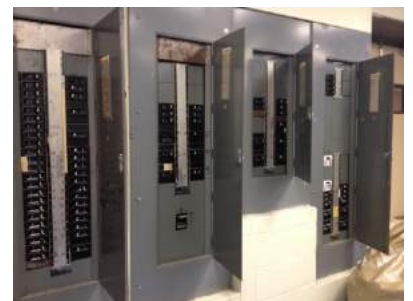
Image 3

Most remote panelboards are of the breaker type but are full and are original to the building, manufactured by FPE and in poor condition. (Image 3)

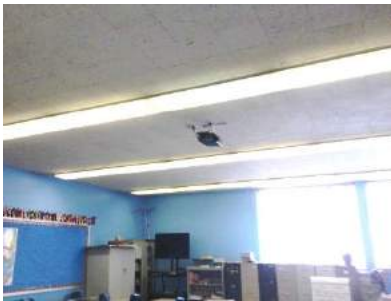
Image 5

Typical Classroom has (4) surface rows of wraparound fixtures with acrylic lens and 2T8 lamps. (Image 5) Classrooms are controlled with one switch.

Although Classroom fixtures and other selective areas have been retrofitted with T8 lamps, the fixtures and wiring were not replaced. Many areas still have T12 lamps and magnetic ballasts.

The lighting system should be replaced with an energy efficient LED lighting system.

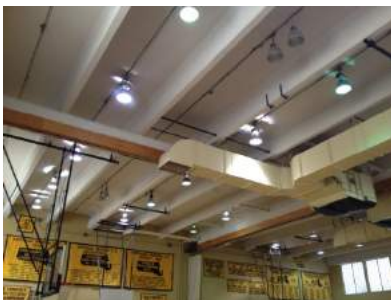
Image 6

The Gymnasium has metal halide high bays with 400 watt lamps. (Image 6) Fixtures do not have quartz restrike sockets for instant on lighting during hot or cold restrike.

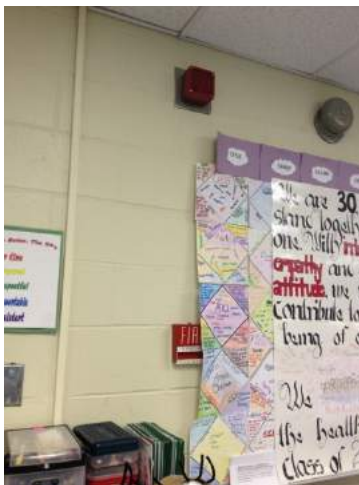
Image 17

The audible devices consist of horns. (Image 17) Speakers with voice evacuation are now required by code. Visual devices exist and while some are ADA compliant, others are not. Coverage of audible/visual devices is inadequate.

The fire alarm system should be replaced with a code compliant, ADA compatible, addressable system. Voice evacuation is now required by code for K-12 occupancies.

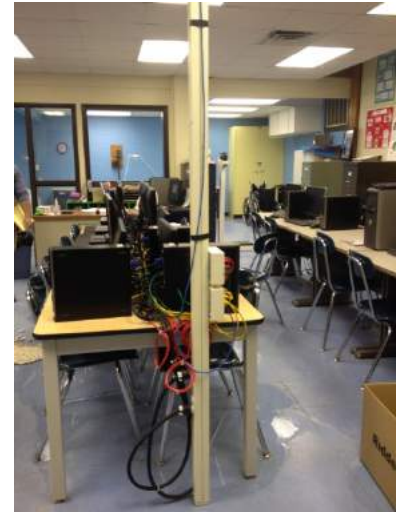
Image 19

The receptacle coverage is inadequate in most spaces. Typical classroom has one duplex receptacle per wall. Extension cords were used throughout Classrooms and Labs. The use of extension cords for permanent wiring is a code violation. Computer Lab has tele/power poles than a series of plug strips. (Image 19)

Additional receptacles should be provided and fed from a system of computer grade panelboards.

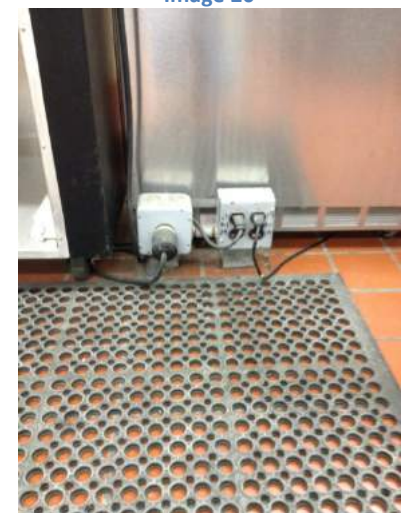
Image 21

Some kitchen receptacles are GFI type while others are not. (Image 21) Cable drops are used at Servery (Image 20).

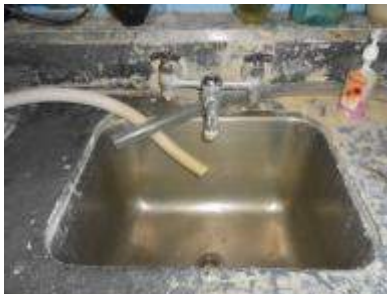
Image 15

Sinks in the Dentistry shops' denture making room is a stainless steel undermount sink with a back mounted faucet with vacuum breaker. Sediment trap located below sink. Sinks located at the dentist examining chair is equipped with a gooseneck rinse faucets. Images 15, 16 & 17.

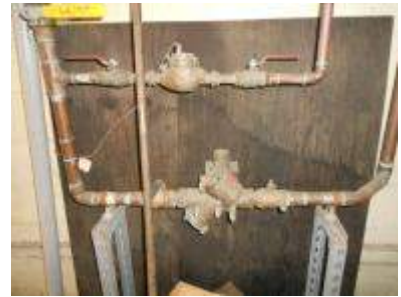
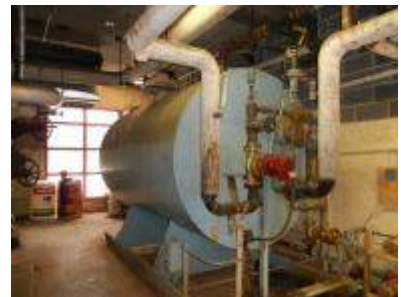
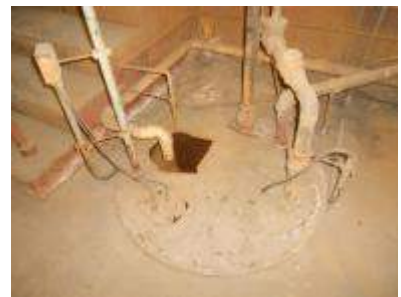
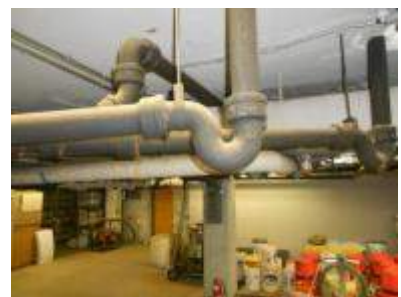
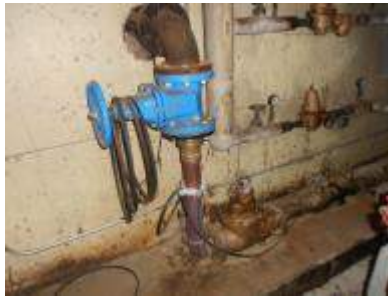
The 4" water service enters in the Mechanical Room Basement. There are multiple meters in the Mechanical Room. There is a building water meter and Fill/Make-up for cooling tower water meter. There is also a sub-meter for the boilers. Images 24, 25, 26, 27 & 28.

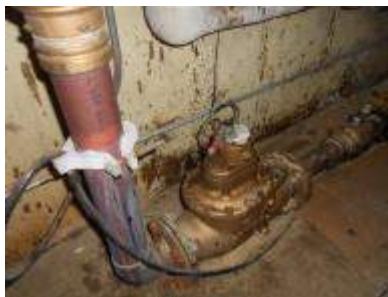
Image 29

The building hot water is generated through (2) oil fired boilers with a separate 500 gallon storage tank. The hot water system is circulated through the building. Water piping is copper tubing sweat joints. Piping is developing pin holes and being replaced as needed. Image 29.

Provide a water heater for summer hot water usage in lieu of running the boilers to generate hot water.

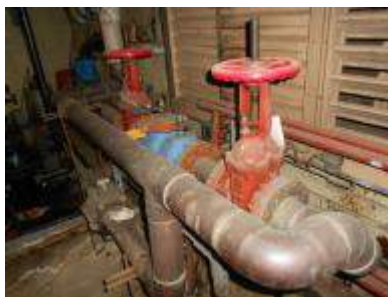
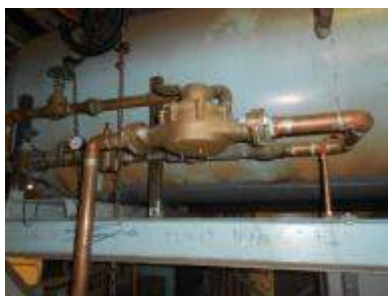
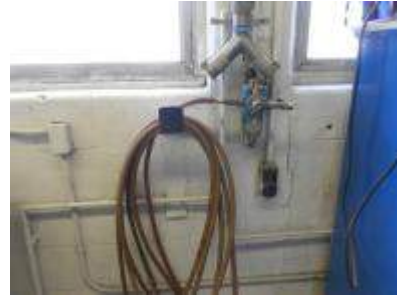
Sanitary, waste, and vent piping is cast iron bell & spigot with areas of new work having no-hub cast iron pipe. Piping appears to be in good condition. The Basement Mechanical room has no floor drains, however, there is an open sump with a single sump discharging to the sewer. Images 30, 31 & 32.

In general, existing cast iron drainage piping can be re-used if sized appropriately. We recommend video inspection of existing drains to confirm integrity.

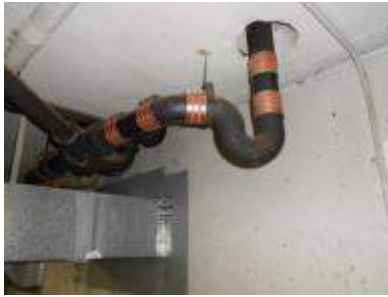
Image 33

LP gas is provided to the building. Gas supplies kitchen equipment, science classrooms and abandoned pool heating equipment. In general, piping is schedule 40 black steel with threaded fittings. Image 33.

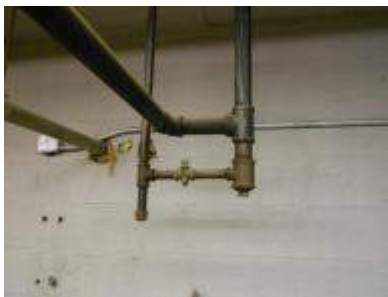
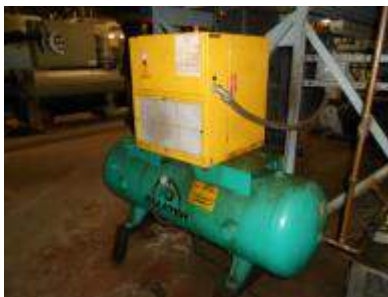
(2) Air compressors in Mechanical room provide air to HVAC pneumatics. Compressors are in fair condition. Images 34 & 35

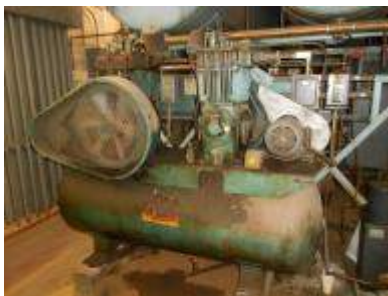
Image 36

(2) Air compressors in the maintenance garage provide compressed air to multiple shops. Image 36.

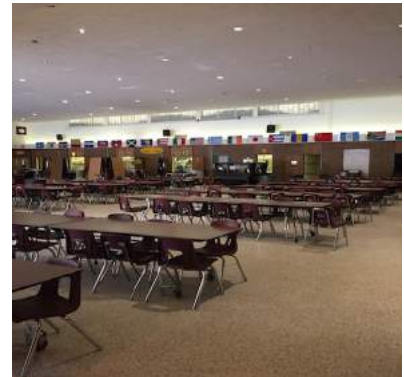
Image 1 is a view of the existing seating area and Image 2 is of the vending machines. If applicable in future planning, vending must be accounted for in the seating area so that it is not placed as shown in image 2 interfering with other function.

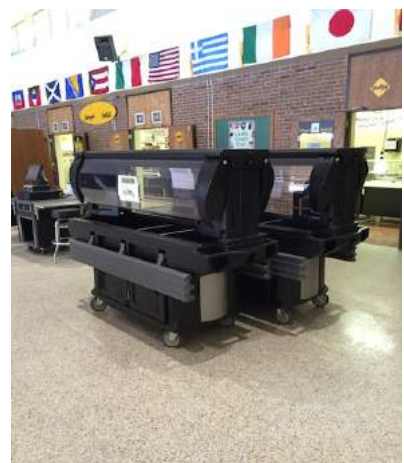
Image 3

Various serving counters and portable salad bars, as seen in image 3 are in fair condition but in planning for the new serving area these items may not be appropriate for reuse depending on the method of serving as well as the atmosphere and décor of a new environment. New serving counters must be tailored to fit within the new design that pull these services out of the seating area and into the kitchen environment.

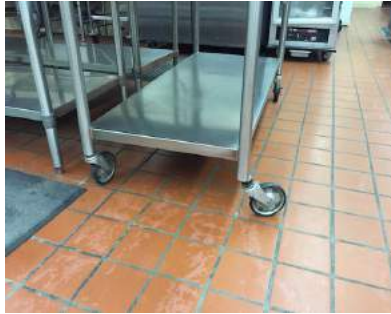
Equipment that is identified for reuse may not be available by the time some future renovation is realized. Additionally some level of rehab and repair will be needed to be able to reuse equipment. Image 4 is an example of a sturdy table in need of caster replacement. Once the casters are replaced this table will serve its purpose for many more years to come. However, depending on the level of repair it may not be feasible to reuse some equipment. As equipment utility consumption and efficiency improves it may not be prudent to reuse certain types of equipment and it may make more sense to replace it with more efficient, modern pieces of equipment.

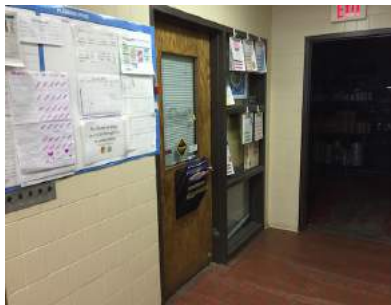
Image 5

The back of house area is what is referred to when discussing the non-serving portion of the kitchen. The back of house consists of the food storage, preparation, cooking, pot washing, and offices. In image 5 there is an office for the foodservice director. Additional office space is needed for the kitchen manager as seen in image 6. For the kitchen manager there is an open desk area but that are should be enclosed in an office. An office would offer security of files and other important documents. In addition, offices should be segregated away from food preparation areas. Creating a distinct office area in needed for the separation of functions and eliminating the potential for cross contamination.

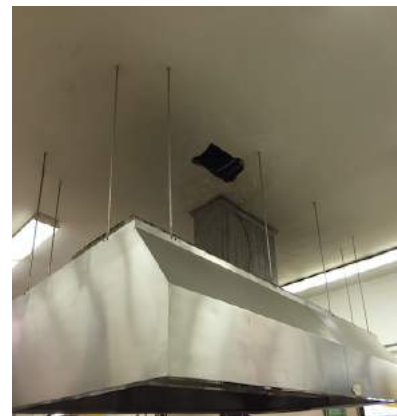
Image 9 shows the original hood. Note the grease leaking down the front of the ductwork. In order for grease ducts to comply with current safety standards ducts must be watertight. A fully welded duct achieves this requirement and the existing condition is not watertight given the presence of grease. It is not clear where the grease is leaking from but it should be assumed that the grease is escaping from the interior of the duct onto the outside surface of the duct. This is a potential hazard, should there be a fire the grease would act as an accelerant. Luckily, the lack of open flame cooking diminishes that threat. With regard to finishes, an open gap in the ceiling is a health code violation. Ceiling must be comprised of smooth non-porous surfaces. Also, current standards require that the area above the hood be sealed to the finish ceiling above to prevent dust and grease from accumulating on any hard to clean horizontal surfaces.

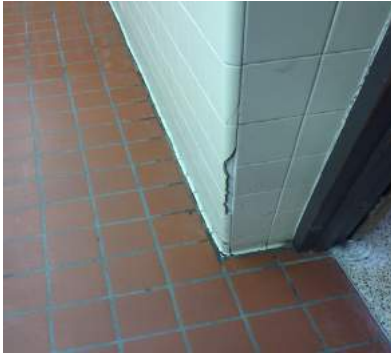
Image 10

With regard to wall finishes they too are appropriate but showing signs of wear. The walls are a very hardy glazed tile. With time normal wear and tear has overcome the finishes. In image 10 there are signs of corners being damaged. Dirt and grime will collect in these damaged areas and they will be difficult to clean.

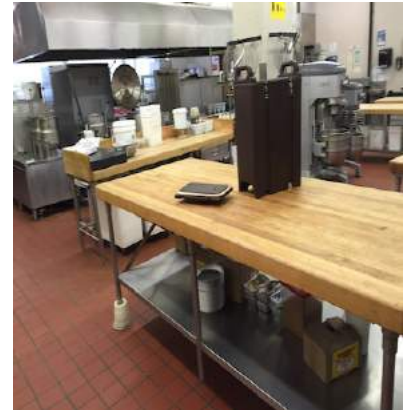
The Culinary Arts Kitchen is well organized and has been equipped with a few new pieces of equipment. However, much of the original equipment is worn and in need of repair or replacement. Image 13 shows a wood top table that has one failed leg. In other cases all the legs have failed and a temporary repair similar to what is shown in the adjacent image was made. The wood tops on all of the tables are original. Wood is an acceptable surface but when it is of the vintage shown in image 13 the woods tends to have splits and gaps where food debris can accumulate. This condition results in an unsanitary condition.

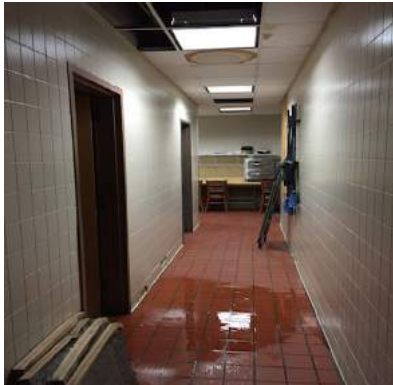
The finishes in the culinary area are similar to the finishes in the main kitchen. The original materials are of the same durable glazed tile and quarry tile flooring. However, roof leaks are affecting the finishes. As seen in Image 16 there is a recurring roof leak. Old stains can be seen and some tiles have been removed from prior leaks and damage.

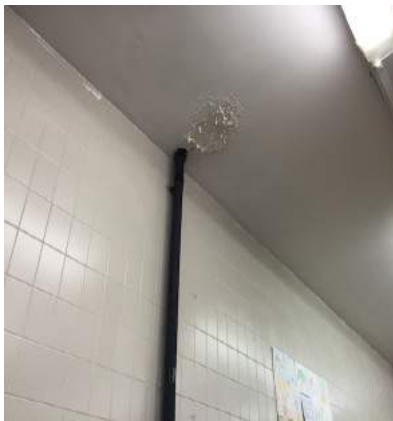
Image 17

In certain places the ceiling paint is peeling - see image 17. The presumed cause is another roof leak. Peeling paint is a major food code violation and a serious hazard. Paint chips of unknown composition can become loose and fall into food products, and could potentially be ingested.

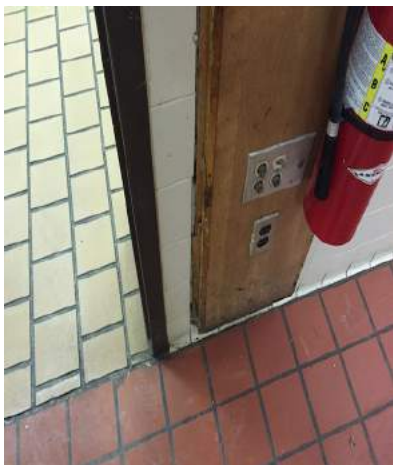
In the case where exposed unfinished plywood is present, that is a direct violation of the health code. Wood is considered a porous surface and is not easily cleaned. Image 18 shows one of the many exposed wood surfaces within the culinary kitchen.

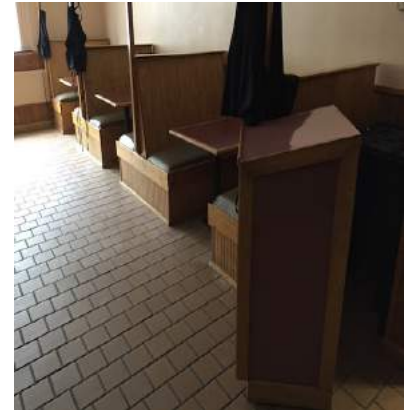
Image 19

The seating is a combination of booths and loose tables and chairs. The seating appears to be in good shape and may have been a recent upgrade to the program. The total seating count appears to be approximately 50 seats. Reuse of the existing seating is a possibility.

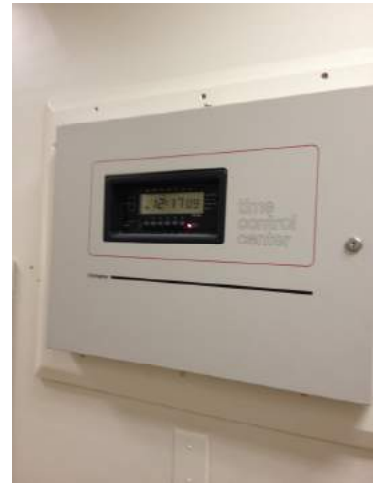
Image 1

The master clock system is operational but beyond its useful life. The Simplex time controller (Image 1) is obsolete. Most classroom clocks are functional and some that have failed have been replaced with battery type stand-alone clocks.

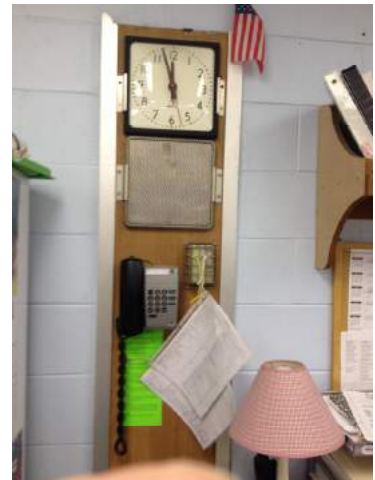
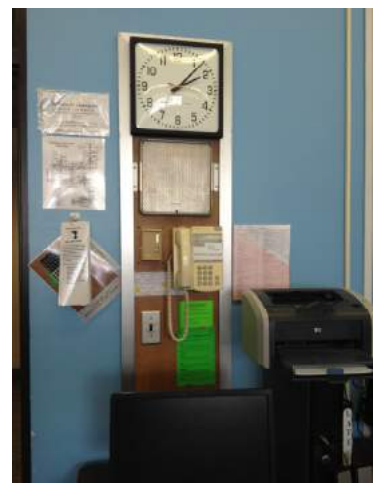
Speakers are located throughout the building. The majority of room speakers are wall-mounted within a clock/speaker/telephone panel. (Image 2 & 3)

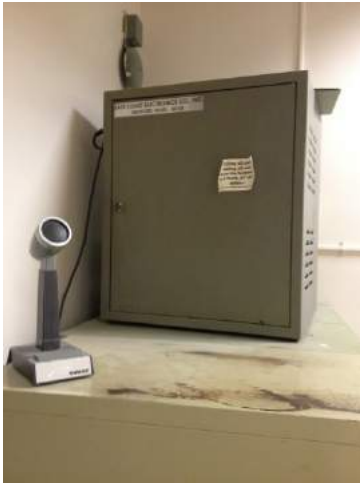
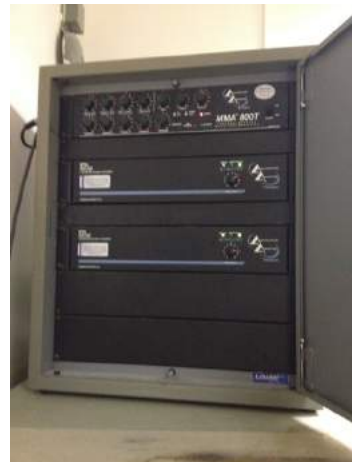
The paging system head end consists of general paging amplifiers, (2) 150 watt architectural acoustics amplifiers and an architectural acoustic MMA 800T 8-zone mixer (Image 4 & 5) with an adjacent Shure microphone for announcements. The system is located on top of filing cabinets and within a ventilated lockable enclosure.

The existing paging system should be replaced with a new microprocessor based paging systems that will establish direct communication between any remote station and desktop instrument. The paging system should integrate with the master clock system for accurate time tone signaling for class changes as well as integrate with the telephone system so that telephone handsets can be used to communicate. The new paging system should be provided with a visual console that is web based where the staff can monitor/manage the following functions:

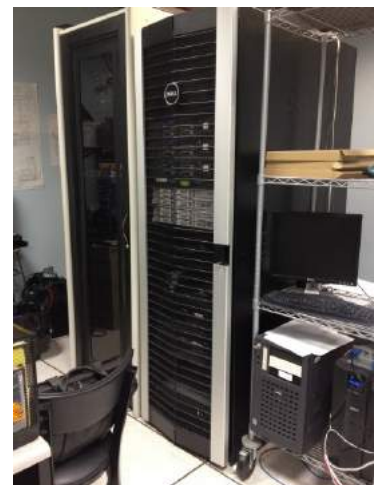
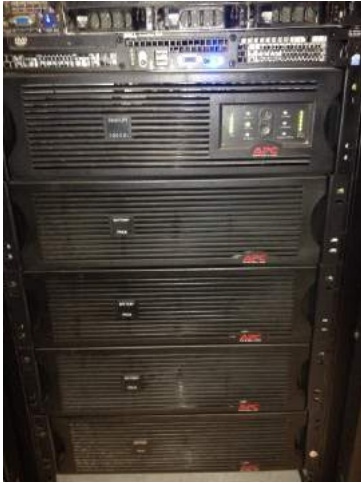
The main IT Room (Head End Room) consists of (2) server racks, a data cabling patch panel rack, and individual UPS units. (Image 9 & 10)

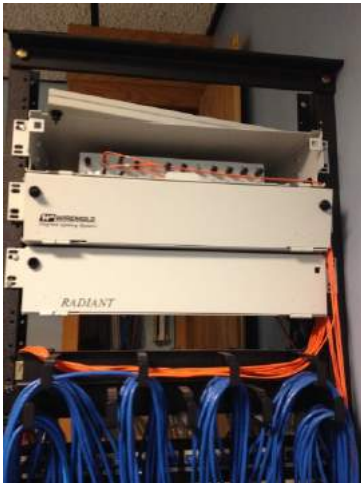
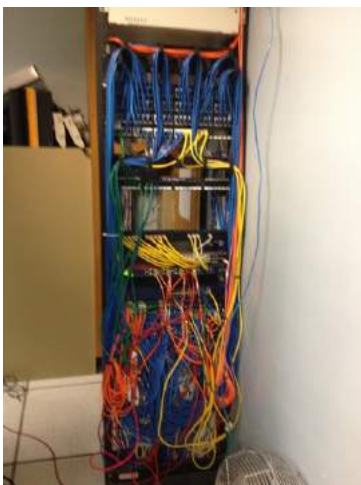
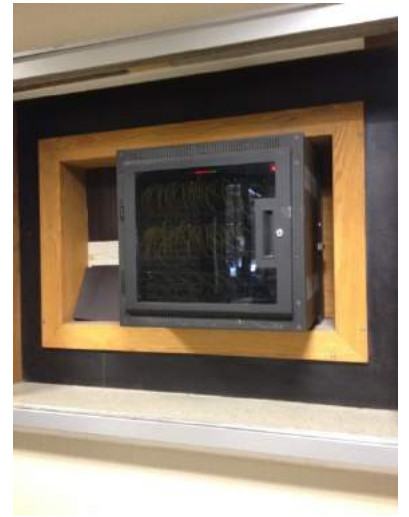
The Head End Room is where the school's ISP fiber is terminated. The back bone consists of multi-mode fiber from the Head End Room to (11) intermediate distribution frames (IDF) throughout the school (Image 11 & 12), typically in wall-mounted lockable cubes (image 13). The CCTV system is a physically separate network with fiber run to each IDF for the security network. Cat 5e cable is then run to the desktop locations from the data patch panels.

Any vintage Cat3 cable should be upgraded to Cat6 cable and any renovation or reconfiguration of spaces shall be taken advantage of to replace any Cat5e with Cat6 cable. IDF closets should be constructed to serve areas of the buildings with proper ventilation power and cooling. This will phase out the individual cubicles currently mounted out in occupied spaces.

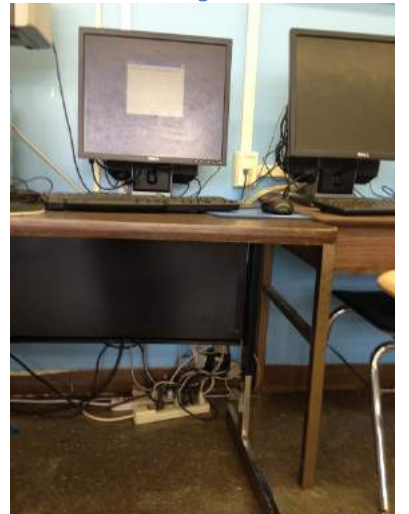
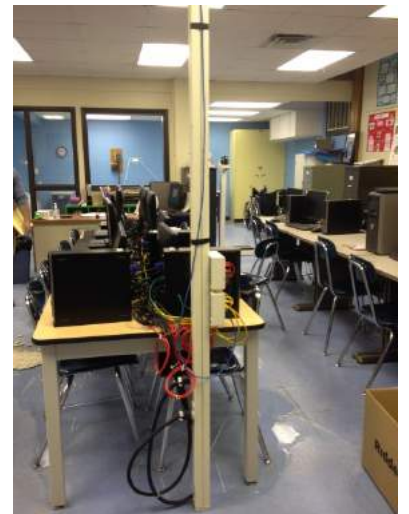
Data cabling has been retro-fitted to accommodate the growing need for technology whether wireless access points or desktop computers. (Image 14 & 15)
