## Architectural Existing Conditions Report

**Northeast Metropolitan Regional Vocational High School**, also known as Northeast Metro Tech, is located at 100 Hemlock Rd, Wakefield Massachusetts. The school was built 1967-68 and was opened in 1968 to teach both traditional high school classes such as English, Math, and Science, along with offering students a multitude of other trades. The existing building is a 3 story, steel joist and masonry framed structure except for the Gym and pool areas where the roof is comprised of large concrete tees. The assumed construction type is Type 2C, not sprinklered. The building measures approximately 624 feet long (at its longest) x 531 feet wide (at its widest) x 33 feet high (at its highest). The building contains a total of 239,444 square feet, spread over three floors. The main floor features multiple levels- one half-level midway into the building and a second half-level by the northwest Carpentry shop wing. Over the last 52 years, there have been a number of additions and minor renovations to the building, including the compressor room for the automotive shop, the storage room for the maintenance department, and numerous partitions to sub

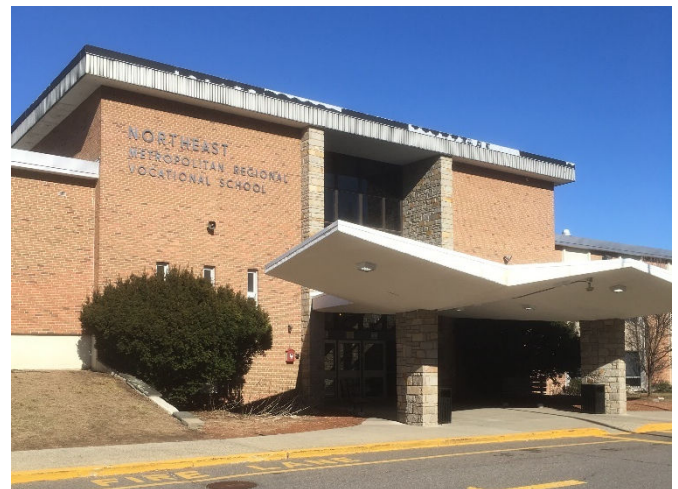
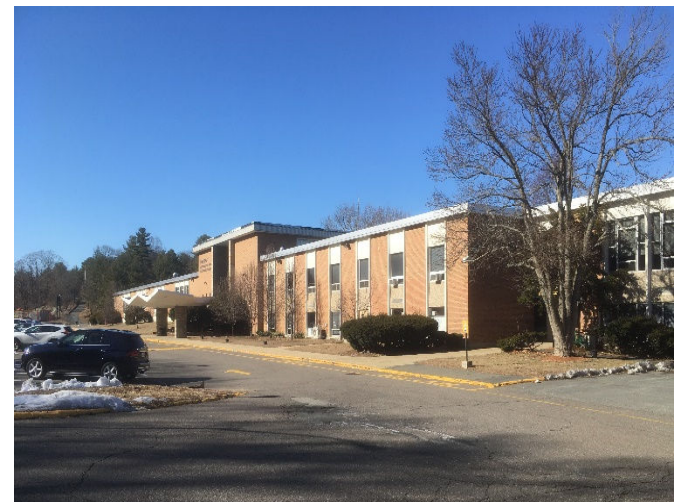
A typical elevated floor is constructed of concrete slab-on-deck supported by steel joist and structural steel girders or precast concrete beams. The lowest levels floors are constructed with concrete slab-on-grade. The typical roof construction is bulb tees (with tectum panels)

supported on steel bar joists and steel girders. Although the building is composed of loadbearing walls, some steel wide flange columns are interspersed throughout the first floor. Concrete columns are located in the basement with isolated spread concrete footings. The exterior masonry walls are supported by concrete strip foundation walls and footings at the lowest level. Fenestration is comprised of single pane windows with non-thermally broken aluminum frames. Also used are fixed translucent panels in non-thermally broken aluminum frames, and metal doors with single-pane vision glass on hollow metal press frames none thermally broken. The front entrance system incorporates hollow metal frames two-stories tall with single-pane glass and single-pane aluminum doors.

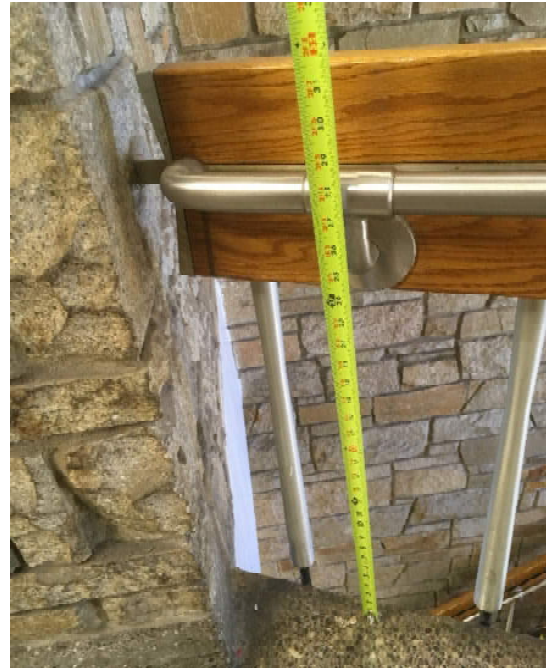
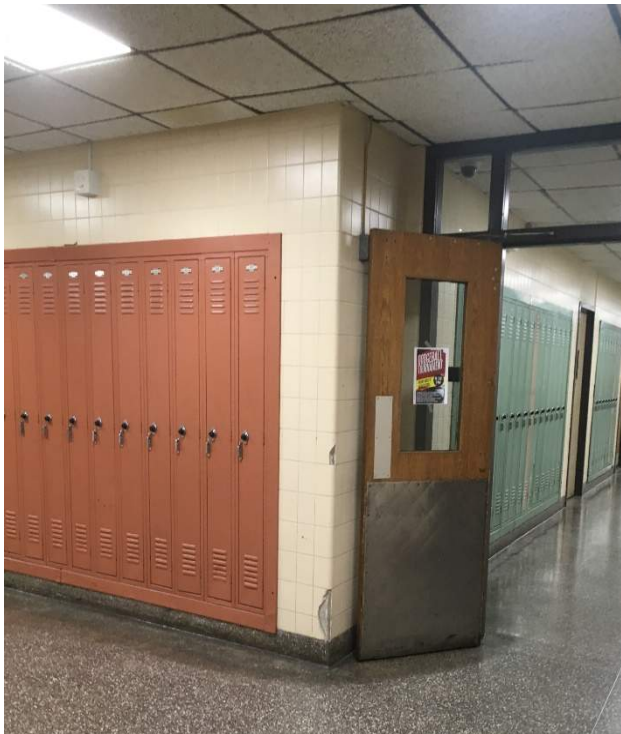
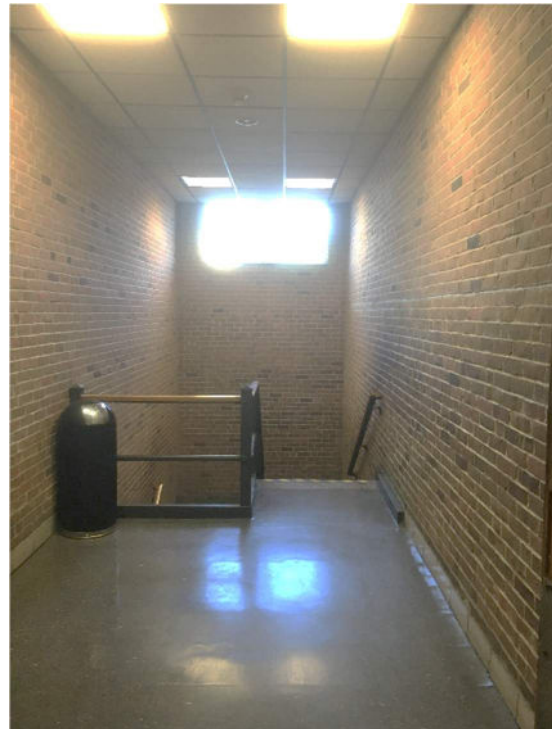
The corridors are all artificially lit with some new LED light fixtures. The acoustic ceiling tiles are being replaced on a maintenance schedules. The corridor terrazzo floors are in

good condition. The brick, painted CMU, and tile walls are all in fair to good condition. Some tiled corners are chipped. Second floor and basement corridors are in similar condition to first floor.

Doors appear to be the original wood doors with half vision panels for corridor doors and small vision panels for classroom doors. Hollow metal frames are in generally good condition except for exterior frames which are rusted and pitted on the exterior side. Most hardware is original to the building and is beyond the expected service life. In addition, most hardware is not barrier-free.

Entrances to some of the classrooms do not meet barrier-free door clearance dimensions. Signage is not Barrier-free and is missing from a significant percentage of classrooms and office doors, making it hard to navigate the building for newcomers and visitors.

**RECOMMENDATIONS:** Existing CMU walls should be painted. Tiled corners should have corner protection. Metal Lockers should be replaced with wider lockers and double tiered. Replace all Doors and Hardware. Provide magnetic hold open hardware at all corridor doors. Provide Exterior door with weather protection hardware including electrical security monitoring protection. Provide fabric wrapped acoustical panels to help with sound control within the two and half-story lobby space. Consider relocating the security desk to the waiting area of the Admin space and recreating an airlock vestibule in the enclosed lobby space. Provide an elevator to make the Main Entrance barrier-free. Replace all guardrails and handrails to meet code, including at all stairs. Provide lifts or ramps at all stairs and half-flight stairs.

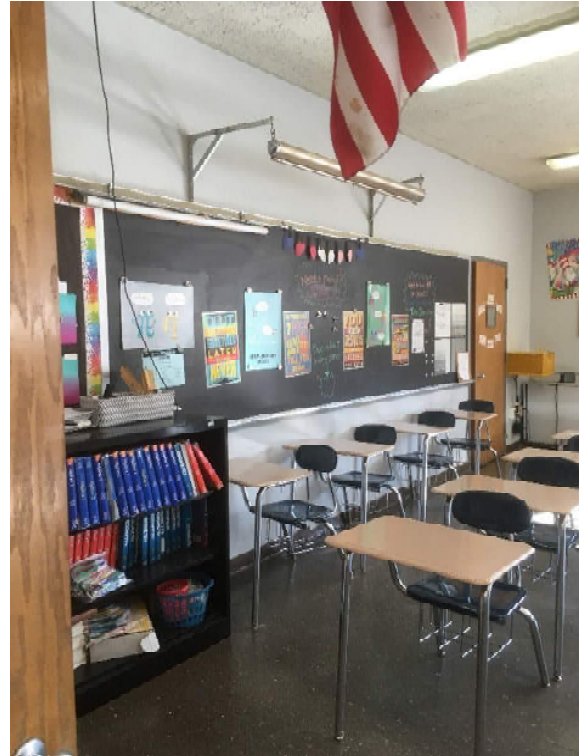
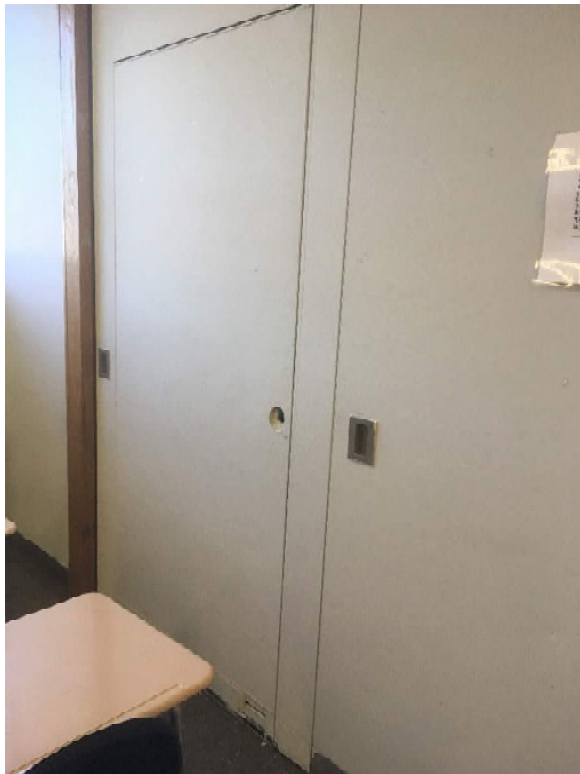
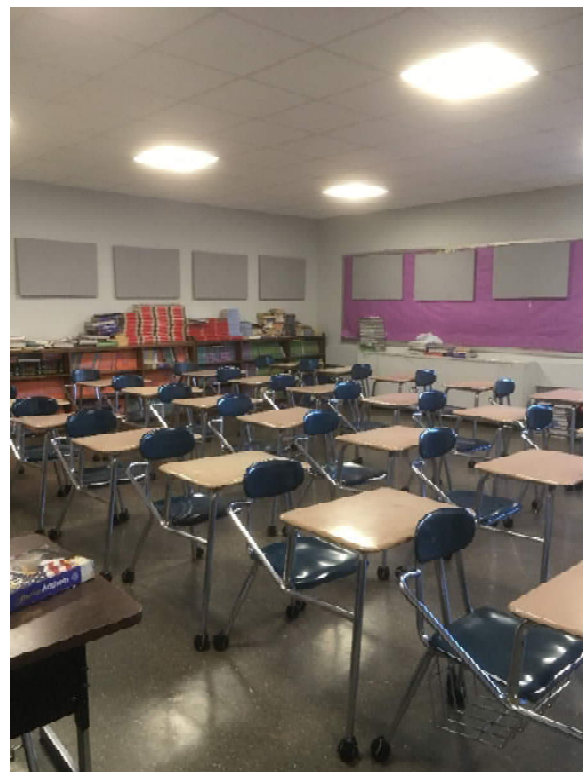
General Classrooms are located at the first and second floors of the building. There are also classrooms in the Vocational Areas which serve as Related Rooms for these programs. Each of the classrooms have similar finishes comprised of ACT ceilings, CMU or Plaster Walls, and VCT flooring. The ACT Ceilings throughout are in poor condition- badly damaged, sagging, and water stained. Most have the original 1x1 conceal-spline tiles. The CMU and plaster walls are generally in fair to good condition, structurally intact but with tired finishes. A few of the classrooms, including Related Rooms, are interior spaces with no access to daylight. Some new partitions have been installed in certain locations to create classrooms but provide poor acoustical separation from the adjoining spaces.

On the second floor there are a few classrooms separated by the movable partitions that are in poor shape, do not provide adequate acoustical separation between the spaces, and do not have functioning pass-doors. Floors are VCT with extensive degradation, wear, and damage. Some areas of tile have been replaced with non-matching VCT. Doors are original wood and metal, all in metal frames, which are in poor condition, heavily used, and badly worn. Most hardware either functions poorly or is inoperable. Window systems are as categorized elsewhere in this report, in poor condition. Minimal storage exists within classrooms. Display boards in classrooms vary between green chalk boards and whiteboards. All are in poor to fair condition. Every room observed has a smart projector for interactive instruction. There are several variations to the size and configuration of the academic classrooms.

**RECOMMENDATIONS:** Replace all finishes and ceiling systems. Install new lighting and HVAC Systems. Existing CMU walls to be patched and painted. Replace all VCT Flooring with Linoleum or LVT tiles. At second floor and first floor over basement classrooms install linoleum floor finish with acoustical properties. Replace all Doors and Hardware. Replace all writing boards with new whiteboards and tackboards. Replace all casework. Provide new smart boards or teaching monitors with new technology to bring classrooms to 21<sup>st</sup> century teaching style.
