## EXISTING CONDITIONS AND FEASIBILITY REPORT

### I. HEATING, VENTILATING, AND AIR CONDITIONING

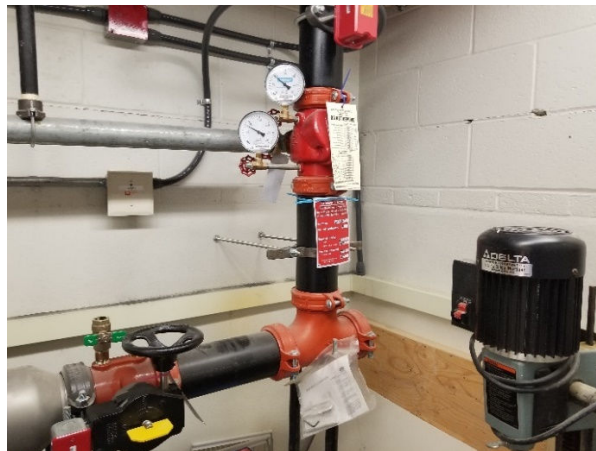
Existing 4 inch Fire Service entry to Carpentry Shop with 4 inch system riser

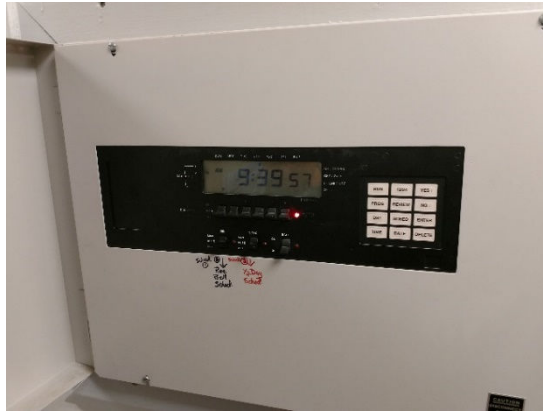
- a. There appears to be a functioning clock system that requires manual adjustments and setting. A limited quantity of existing clocks is controlled by a Simplex central clock control panel located in the front administrative office area. The school essentially does not include a fully functional central clock system.

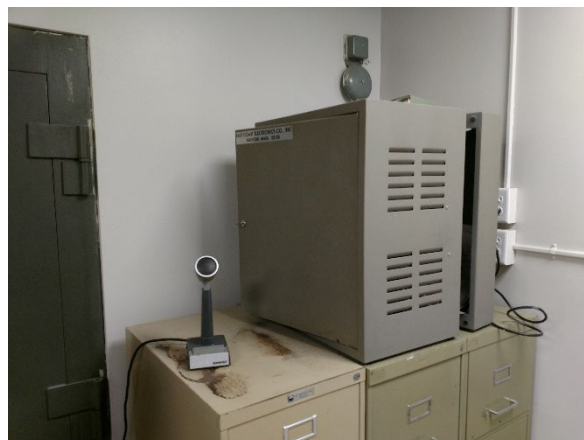
- a. Internal phone distributions appear to be voice over internet protocol (VoIP) and communication wiring appears to be aged beyond its expected life. The phones appear to be operational, but do not appear to support many of today's phone system technologies.
