GEOTECHNICAL ANALYSIS

Re: **Geotechnical Report**
Proposed Northeast Metropolitan Regional Vocational Technical High School
Wakefield, Massachusetts
LGCI Project No. 2025

**GEOTECHNICAL REPORT
PROPOSED NORTHEAST METROPOLITAN
REGIONAL VOCATIONAL TECHNICAL HIGH SCHOOL
WAKEFIELD, MASSACHUSETTS**

LGCI Project No. 2025

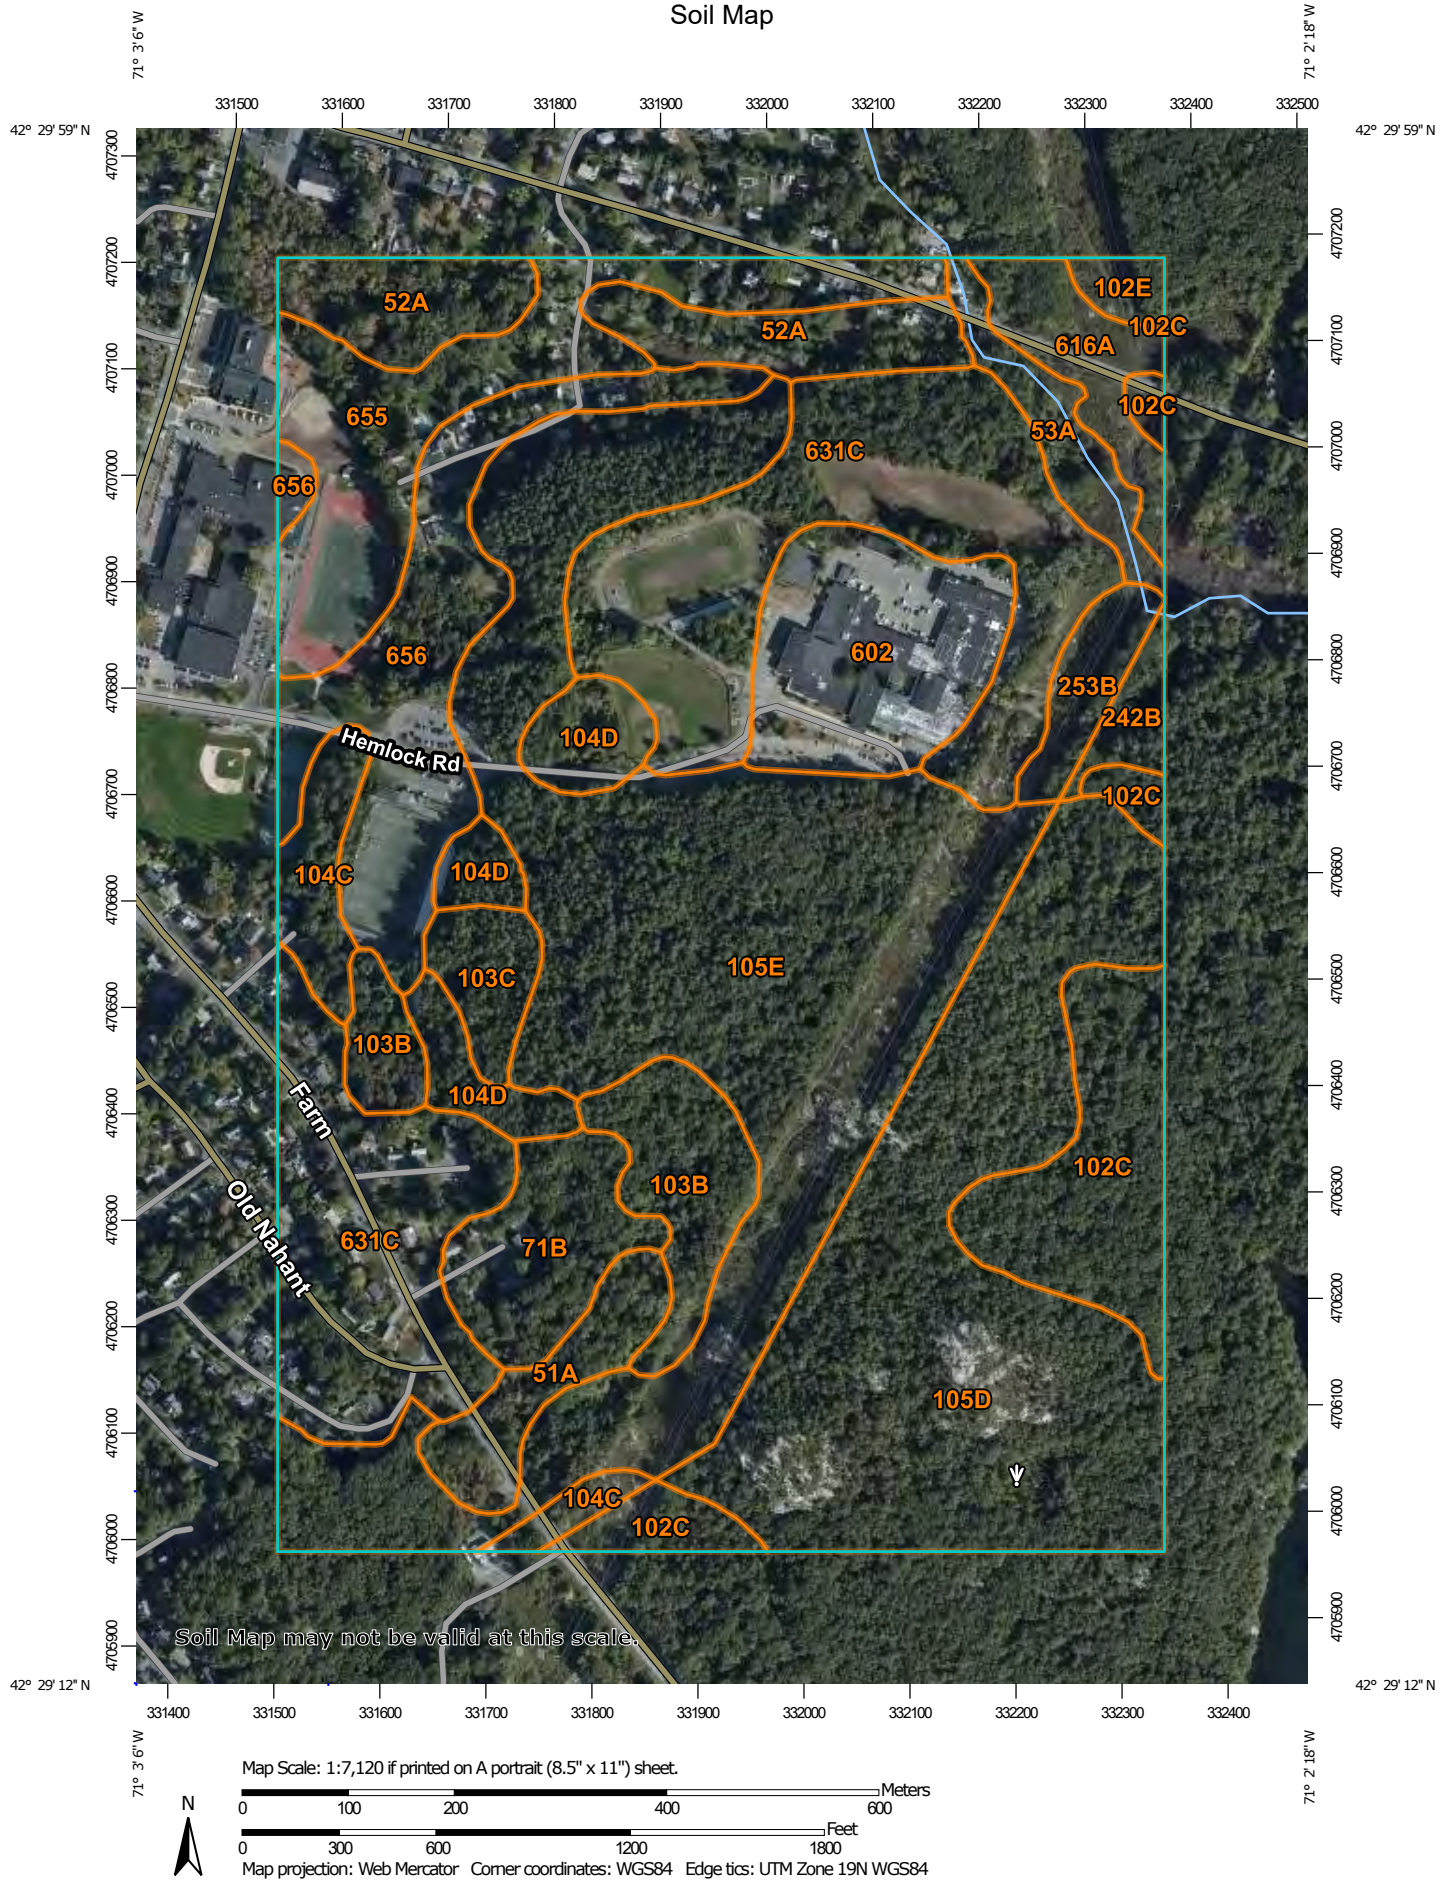
Custom Soil Resource Report Soil Map

The soil map section includes the soil map for the defined area of interest, a list of soil map units on the map and extent of each map unit, and cartographic symbols displayed on the map. Also presented are various metadata about data used to produce the map, and a description of each soil map unit.

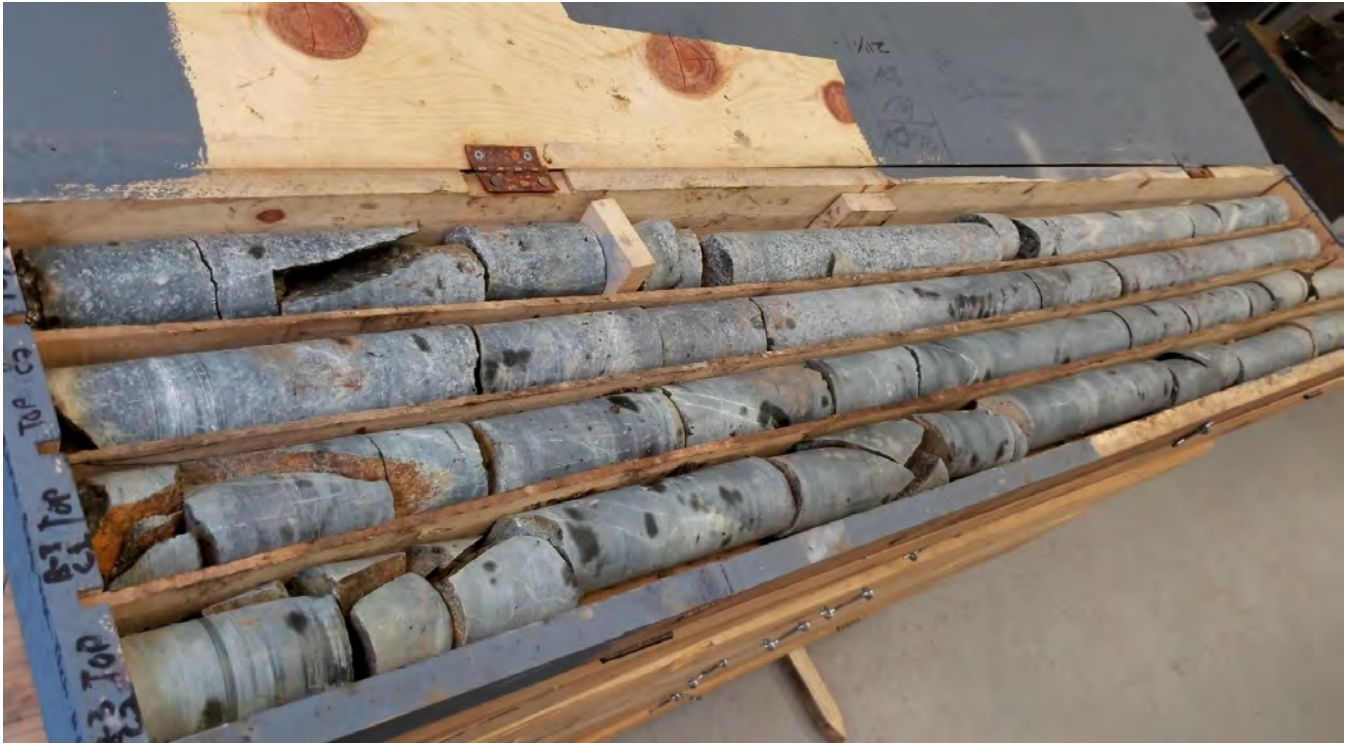
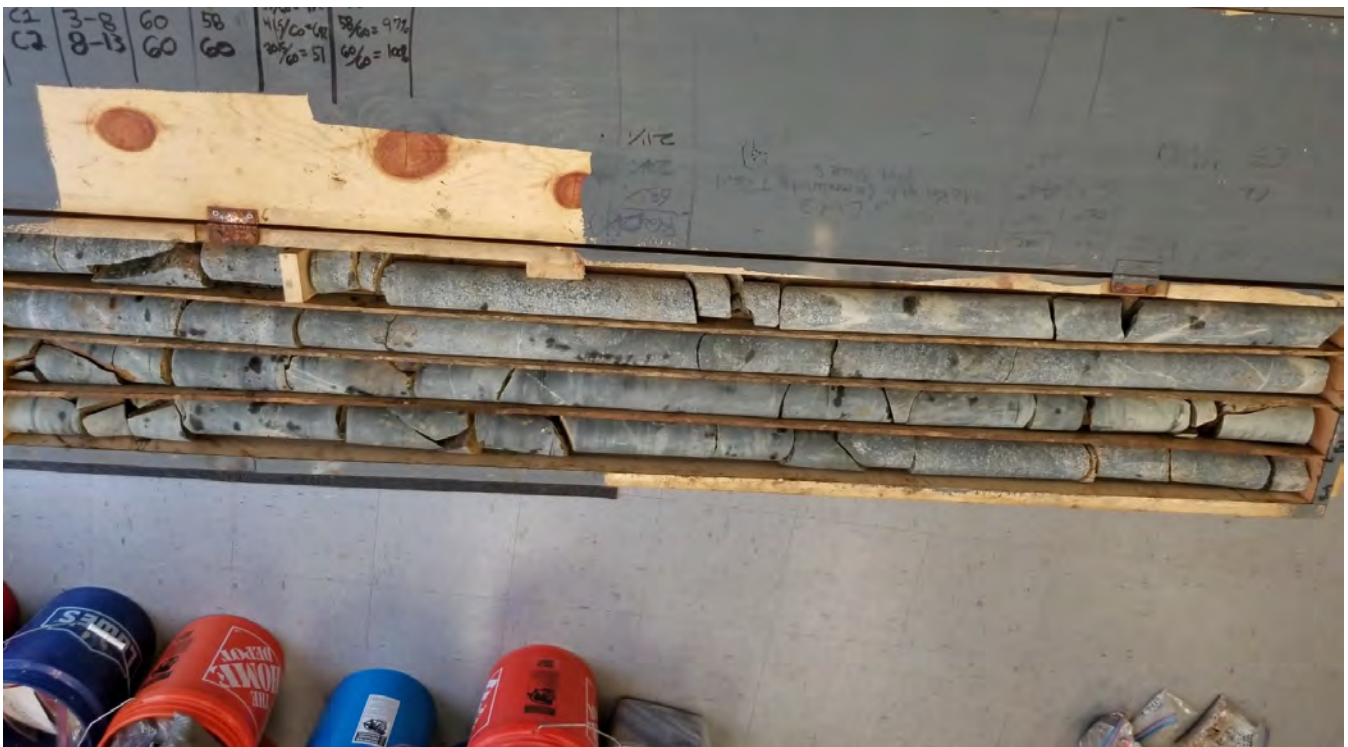
Core Photos (from top): B-1-C1, B-1-C2, B-3-C1, B-3-C2

To confirm and characterize the rock, rock was cored in borings B-1-OW, B-3-OW, and B-101-OW to B-106. The rock generally consisted of hard to very hard, slightly weathered to fresh, extremely fractured to sound, fine-grained to medium-grained, gray to blue, Rhyolite. The rock core recoveries ranged between 81 and 100 percent and the Rock Quality Designation (RQD) ranged between 46 and 100 percent. The coring rate was generally less than 20 minutes per foot
